**Panama Maritime Authority**  
Directorate General of Merchant Marine  
Marine Accident investigation Department

**M/V “MSC ELOISE” & FISHING BOAT  
“CIUTAT DE BENICARLO” R- 026-2012-DIAM  
Date: 23rd May 2012**

**REPORT OF INVESTIGATION**

**FISHING BOAT “CIUTAT DE BENICARLO”**

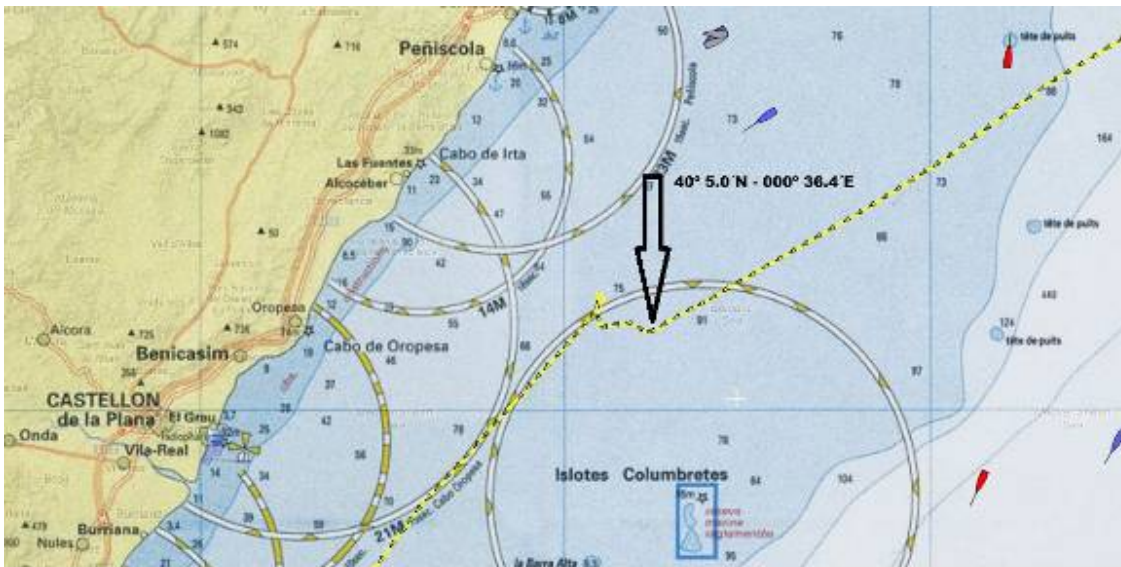
Figure 1 – MSC ELOISE AIS track, location of collision and location of Islotes Columbretes

- 1.10 The collision occurred at 08, 10 hrs LT in position 40° 50.0' N – 000° 36.4' E. while the vessel was on a heading of 242° with a speed of about 19 kt.

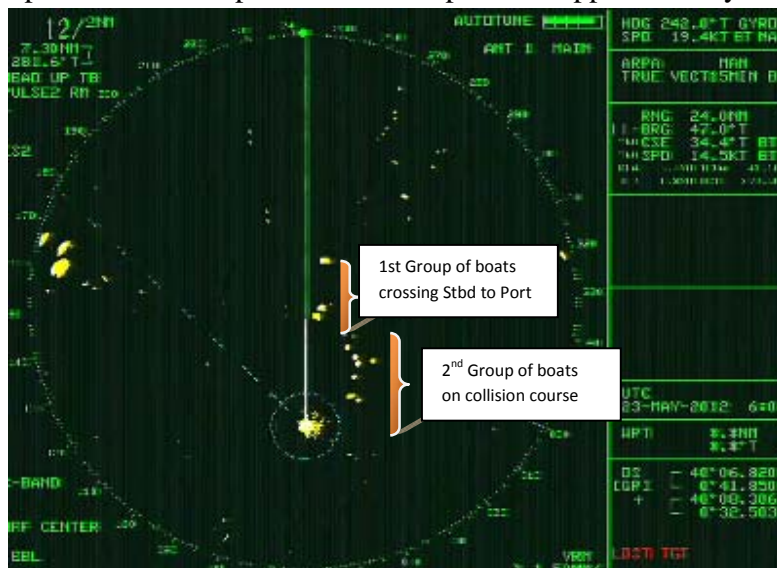
VDR – Radar: 23<sup>rd</sup> May 12 08.00 hrs (UTC+2)

- 5.10 When arriving on the bridge the Captain found the Chief Officer looking forward to a group of fishing boats situated forward on the starboard side.

- 5.11 This Group of boats was reported to be composed of approximately 15 fishing boats.

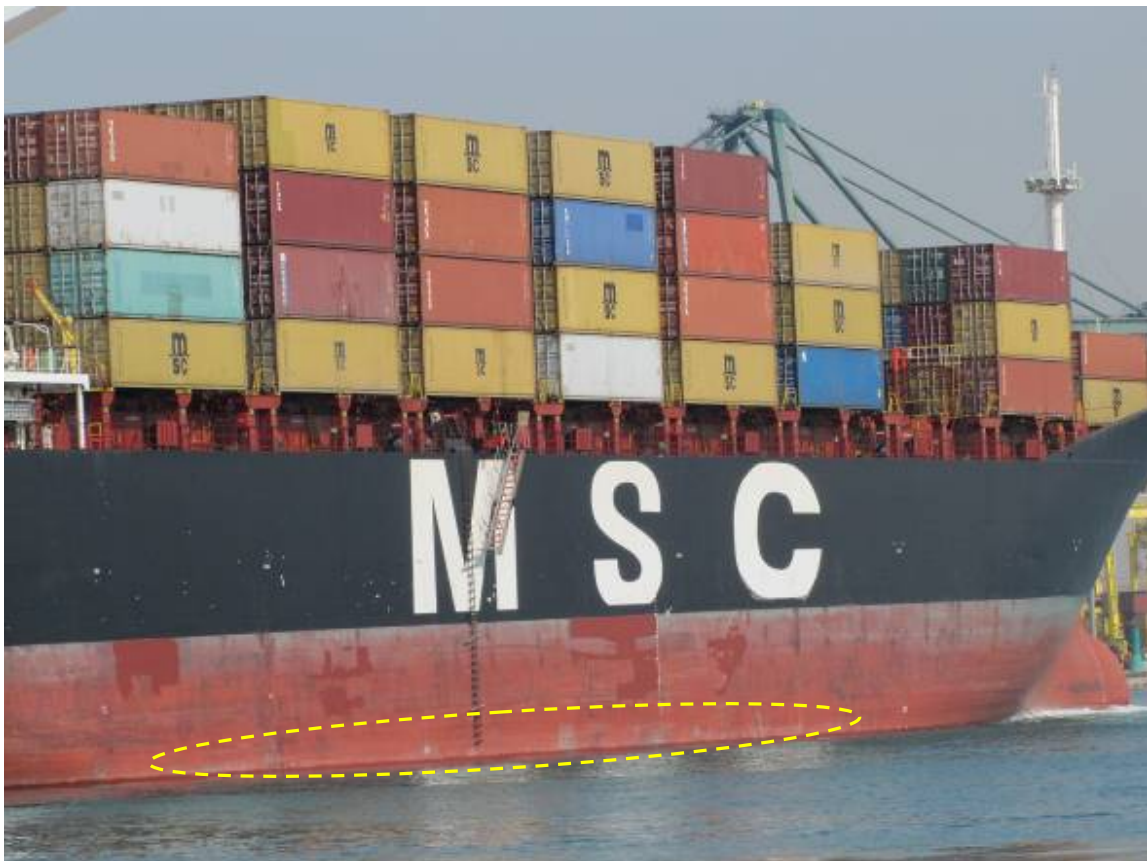
Figure 7 – MSC ELOISE light scratches on parallel body

- 1.13 Neither visual damages nor pollution was observed and only small scratches on the hull coating were seen on the vessel's parallel body.

Several LIGHT scratches on hull paint were reported from Hold no. 3 to Hold no. 5 on the starboard side parallel body above the waterline.

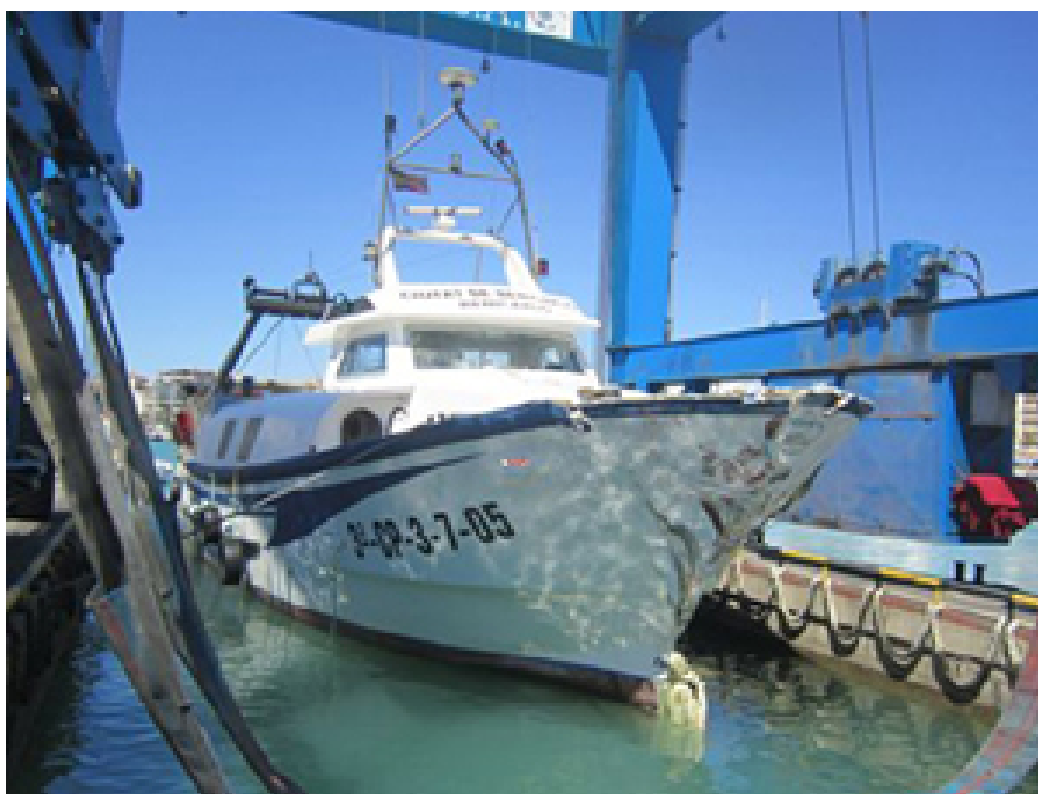
Figure 8 – CIUTAT DE BENICARLO Damages on forward end

- Forward bulwark and deck cracked
- Forward hull damaged and cracked
- Bulbous bow damaged

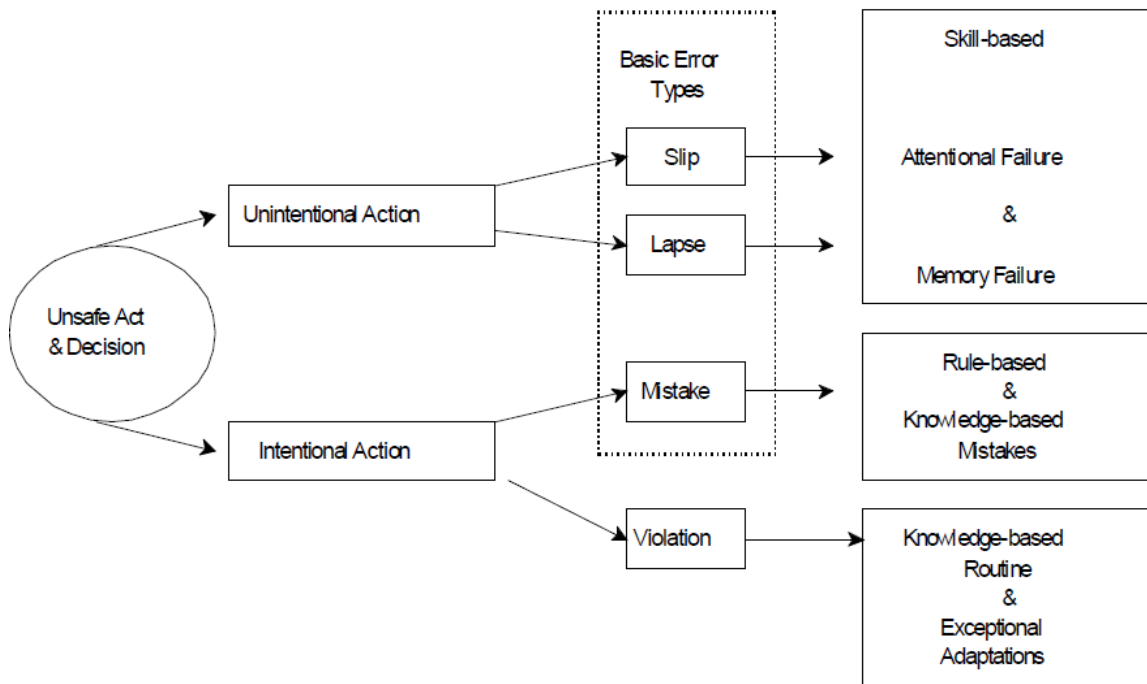
The analysis is drawn from the figure below with the identification of the type error or violation

8.1 Based on the fact and the assumption that the lookout of the boat might have been away from the navigational bridge the error lies on an intentional action leading to a mistake.
