## **Mv MANISA STAR**

**VERY SERIOUS MARITIME CASUALTY**

**Loss of contention, with loss of one life**

Maritime safety investigation report

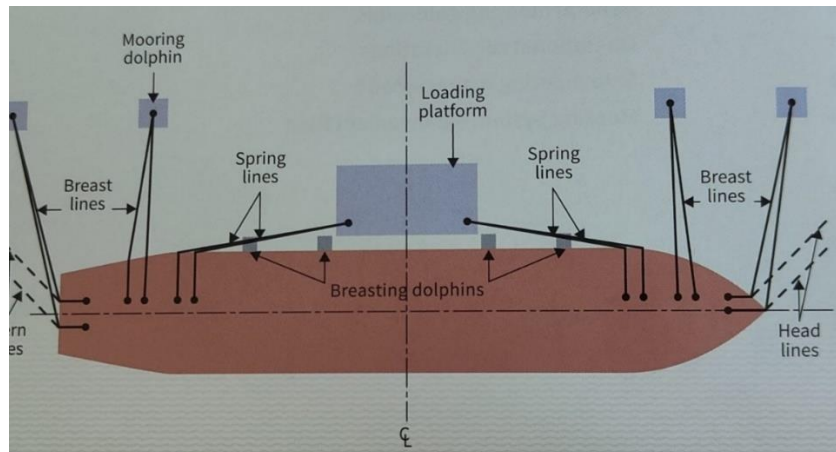
Figure 2 – Example of mooring pattern and mooring lines in use.

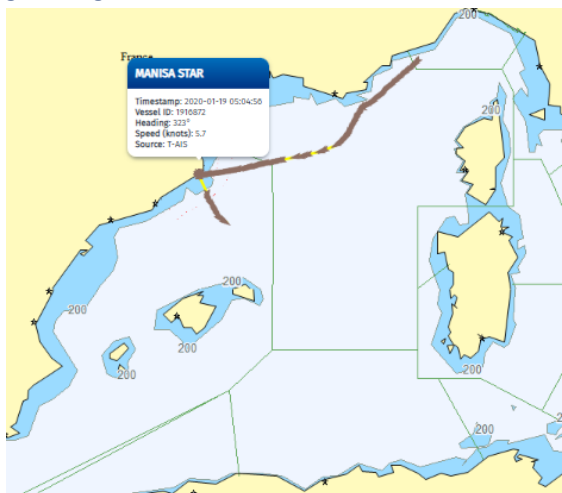
- 23/01/2020, at 18:27 hours  
Mv MANISA Star departed from Pálamos port (right figure).

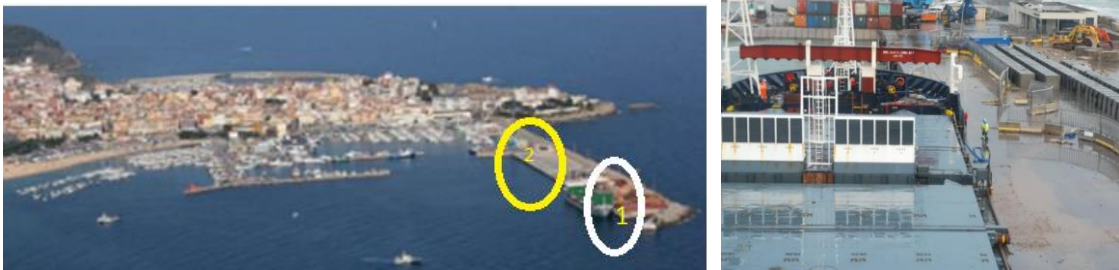
Palamos port entrance was closed to all navigation due to the weather conditions and sea state, the harbour was also closed and there was no linesman nor tugs available. The vessel shifted 150 meters forward to position 2, indicated below, using the main engine and crew.

Figure 3 – Mv MANISA STAR shifted from position 1 to position 2 to better protection of adverse forecasted weather conditions

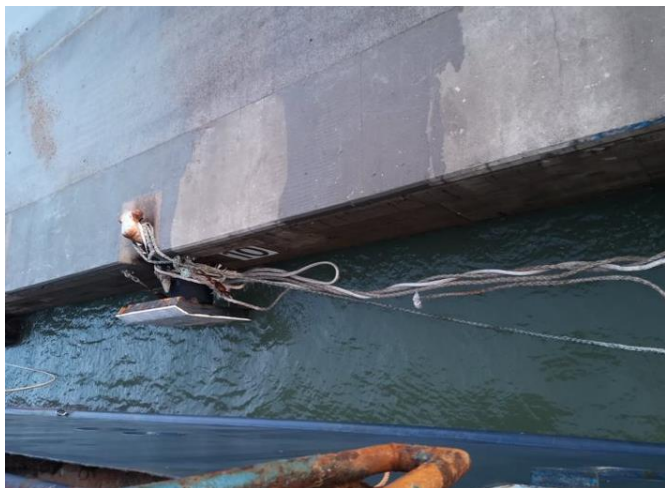
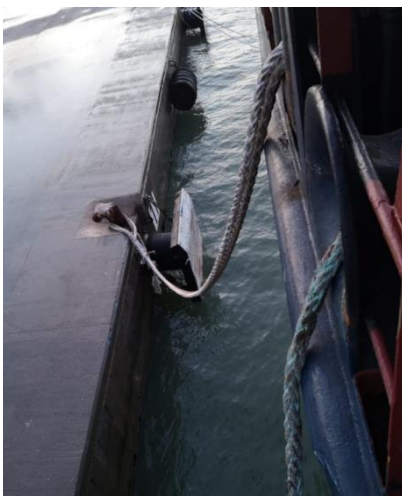
MANISA STAR crew replaced eight parted mooring lines during the passage of storm Gloria, both aft and forward. In November 2019 the new owners purchased two coils of 220 meters each, i.e., 4 mooring lines were purchased for the vessel. On the day of the occurrence MANISA STAR had four new mooring lines and four mooring lines from previous owner. After the occurrence ten new mooring lines, in five coils, were provided to MANISA STAR.

On the day of the occurrence MANISA STAR was moored as follows:

- Forward – 4 headlines, 2 brest lines, 3 spring lines;
- Aft – 4 stern lines, 3 spring lines;
