Panama Maritime Authority
Directorate General of Merchant Marine
Marine Accident investigation Department

REPORT: M/V “TERVE”R-047-2014-DIAM
IMO No. 9204348
DATE: 27th February 2014

REPORT ON THE INVESTIGATION OF THE COLLISION OF

**m.v. “TERVE”
IMO number 9204348
Register Number 2639499CH**

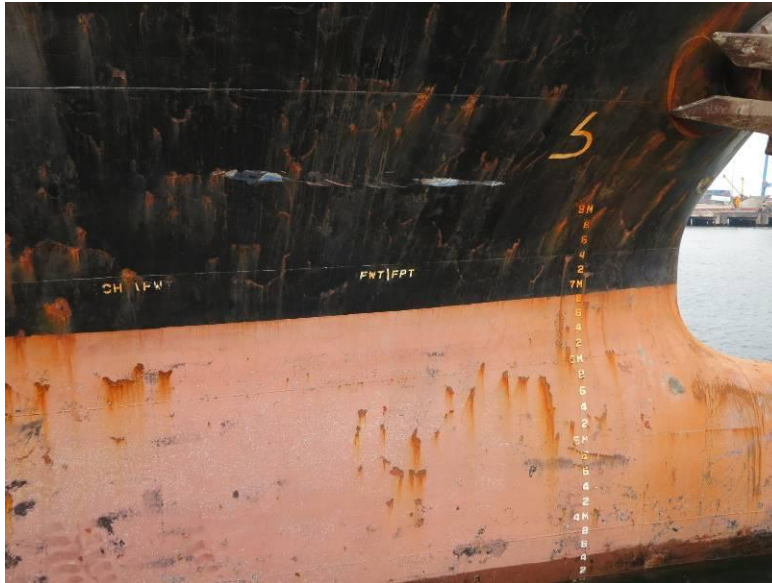
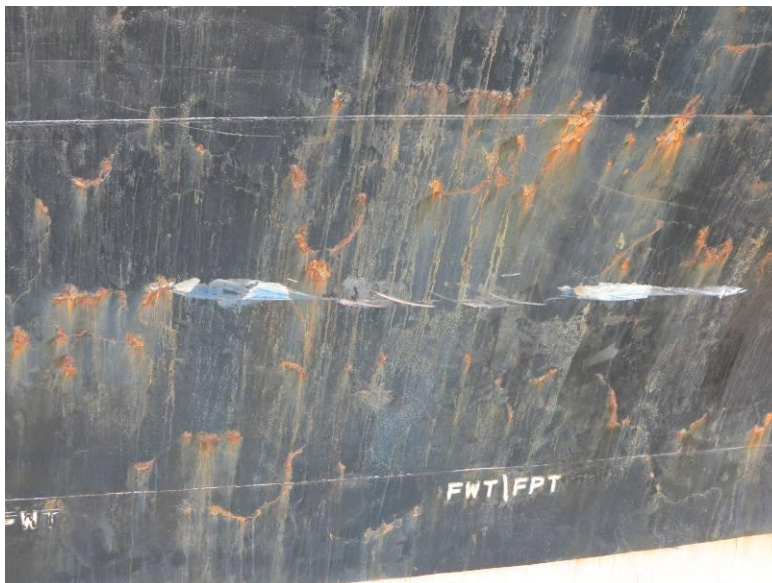
5.1 The TERVE suffered no damages to her hull or structural items

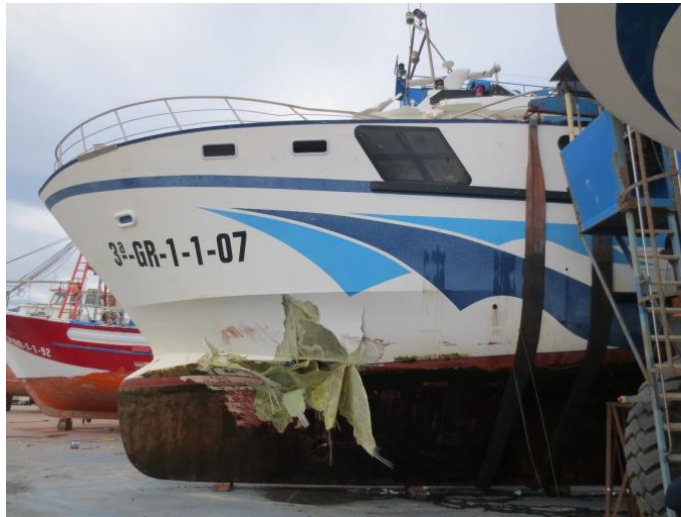
5.2.1 Holes and cracked hull forward port side

Figure 5.1– Hull Damages on Port side

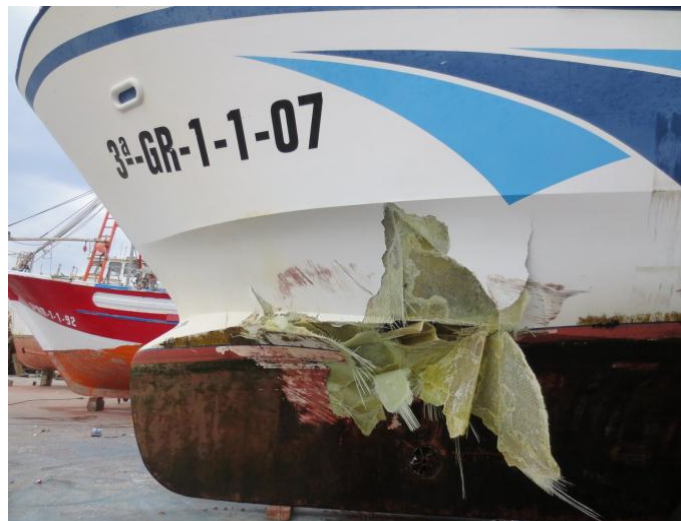
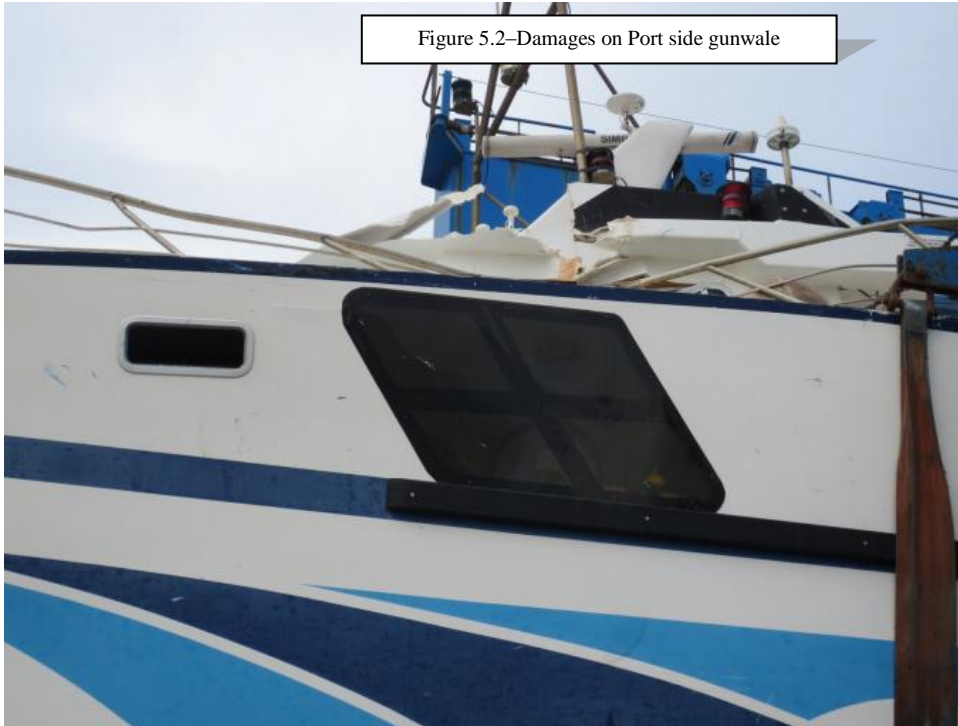
5.2.2 Cracked fiber next to gunwale and fissure in the methacrylate

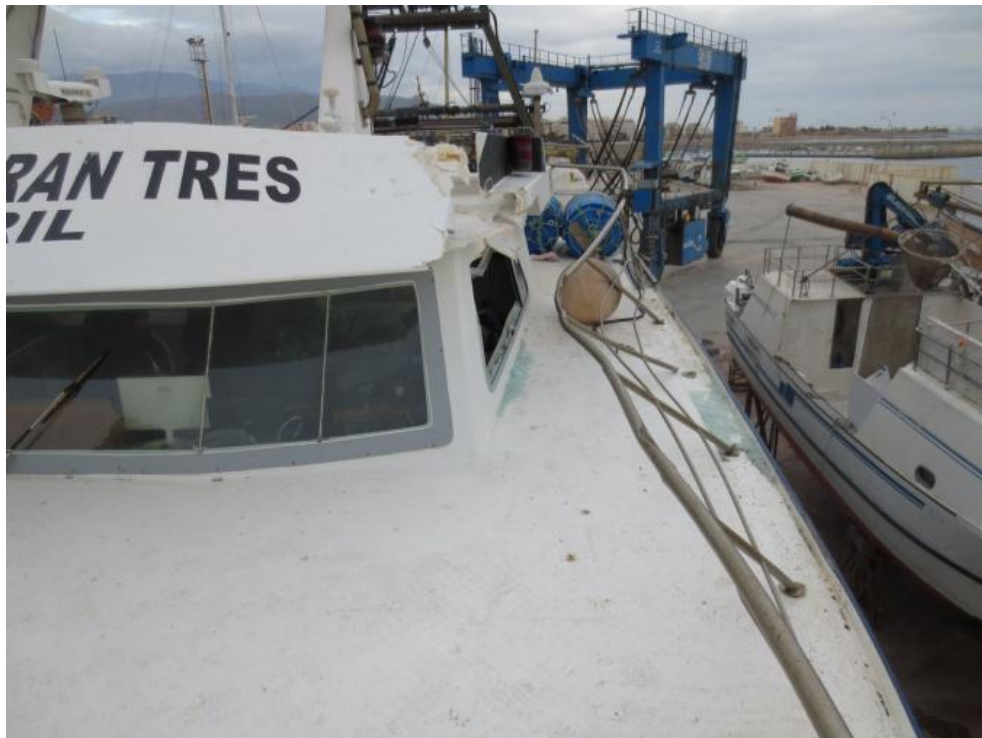
5.2.3 Handrail bent inwards

Figure 5.3–Damages on Port side handrail

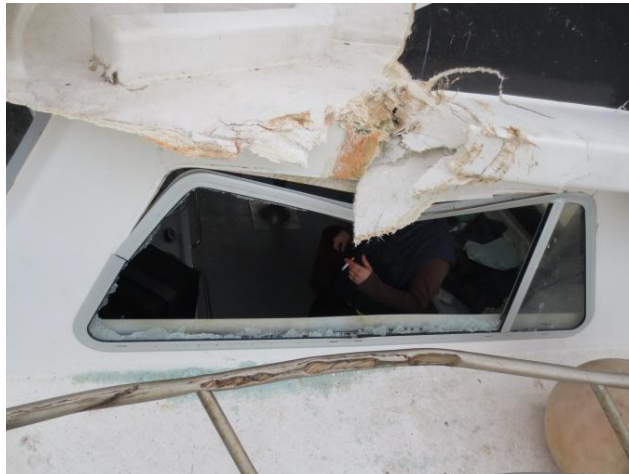
5.2.4 Port side bridge fiber torn and window broken

Figure 5.4–Damages on Port side bridge

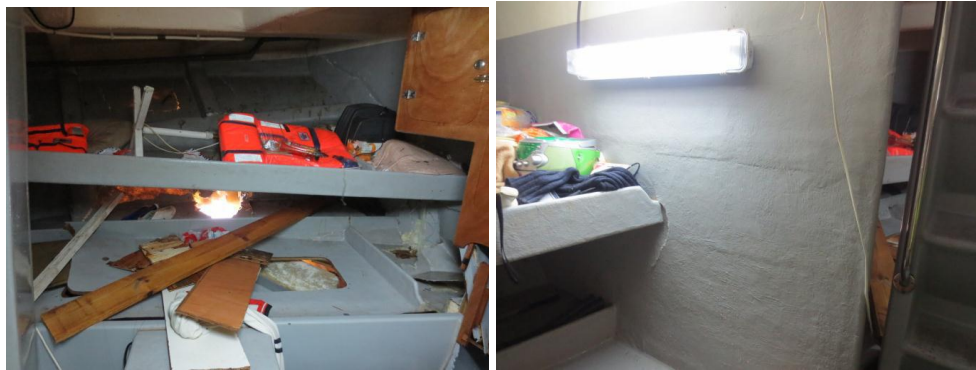
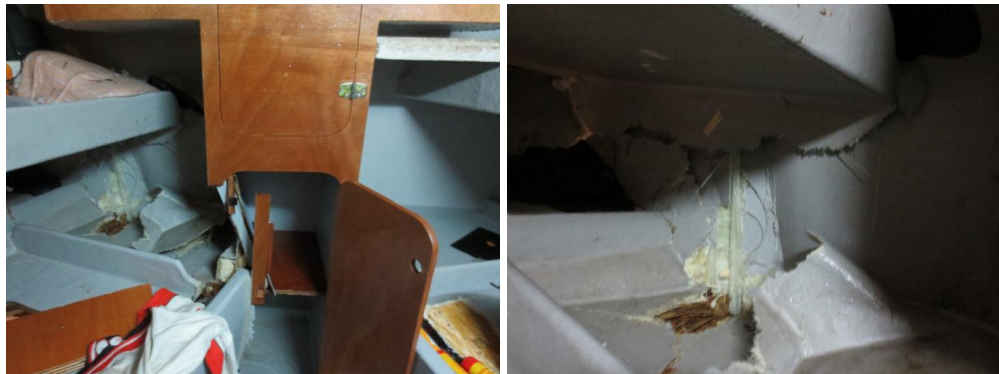
5.2.5 Forward port side cabin damaged

Figure 5.5/5.6/5.7.5.8–Damages on Port side accommodation

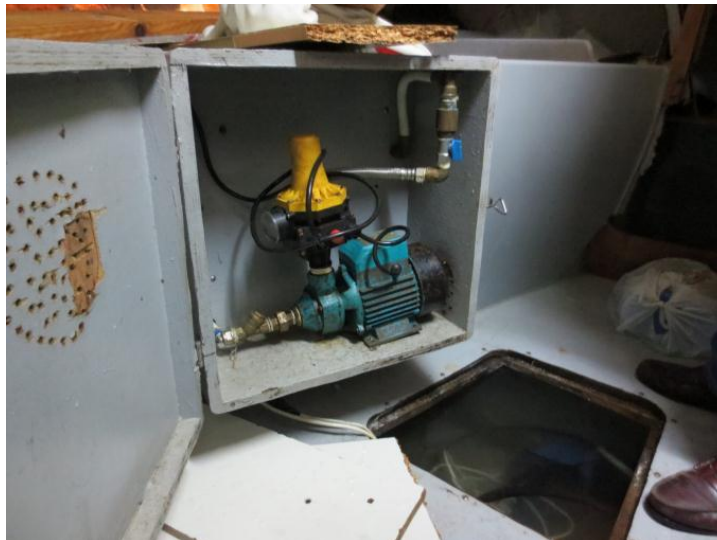
5.2.6 Bilge pump displaced

Figure 5.4–Damages on bilge pump
