Report on the investigation of the
grounding of
Muros
Haisborough Sand
North Sea
3 December 2016

At 0248 (UTC+1) on 3 December 2016, the bulk carrier *Muros* ran aground on Haisborough Sand on the east coast of the United Kingdom. Attempts to manoeuvre clear of the shallows were unsuccessful but the vessel was re-floated 6 days later with tug assistance. There were no injuries and no pollution, but damage to *Muros*'s rudder necessitated the vessel being towed to Rotterdam, Netherlands, for repair.

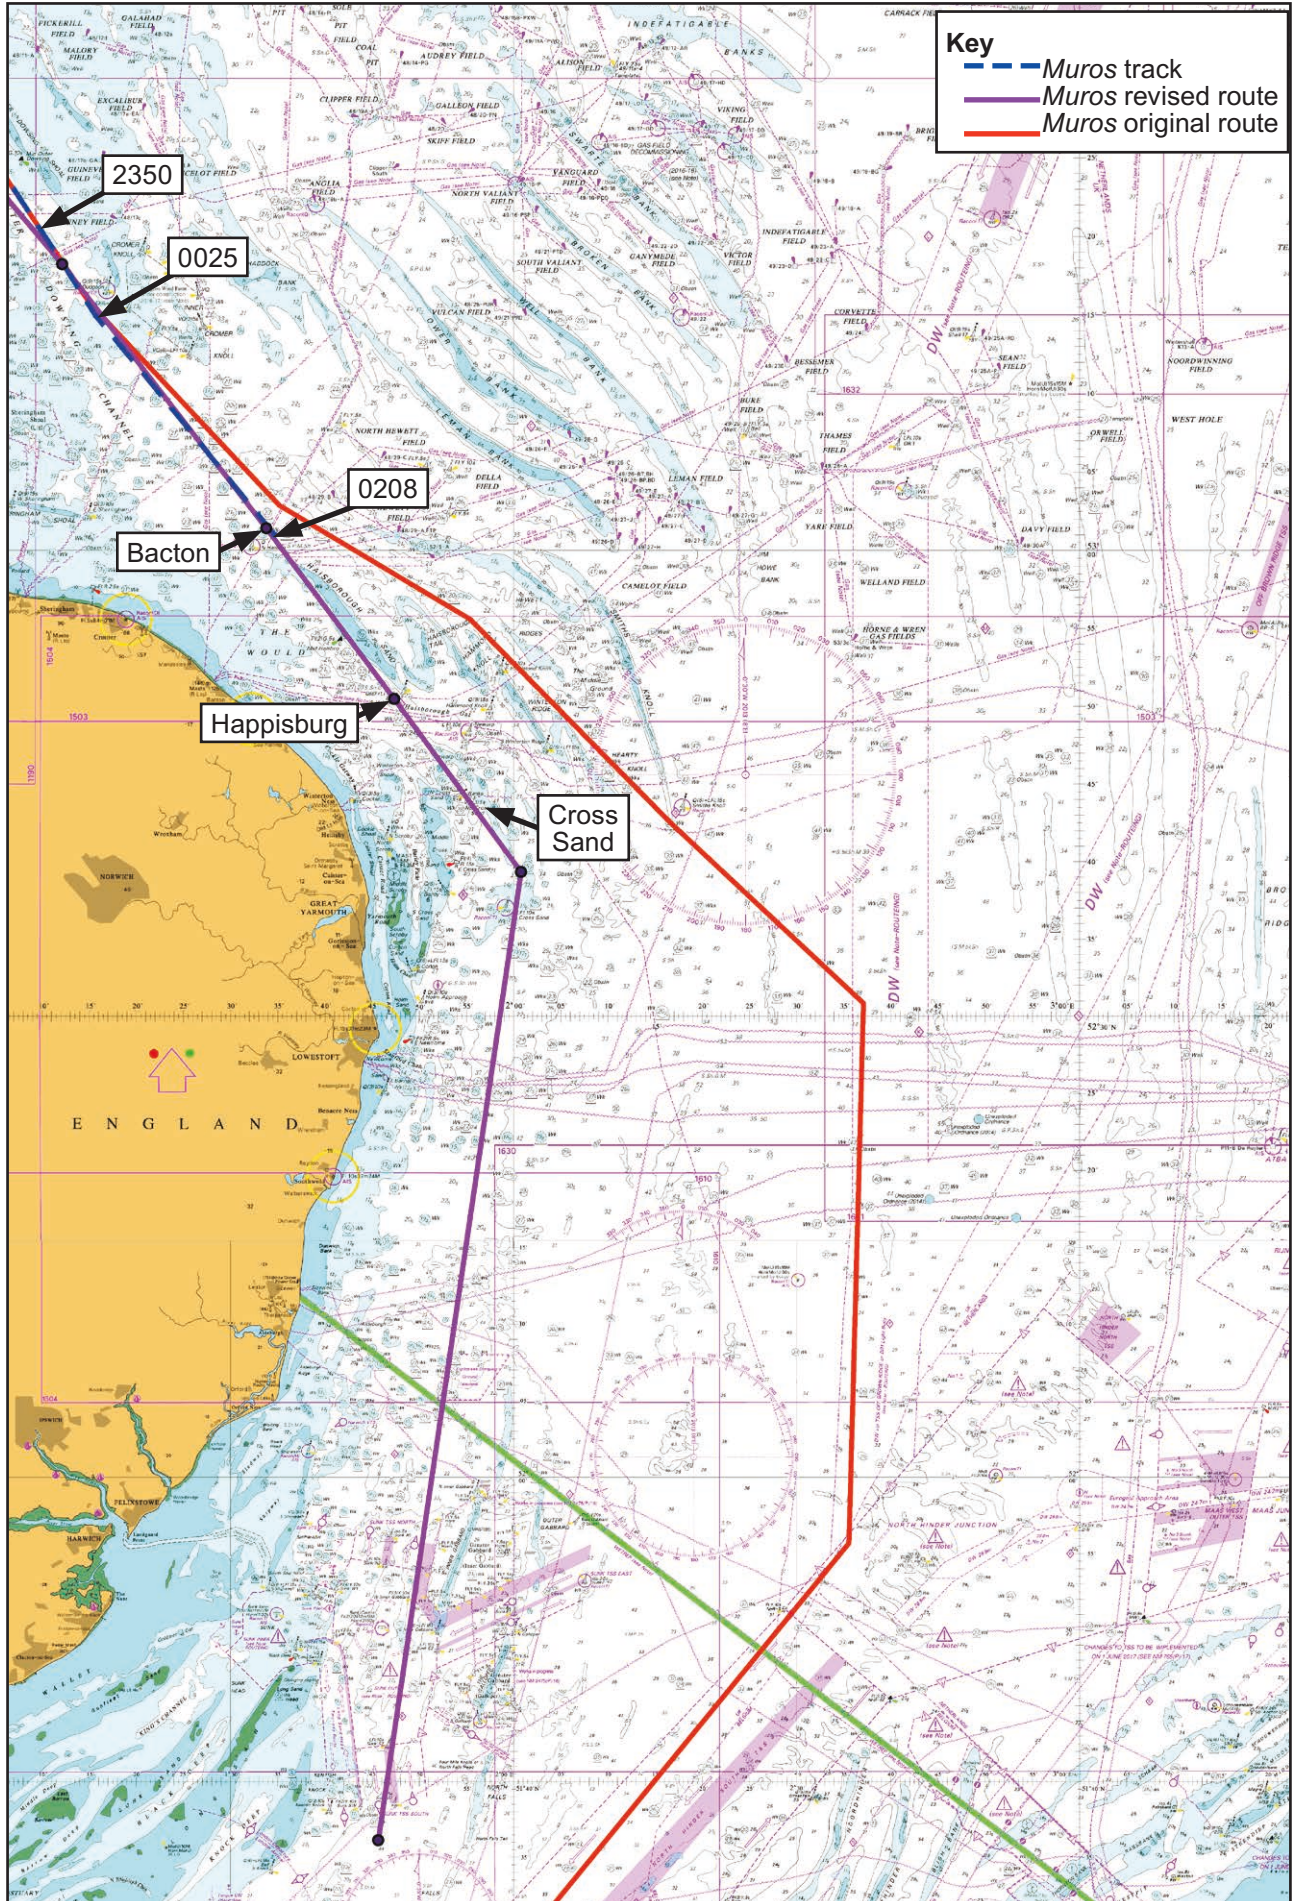
Figure 1: Extract of original and revised passage plans
(note: all times UTC+1)

The 2/O used the ECDIS mouse and cursor to 'drag and drop'⁸ several waypoints included in the original voyage plan (including waypoints 'Bacton' and 'Happisburg') further to the west (Figures 1 and 4). She then scanned over the amended route starting at the Sunk TSS and working towards the north.

While scanning the route, the 2/O noticed that the revised track appeared to pass close to Cross Sand, the shallows to the south of Haisborough Sand. The 2/O zoomed onto a larger chart scale that provided better clarity and saw that the course line was more than one mile from the shoal water indicated by the safety contour.

The 2/O zoomed back out to a smaller chart scale and thought that the intended course line also passed close to the shallows of Haisborough Sand. However, the proximity of the course line was similar to the course line she had recently checked further to the south, and she did not zoom onto a larger scale to obtain a more accurate assessment. The 2/O assumed that the course line would be clear of the safety contour by a similar margin to that near Cross Sand.

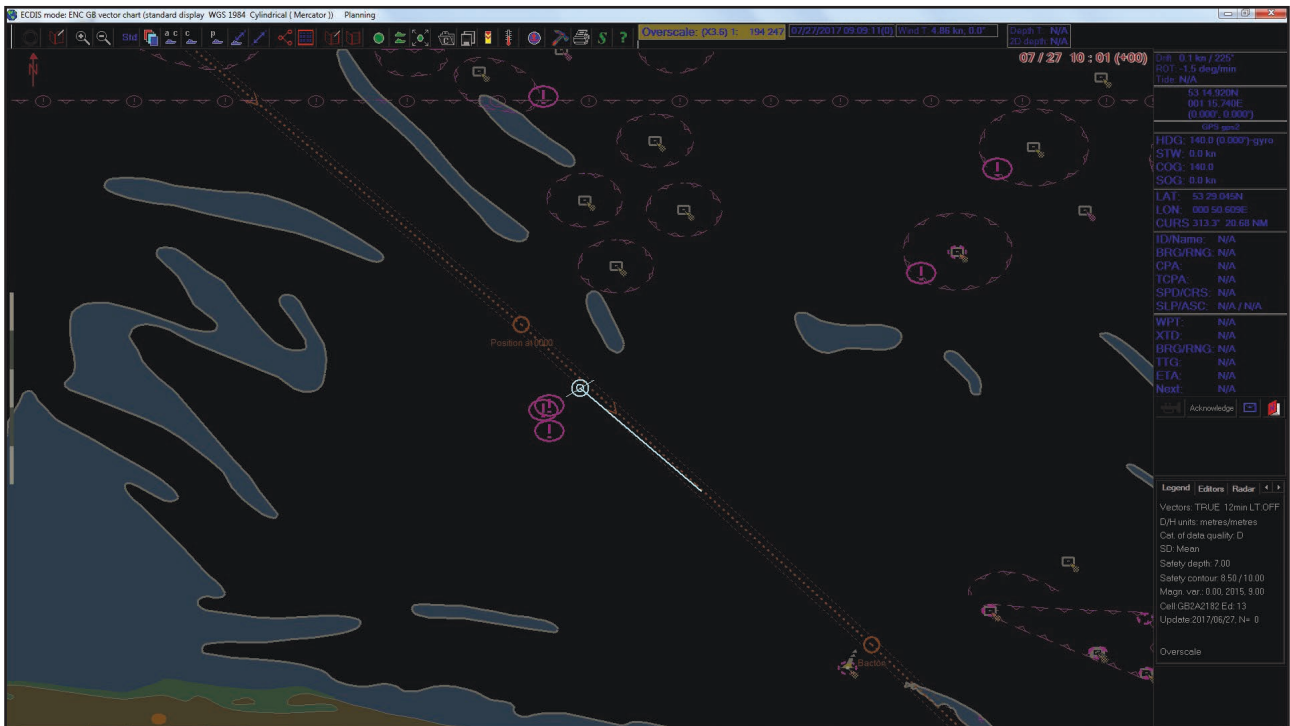
Figure 3: Reconstruction of ECDIS display at 0025

The 2/O amended the passage plan on the ECDIS at the starboard bridge conning position (**Figure 2**) and at 0025 she adjusted the vessel's heading set on the autopilot to 140° to follow the revised track (**Figure 3**). The 2/O then sat in the starboard chair. The lookout alternated between standing on the bridge's port side and sitting in the port chair. He routinely reset the BNWAS.

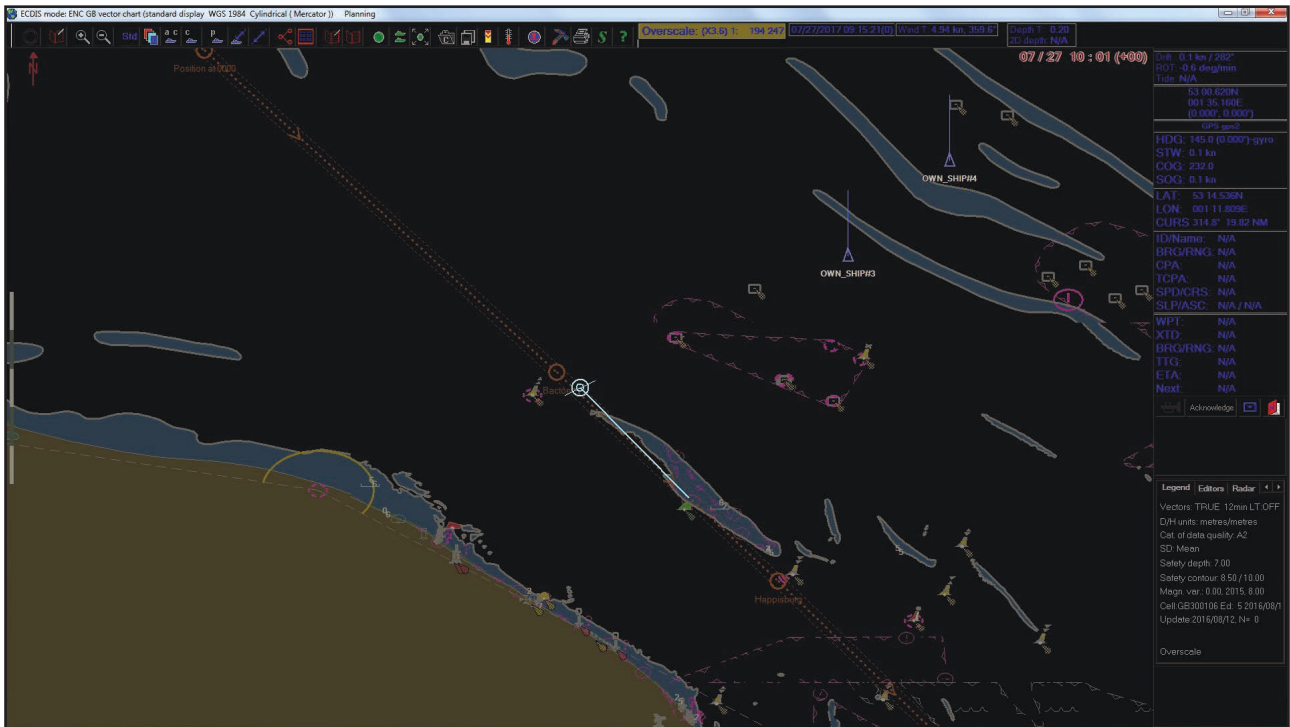
Figure 4: Reconstruction of ECDIS display at 0208

Over the next 1½ hours, the bridge watch remained very quiet with only a few other vessels in the vicinity. At 0208, *Muros* was 600m to the north-east of the revised track and was making good a speed of 10.1kts when the 2/O adjusted *Muros*'s heading to 146° towards waypoint 'Happisburg' to the south of Haisborough Sand (**Figure 4**).

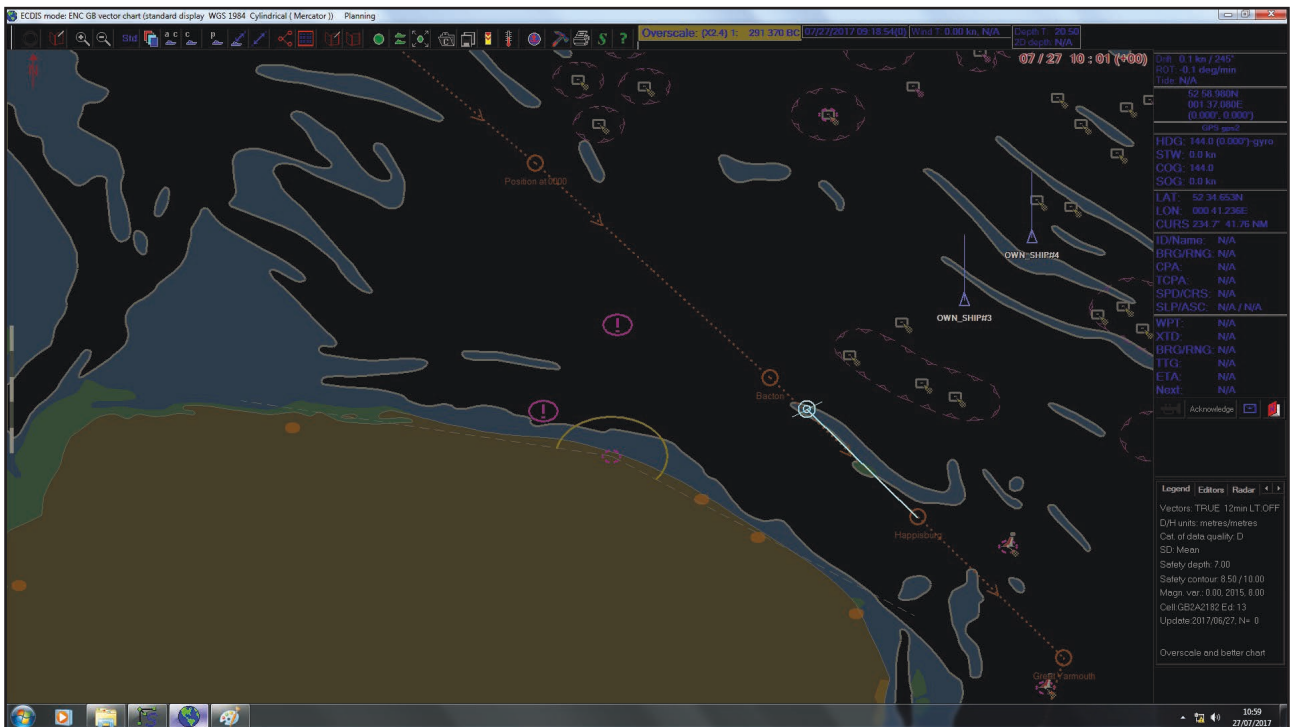
Figure 5: Reconstruction of ECDIS display at 0220

At 0220 (**Figure 5**), the 2/O noticed that *Muros*'s speed shown on the ECDIS display had reduced to 9.1kts. She thought this was unusual as there had been no change in the wind or sea conditions. At 0248 (**Figure 6**), the 2/O felt a change in the vessel's motion and saw its speed quickly reduce. In response, she selected manual steering. The 2/O also called the master and informed him that the vessel's speed was only 0.8kt, but that she did not know why. The master told the 2/O to inform the chief engineer.

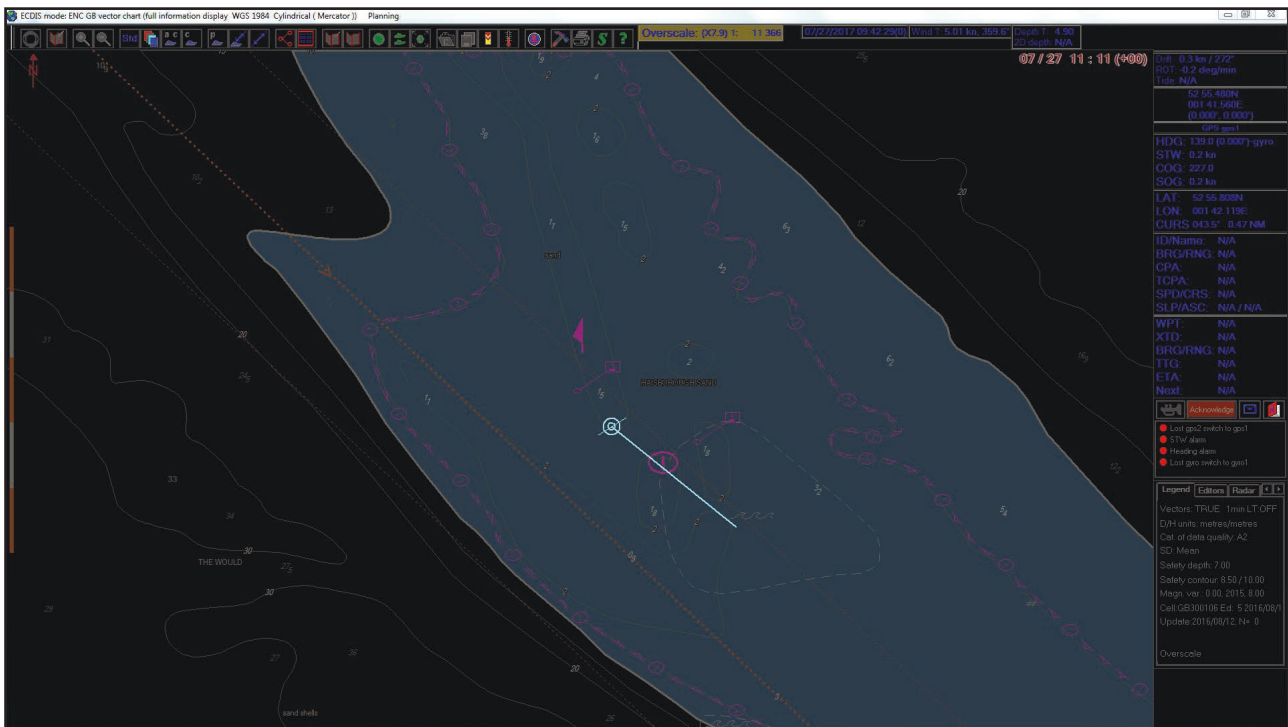
Figure 7: Reconstruction of ECDIS display at 0250 (zoomed in and 'all')

Within 1 minute of being called by the 2/O, *Muros's* master and chief engineer arrived on the bridge. Meanwhile, the 2/O had zoomed in the ECDIS display and changed the chart view from 'standard' to 'all'³, which showed more detailed depth information (Figure 7). The master realised that the vessel was aground and put the engine telegraph control to stop.

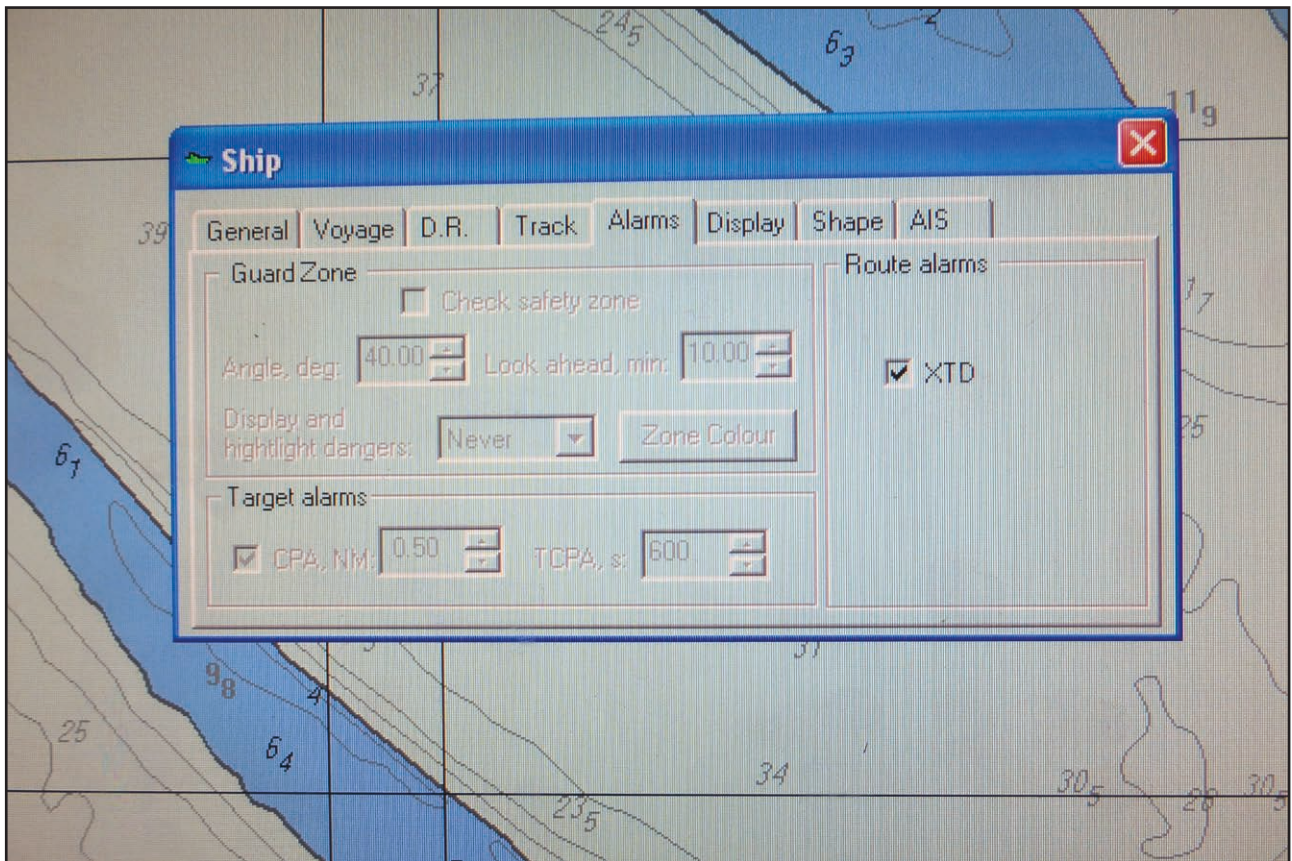
Figure 8: Maris ECDIS900 showing the 'guard zone' settings

- The depth settings were:
 - Deep contour¹⁰: 10m
 - Safety contour: 8.5m
 - Shallow contour: 10m
 - Safety depth¹¹: 7m.
- The guard zone was set to 40° and 10 minutes. However, the ‘Check safety zone’ check box was not ticked and the ‘Highlight and display dangers’ box was set to ‘never’ (**Figure 8**). Therefore, the guard zone was not active.

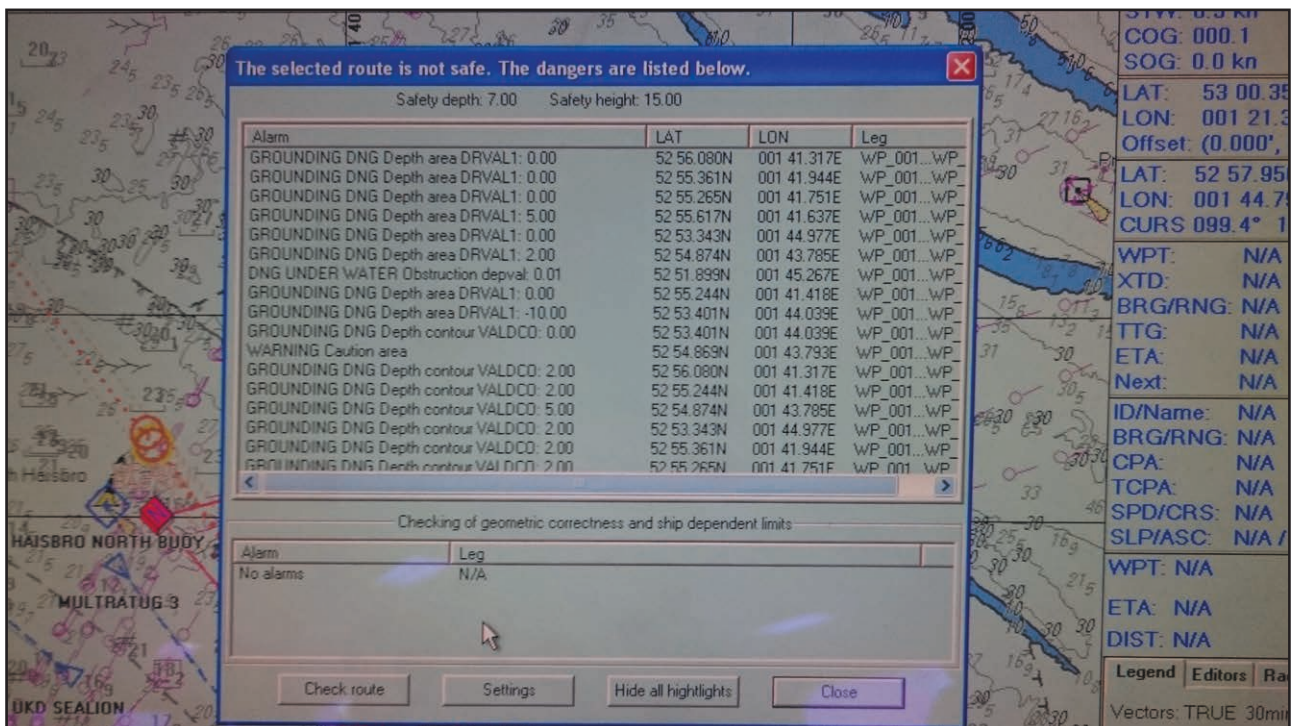
Figure 9: Maris ECDIS900 showing alarms generated on the 'check route' page

- The cross-track distance (XTD)¹² was set to 0.5 mile and route alarms were selected.
- With the Teesport - Rochefort route selected, over 3000 warnings were indicated on the ‘check route’ page, including the risk of grounding on Haisborough Sand (**Figure 9**).
