**INDEPENDENT INVESTIGATION REPORT
INTO THE VERY SERIOUS MARINE
CASUALTY**

MV “HANSE FORTUNE”

AT BARCELONA

ON the 12.09.2015

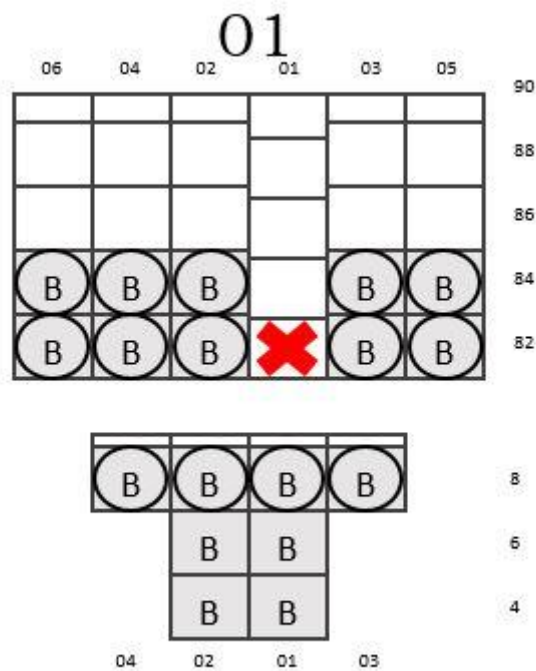
MV Hanse Fortune Bay 1 (most forward bay)

The position on the forward hatch cover chosen was between containers secured to the port and starboard, starboard of the centre of the first forward row right behind the vessel's focsle (Bay 01, row 01). The spreader was to be secured by its twist locks directly to the hatch cover.

The OS, when near the intended stowage position could not be seen by the crane operating crew member, who in consequence operated only by verbal instruction over the handheld VHF. This also meant that the crane operator could not see the spreader when lowered between the adjacent container stacks. It was established from later statements that, when the spreader was being lowered, it got caught on one corner on the starboard adjacent container stack.

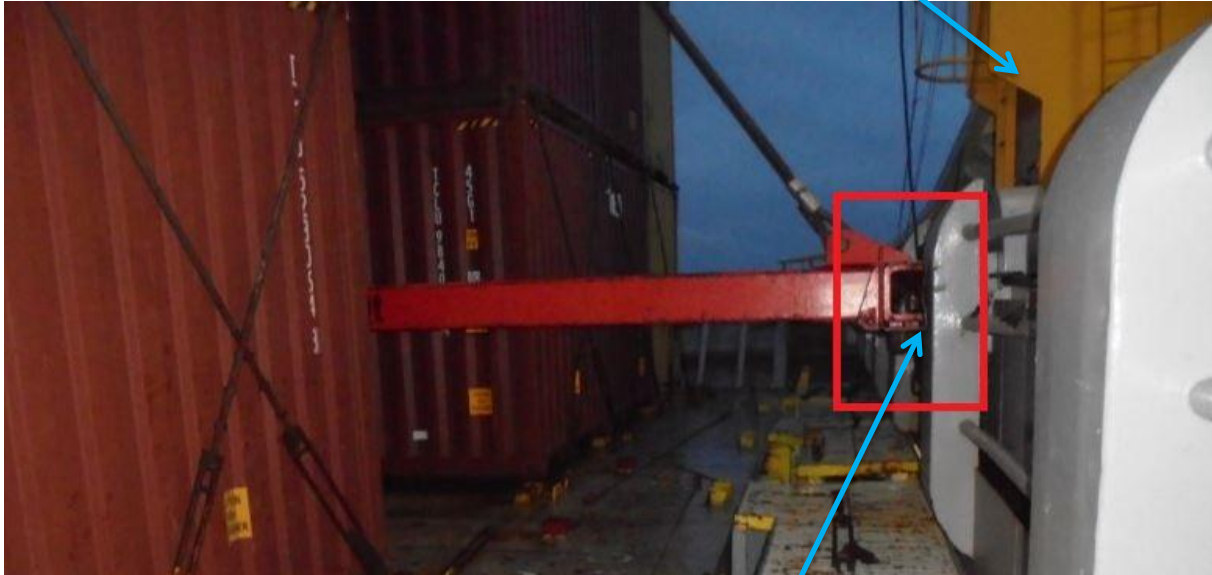
Ship's forward mast

Most probably to have a clear view of the situation the directing OS positioned himself in front of the stuck spreader with the forward bulkhead behind him. When the crane operator swung the crane a bit to port, the spreader came free from the container on port and swung towards the OS who was then struck on the head and was in consequence squashed between spreader and the ship's structure just below the forward mast.

The space chosen to stow the cargo spreader can be described as confined to all directions, causing the signalling crew member to be limited in his options to find a safe position with a clear view. Having to direct the crane operator on how to move the crane to free the spreader from its jammed position caused him to position himself in clear view of the situation but dangerously in the path of the then forward swinging spreader once freed as per his given instructions.
