Panama Maritime Authority
Directorate General of Merchant Marine
Marine Accident investigation Department

REPORT: M/V “SICHEM AMETHYST”R-038-14-DIAM
IMO: No. 9354571
Date: 28th March 2014

REPORT ON THE INVESTIGATION OF THE FIRE OF

m.v. “SICHEM AMETHYST”

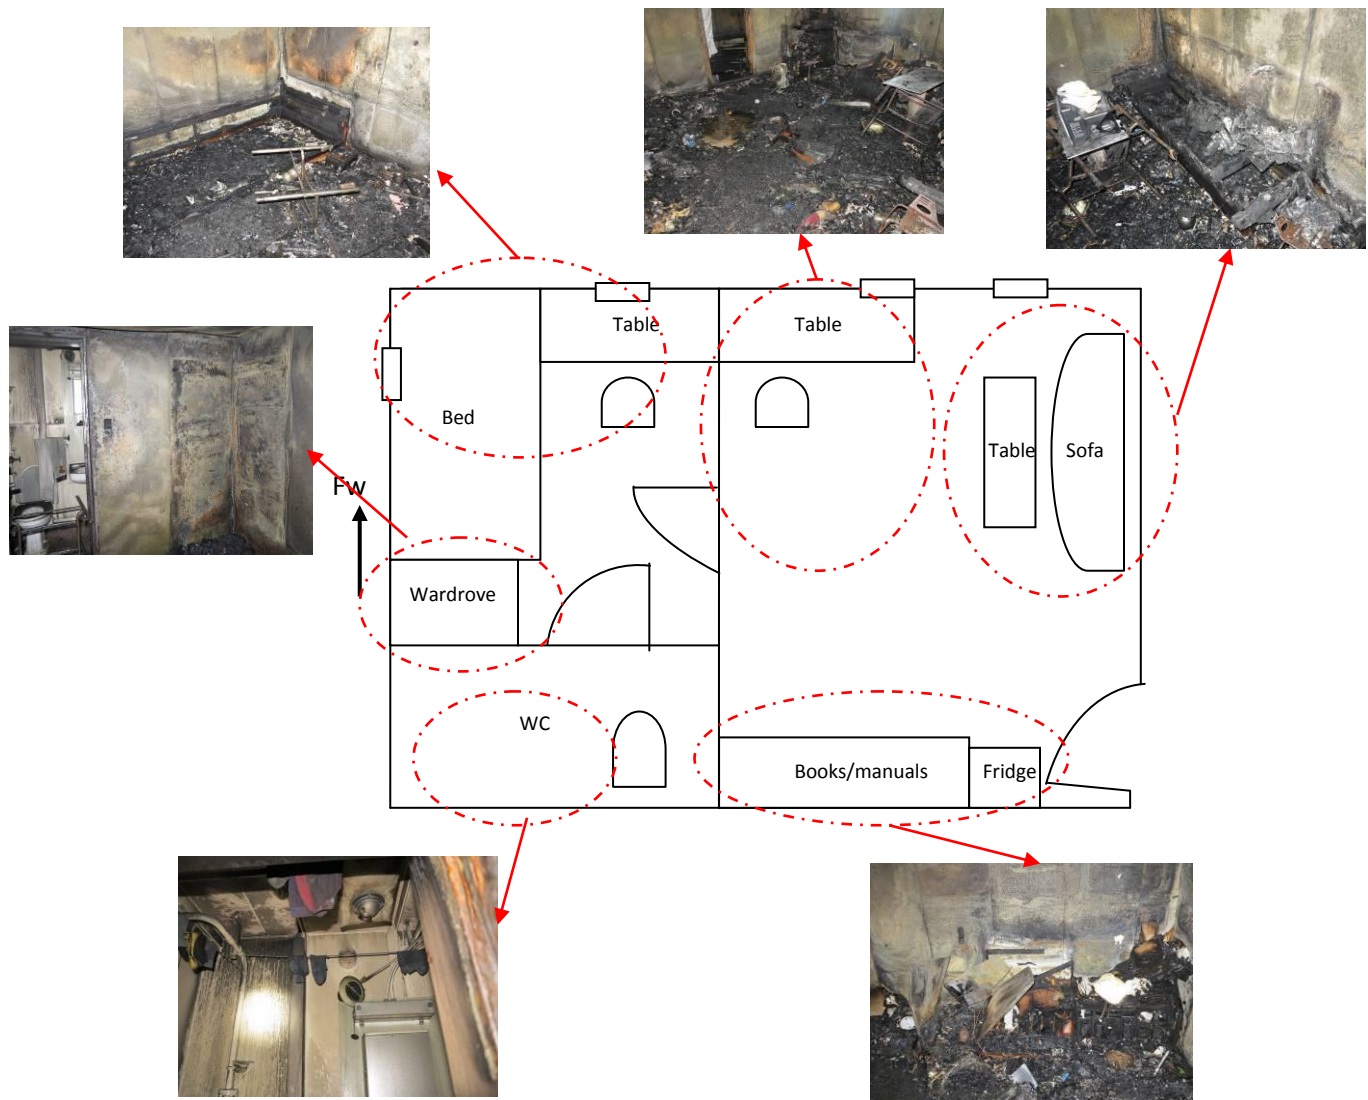
7.1 The main damages were located in the Chief Engineers Cabin and office.

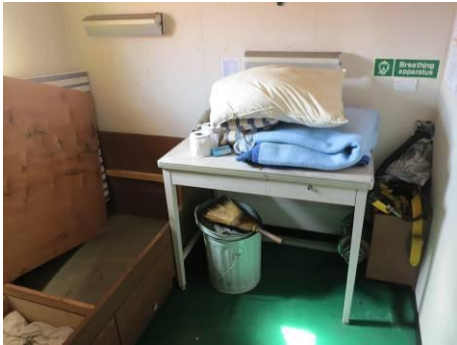
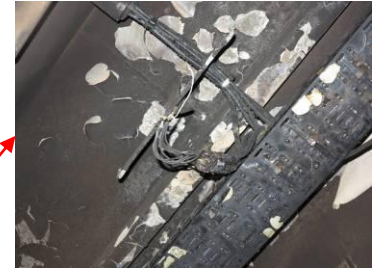
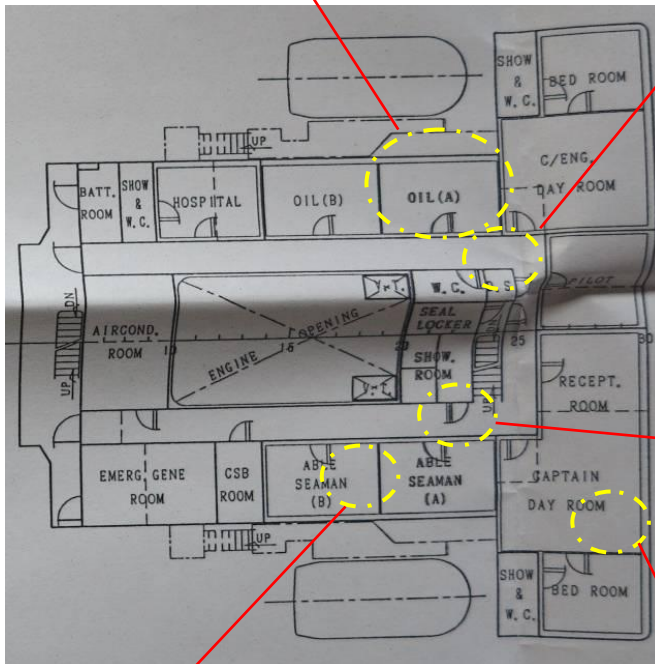
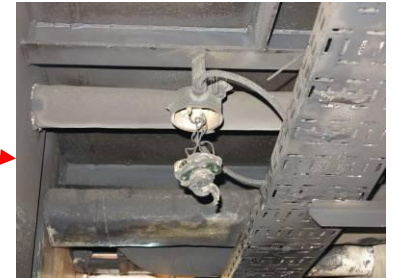
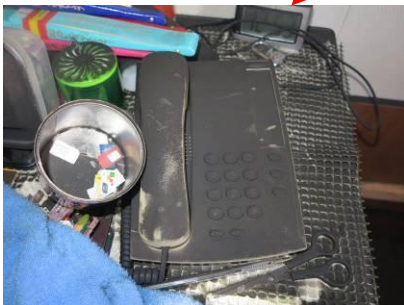
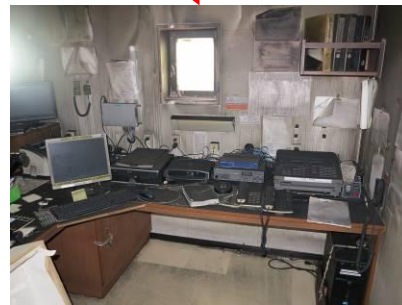
7.2 Damages extended along the Captains deck due to heat

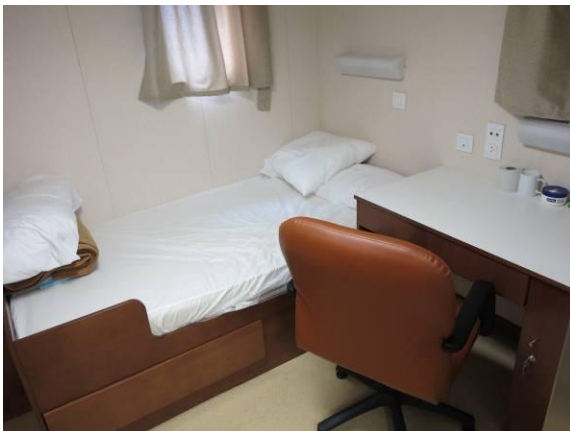
Figure 7.1– Repaired Chief Engineer’s Cabin

- 7.3 Further damages extended on the electrical systems which led to a black out. At the time of the investigation electrical damage extend was being investigated by engineers and technicians.
- 7.4 Navigational equipment had been stopped during the accident due to black out and hence pending of evaluation until power is restored.
- 7.5 The Captain’s Deck was finally repaired and put back in service on the 27th April 2014

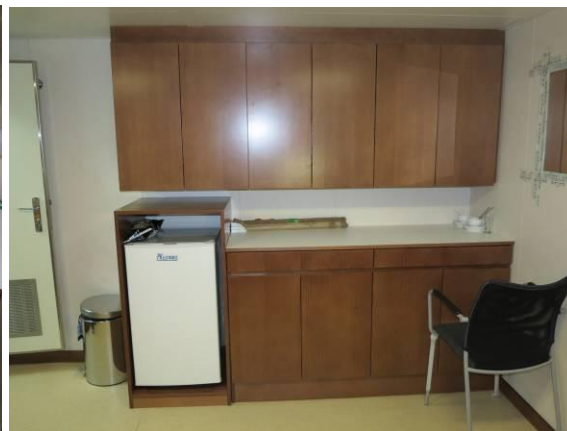
Figure 7.2– Repaired Chief Engineer’s Office

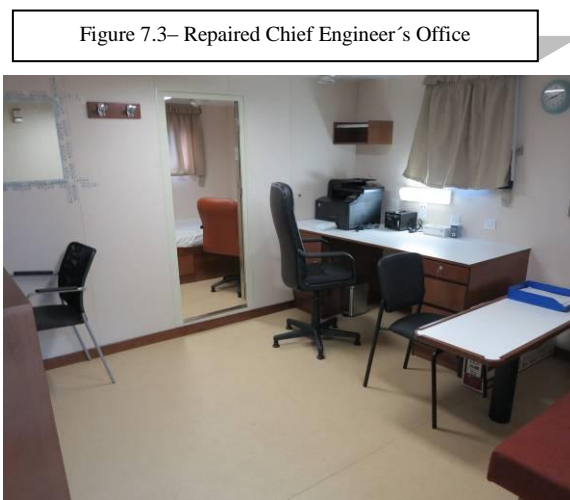
Figure 7.3– Repaired Chief Engineer’s Office

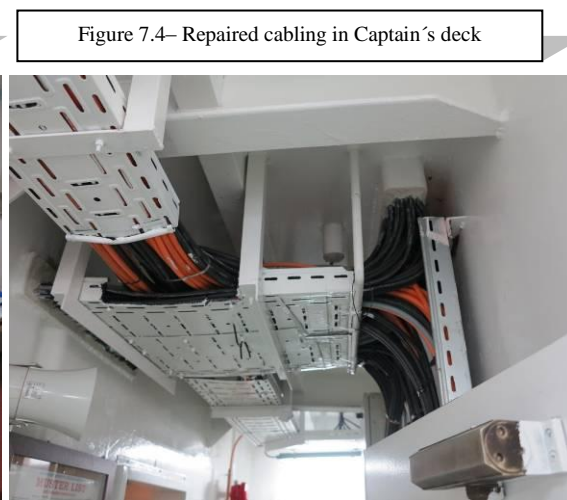
Figure 7.4– Repaired cabling in Captain’s deck

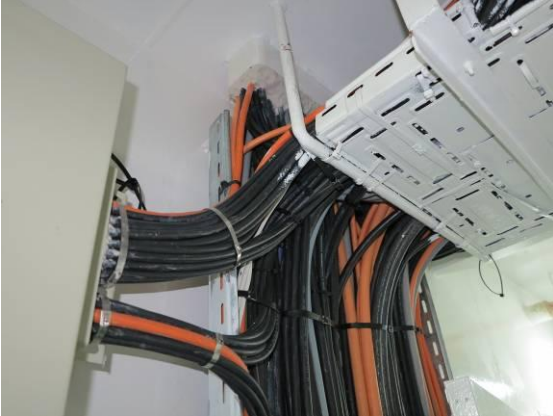
Figure 7.5– Repaired cabling in Captain’s deck

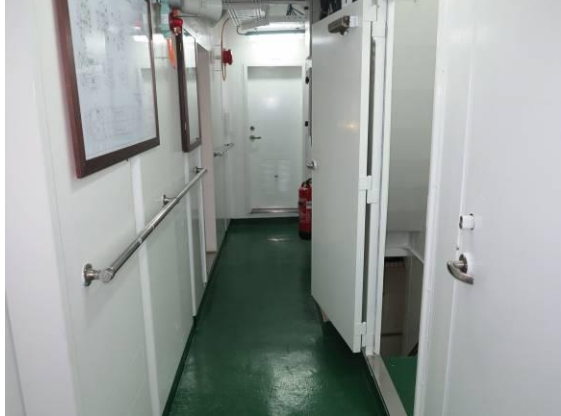
Figure 7.6– Repaired Captain’s deck

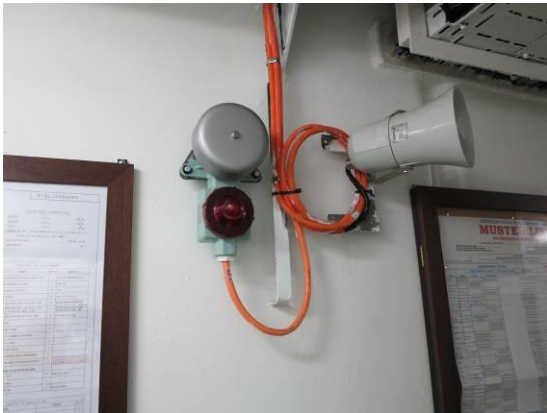
Figure 7.7– Repaired fittings in Captain’s deck

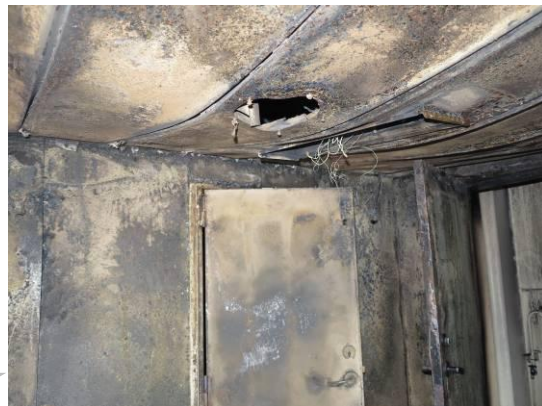
8.14 Based on the above table the peak heat release rate hence it could be estimated although in the enclosed room surrounded with steel boundaries and ceiling such values would have increased even further since the heat would have been radiated back on the burning items. This was evident from the buckling of the ceiling on the bedroom.

Figure 8.3 – Cabin ceiling buckled due to heat

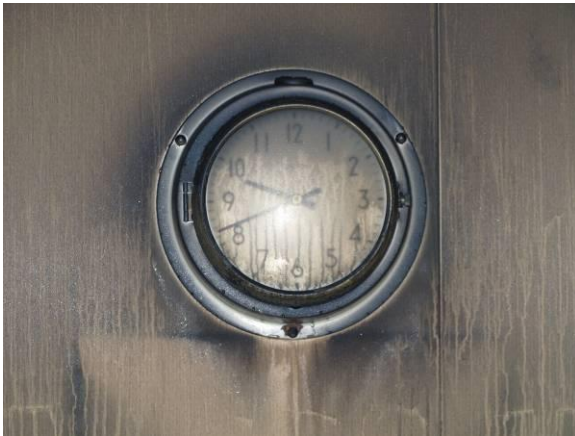
- 8.15 The destruction of the area gave no room for finding a clear evidence of the source of ignition although it is most probable that such ignition was of a piloted type.
- 8.16 Sparks, arcs and open flames are the common sources of piloted ignition in which an external ignition source ignites the fuel item. Such fuel item could have been sheets of paper, manuals or plastic.
- 8.17 To heat the fuel item to its ignition temperature, the rate of heat transfer must overcome the rate of the heat loss due to convection or conduction as well as the loss of the energy as a result of pyrolysis or vaporization
- 8.18 The first alarm was given at 09.40hrs and the onboard clocks were stopped due to loss of power at around 09 hrs 41 min 45 sec.

Figure 8.4 – Captain clock stopped

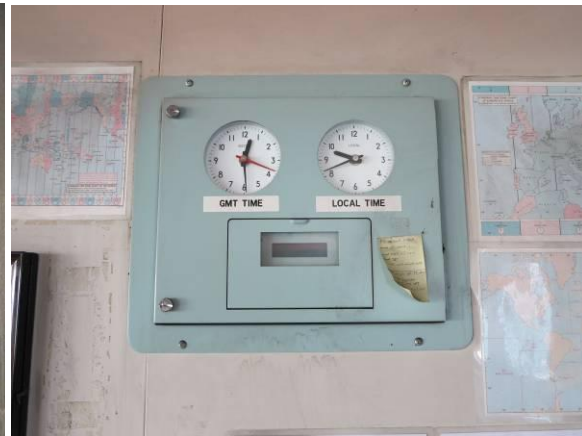
Figure 8.5 – Bridge clock stopped

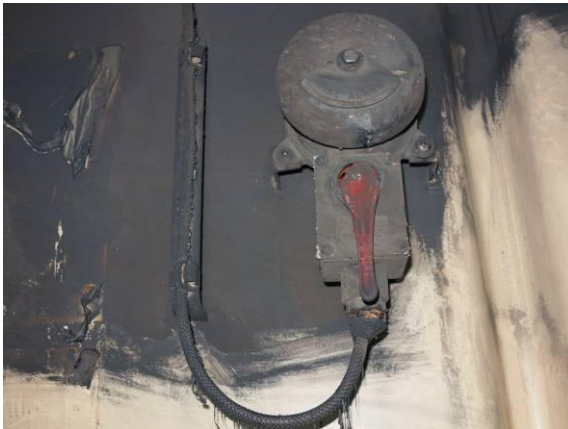
- 8.22 Melting of plastic material near the ceiling in the captain deck passageway and onto the captain's office was evident. That gives an indication that high temperatures over 300°C were reached along the passageway and the captain's office. Therefore the lack of shore fire fighters would have at some stage extend the fire to other areas of deck.

Figure 8.6 – Melting of plastic on fire alarm

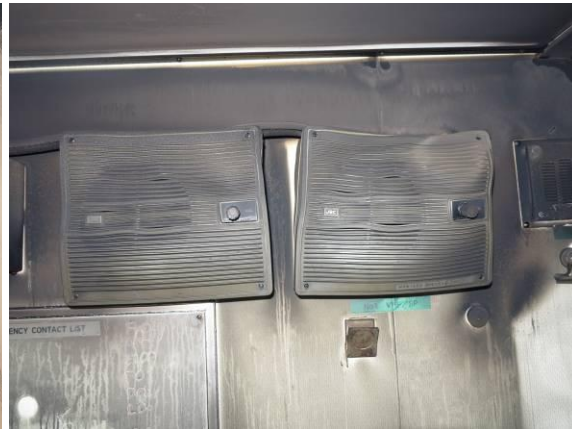
Figure 8.7 – Melting of speakers in Captain office

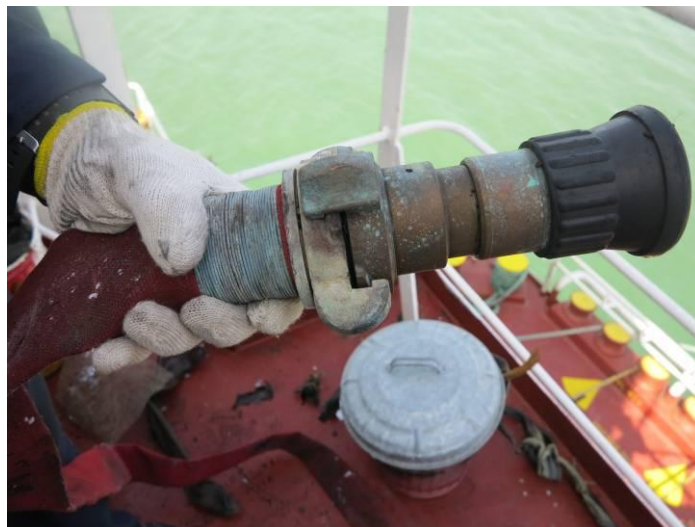
- 8.25 The following comments were gathered from shore fire fighter: Hose with no sufficient pressure and water flow not able to be controlled efficiently. Hence the uncontrolled flow of water had created superheated steam.
- 8.26 The type of fire nozzle onboard was of a standard type found on ships.

Figure 8.10 – Type of fire nozzle used

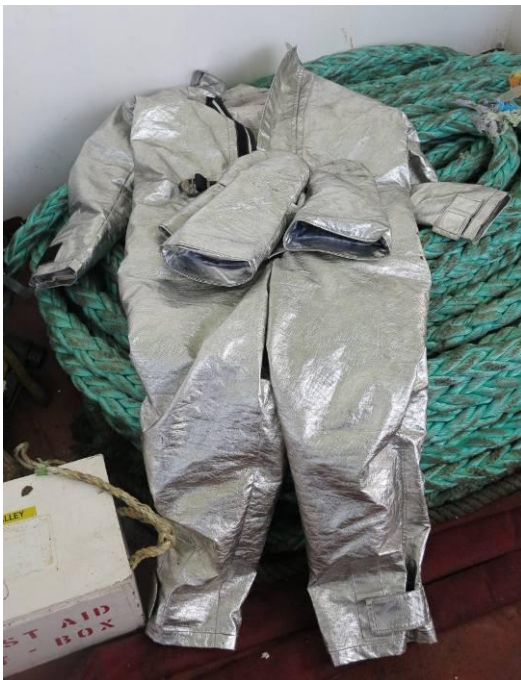
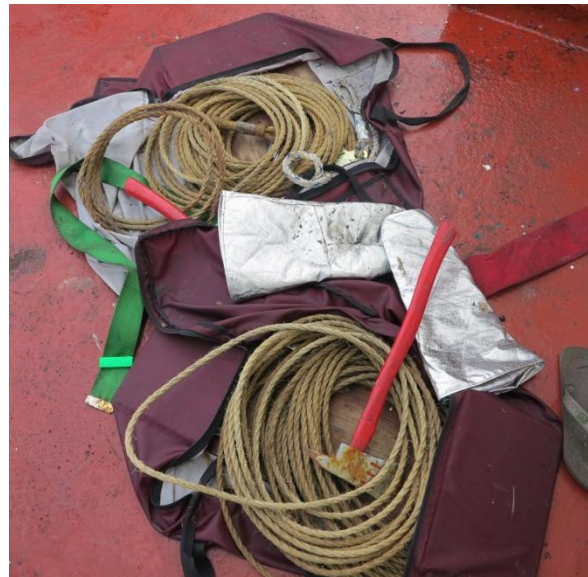
Instructions to be maximum for 15 minutes with the suit on are not compatible with a normal firefighting operation.

Figure 8.11 – Type of fire outfit used onboard

- 8.35 No shore fire fighters use this type of fire suits hence the professional advise of shore fire fighters should be addressed.
- 8.36 The fact that long firefighting can cause death hence denotes that the suit is not suitable for ship fires on enclosed spaces. This was proved by the 3rd Officer who claimed that he was not capable to approach and remain in the chief engineer’s office for long due to heat.

- 8.37 This statement above also proofs that such type of fire suit is not suitable for normal fire fighting on enclosed spaces.
- 8.39 The aluminum coated gloves are of a mitten type with a finger on the side. That type of gloves makes more complicated handling of hoses, feeling of surroundings opposed to a five finger glove.
- 8.40 The complete fire suit was inspected by a shore company in Portugal on the 26th December 2013 certifying that the suits were in good condition and fit for work.
- 8.41 Neither of the fire line guides was used.
- 8.42 The use of fire lines are questionable when entering accommodation and enclosed or obstructed areas since the line could get trapped endangering the fire fighter.

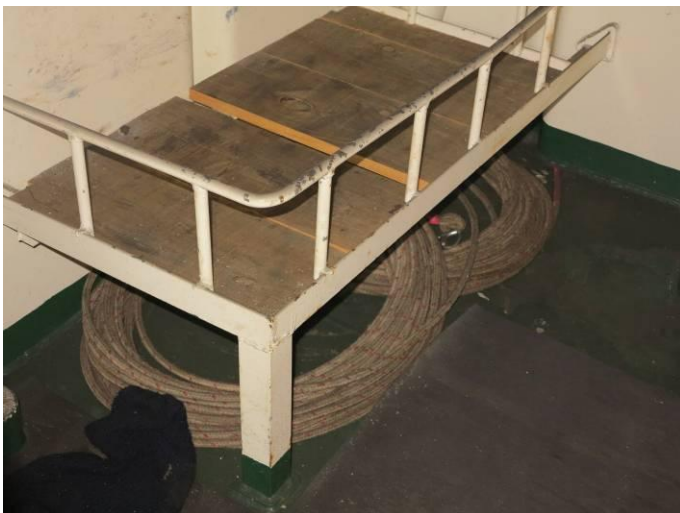
Figure 8.12 – Type of fire line guides not used
