MARINE SAFETY INVESTIGATION REPORT

Safety investigation into the failure of a lifeboat
wire rope fall resulting in five fatalities and three injuries
on board the Maltese registered passenger ship

THOMSON MAJESTY

MARINE SAFETY INVESTIGATION REPORT NO. 05/2014

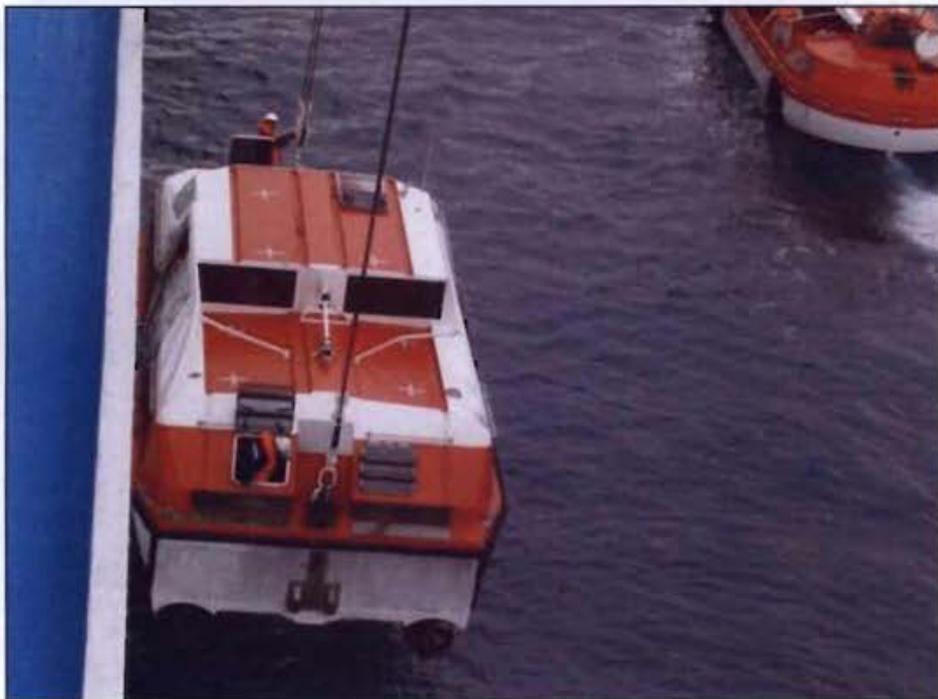
Figure 4: Lifeboat no. 9 stopped about one metre above water while the hydraulic leak was being repaired

Shortly after 1100, the nominated crew embarked lifeboat no. 9. The lifeboat was lowered to the water by the bosun, who released the winch brake. However, during the lowering process, he noticed a hydraulic oil leak from a pipe near the brake handle. He stopped lowering and went to inform the chief engineer. The safety officer decided to try and 'drive' the lifeboat to the water using the electric lowering system. However, this system also releases the brake, and had the effect of increasing the hydraulic leak, so he stopped lowering again.

The chief engineer arrived with one of his fitters and disconnected the leaking pipe and took it to the engine-room workshop for repair. The lifeboat remained suspended about 1 m above the water level (Figure 4). The repair took around 40 minutes and when it was replaced, the safety officer decided to abort the training exercise and hoist the lifeboat back up.

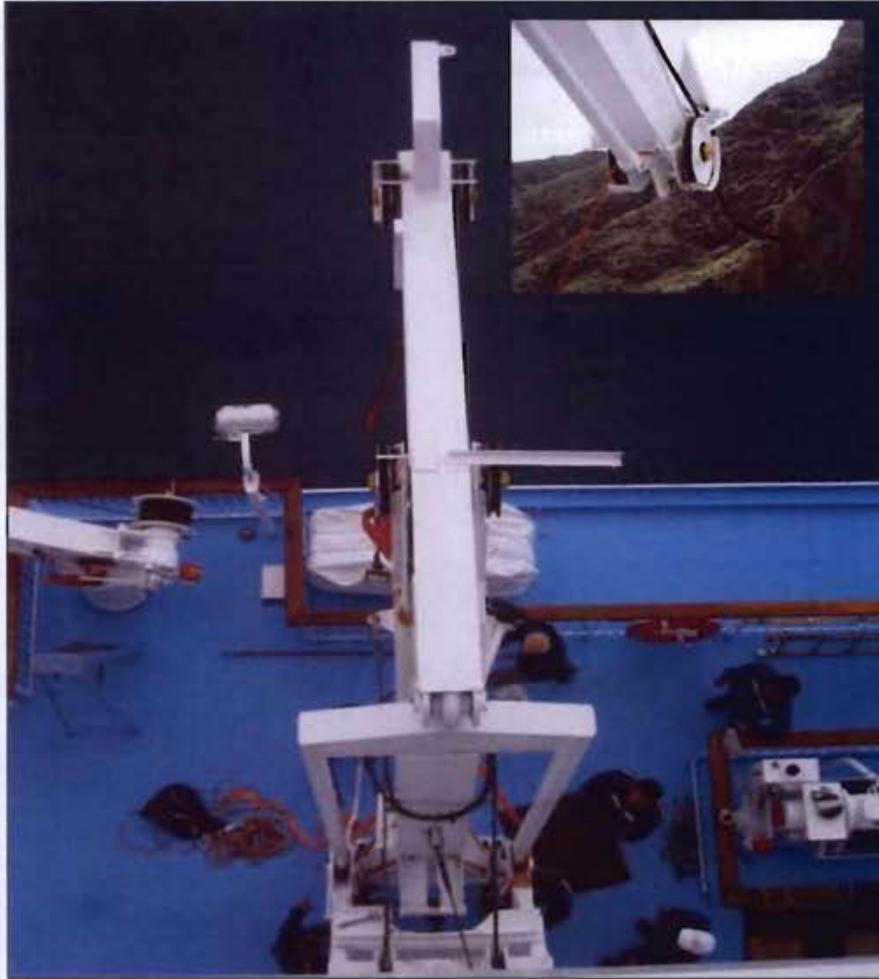
Figure 7: Lifeboat no. 9 forward davits arm showing the parted wire rope

The safety officer re-hoisted the lifeboat and just as the blocks had engaged with the davit head and the davit arms had started to move upwards (Figure 6), the forward wire rope fall parted (Figure 7). The lifeboat then swung through around 45° and as the weight of the lifeboat was taken by the aft wire rope, the transom of the lifeboat and the aft lifting hook failed. The lifeboat dropped about 20 m, landing upside down in the water. The time of the accident, as recorded by the vessel's Closed Circuit Television (CCTV) footage, was 1154.

The fall of the lifeboat was the result of a parted wire rope fall that was caused by severe internal corrosion at the break point.

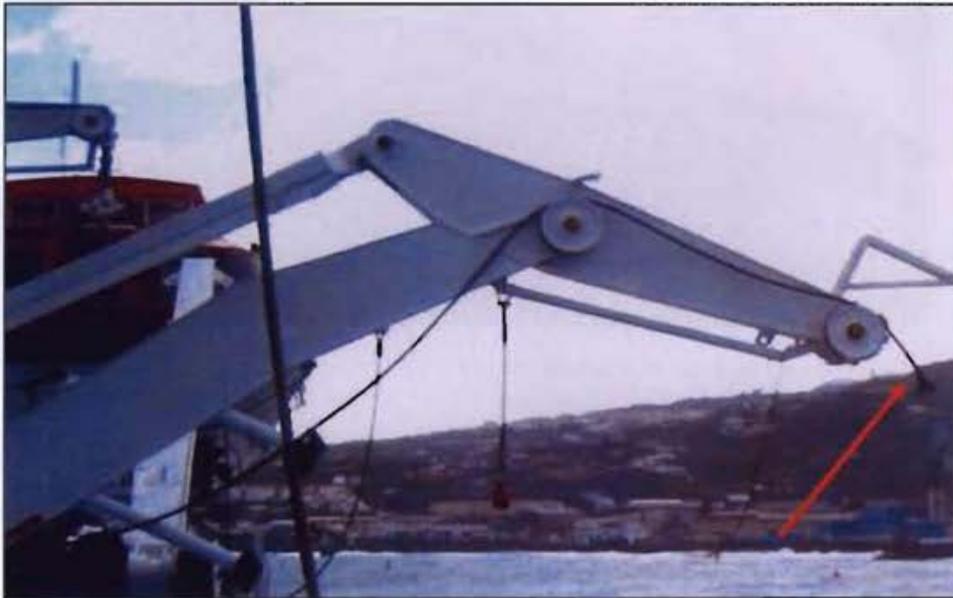
Figure 10: Davits and parted wire

Although, this made it very difficult to ascertain the exact position where the wire rope had parted, the team was able to establish (with the help of witnesses and photographs taken by the crew) that it had parted in the region around or near the fall block and davit's head (Figure 10).

Davits no. 9 appeared to have suffered no visual damage, although the forward block was lost during the accident. Due to the shock loading, the davits would require a detailed inspection and re-approval by the manufacturer before being put back into service.

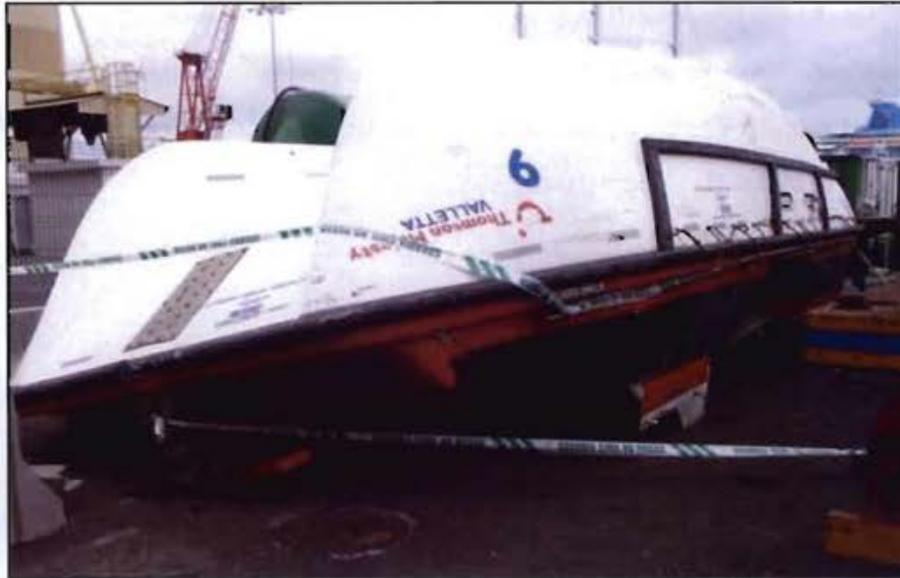
Figure 11: Extensive damage to the lifeboat tender

The lifeboat suffered severe damage (Figures 11 and 12). The initial damage due to the impact with the water was to the lifeboat's canopy, transom and the aft lifting hook. However, it sustained further damaged when it was lifted out of the water and placed ashore.

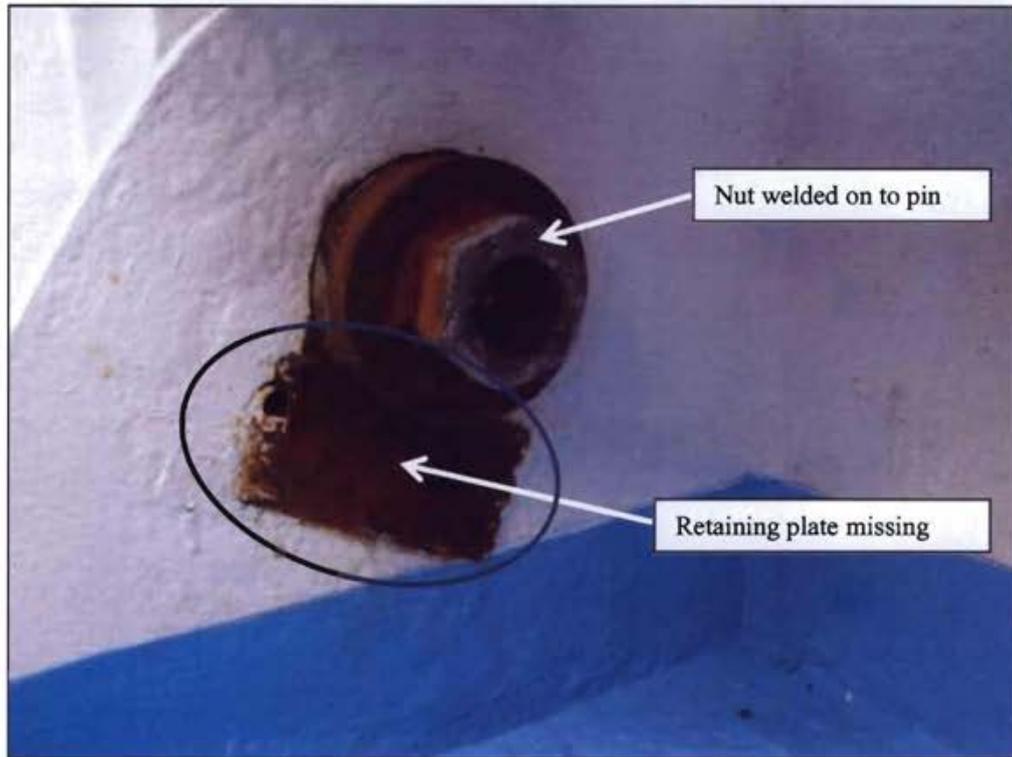
Figure 13: Seized davits arm with modification

The safety investigation established that all the sheaves and moving parts were running free except the aft davit's arm base swivel (Figure 13), which was seized and had been modified by welding a large nut to the inboard edge.

This defect was clearly visible but records indicated that it had not been reported as a defect to the Company. Although it was difficult to say how long this defect had existed, it may well have been in place at the last examination and dynamic test in April 2012. The main purpose of planned maintenance by the ship's staff, and the annual and five-yearly examinations by an approved contractors, is to identify and rectify defects in a timely manner and before they can lead to unacceptable levels of risk.

- .4 The wire ropes and the davit were examined by an approved contractor in April 2012 and overload tested to 110% of the maximum load at the same time;
- .5 The aft arm of davit no. 9 showed signs that the shafts and bushes at the base were seized. A nut had been welded to the aft shaft, which was probably an attempt to free the bush. This should have been noted both by ship's staff and the service provider's technician at the time of the annual examination.

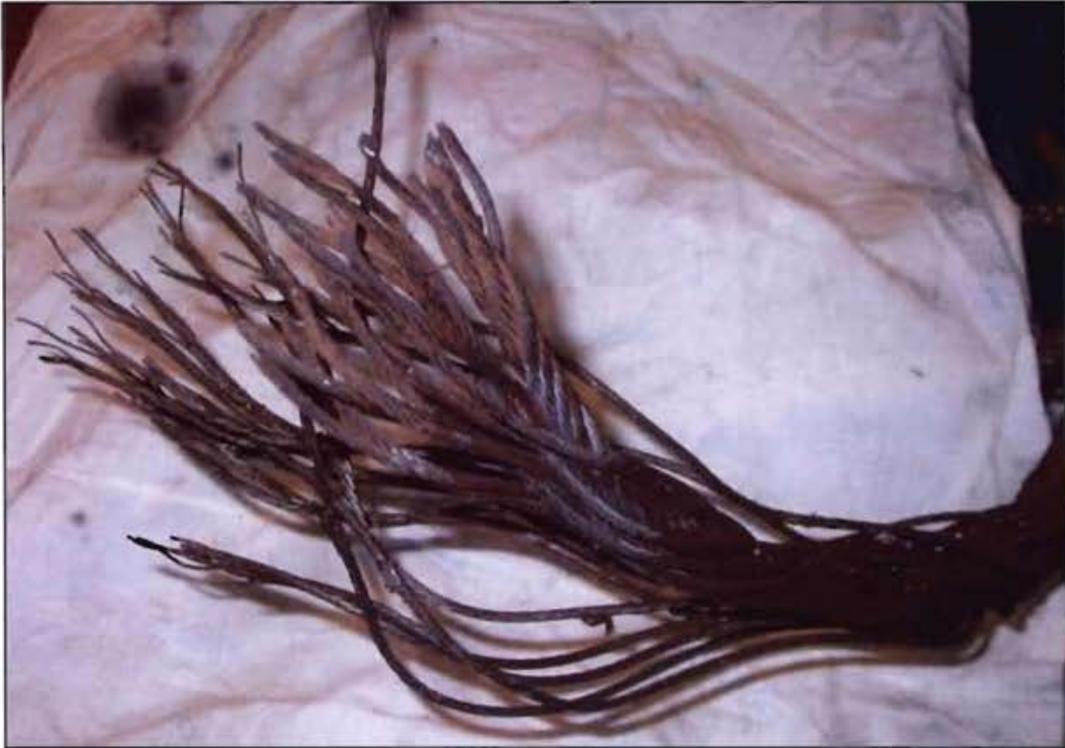
Figure 14: Break site

The examination and tests concluded that the wire rope parted at a site of very severe pre-existing corrosion wastage of the wire rope's construction. The corrosion had consumed all the zinc plating and the core of the wire rope appeared dry and totally void of lubricant (Figures 14 to 17).

- the wire rope was not of a high strength type and did not meet the minimum break load strength specified by the manufacturer. The presence of clearly resolvable microstructural products would suggest that the wire had only received a limited heat treatment after the cold drawing process;
- the failure to maintain a suitably protective level of lubricant at sheave locations where the wire rope resided under tension when the lifeboat was stowed; and
- the apparent failure to monitor the wire rope's deteriorating condition through regular effective inspections.

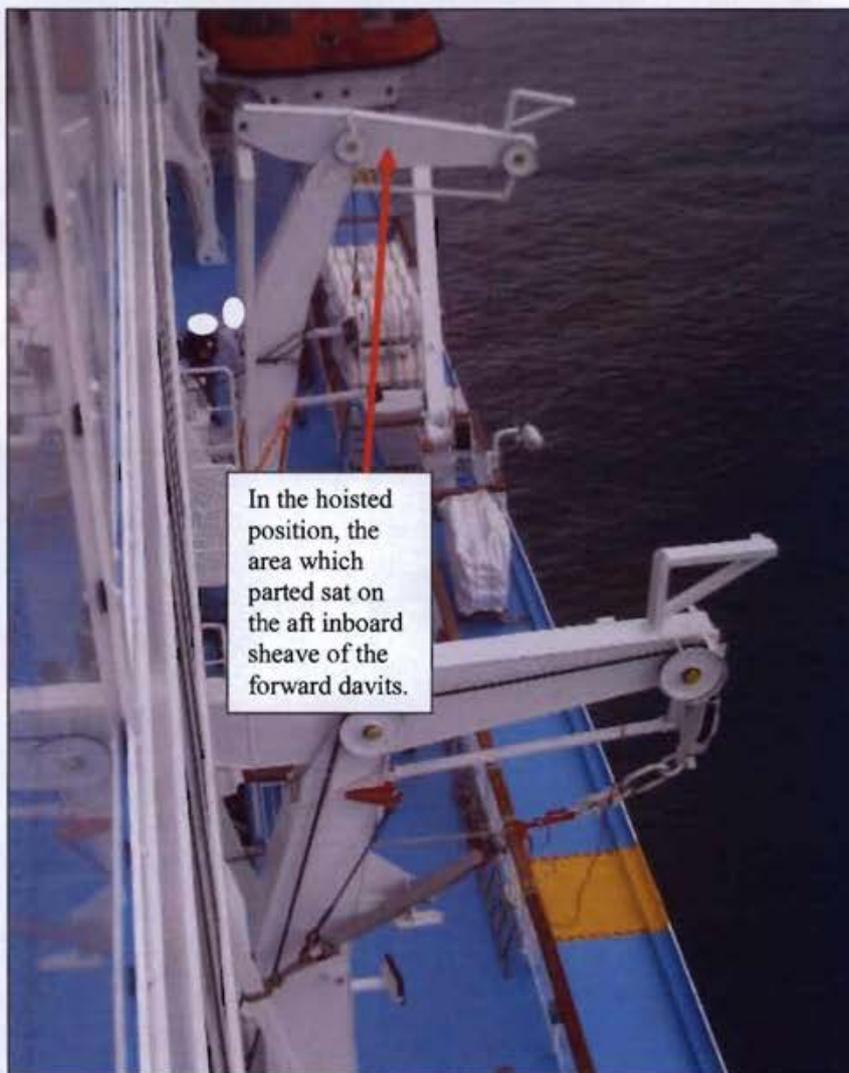
Figure 18: Davits no. 9 in the hoisted position

There are a number of factors that resulted in the corrosion of the wire rope. When the lifeboat was secured in position, the strands in the section of the wire rope resting on the sheave (and under tension) opened slightly (Figures 18 to 20). Unlike other davit designs, these davits did not have the facility (chocks) to relieve the tension of the wire on the sheaves. As such, the wire rope has a relative high load when the lifeboat and davits are in a stowed position. Without relieving the tension, the wire rope would have been exposed to additional dynamic loads over time when the vessel is moving in different sea states.

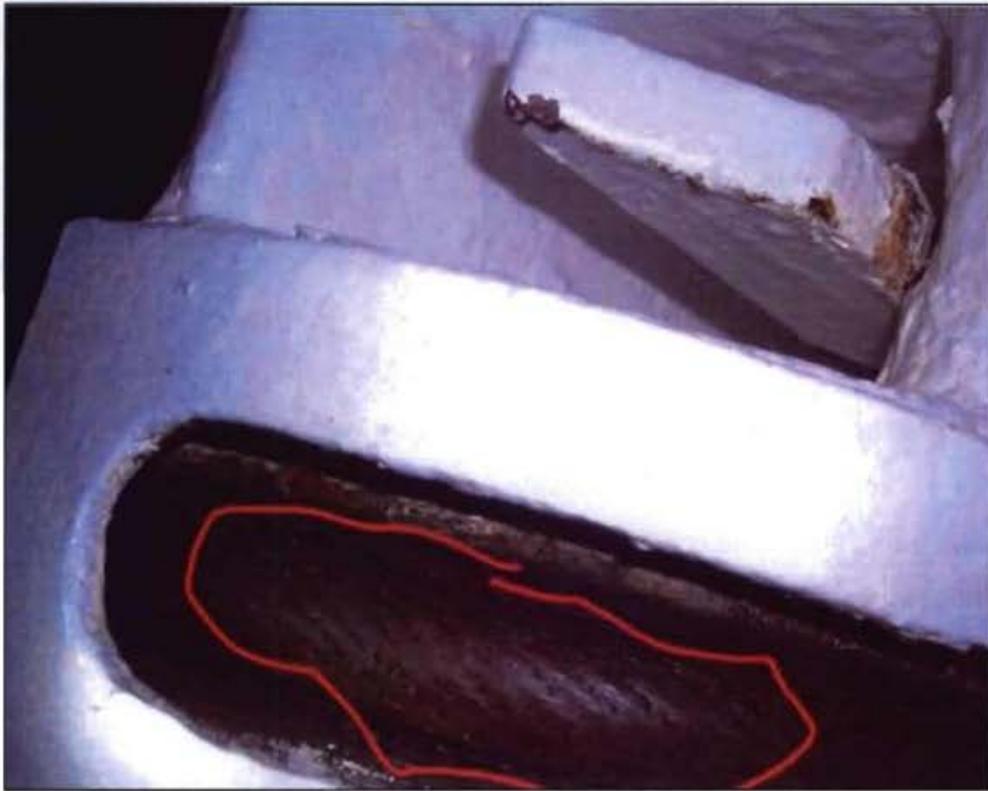
Figure 19: Wire rope strands 'opening up'

This opening up of the tensioned wire rope strands allowed salt water and / or other contaminants to enter the internal part of the wire rope and start the corrosion process.

This is considered to be the most likely cause of the corrosion that caused the wire rope to eventually part.
