CIAIM REPORT 03/2018

Fall of the rapid rescue boat on the vessel AL ANDALUS EXPRESS at the Port of Motril (Granada) on 5 October 2016, injuring two crewmembers

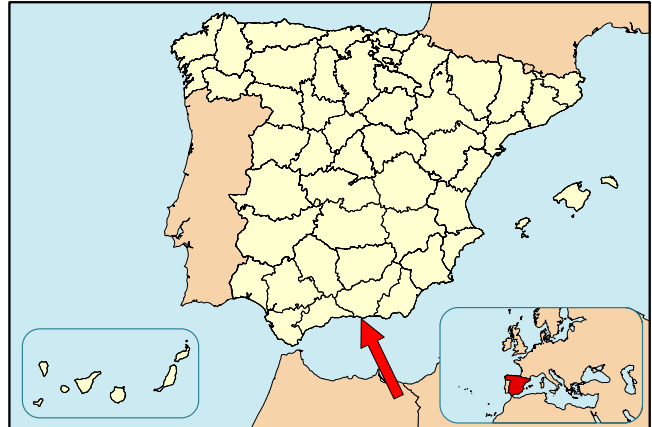
Figure 2. Area of accident.

The two crewmembers climbed aboard the fast rescue boat on the port side and actuated the davit from the remote station located inside the boat. The maneuver began correctly and the davit swung out without problems. The boat then began to lower, descending the first two meters normally, after which it began to descend uncontrollably at an abnormally high speed, eventually impacting the surface of the water.

The two crewmembers sustained various bruises, and the second bridge officer also suffered a fractured lumbar vertebra.

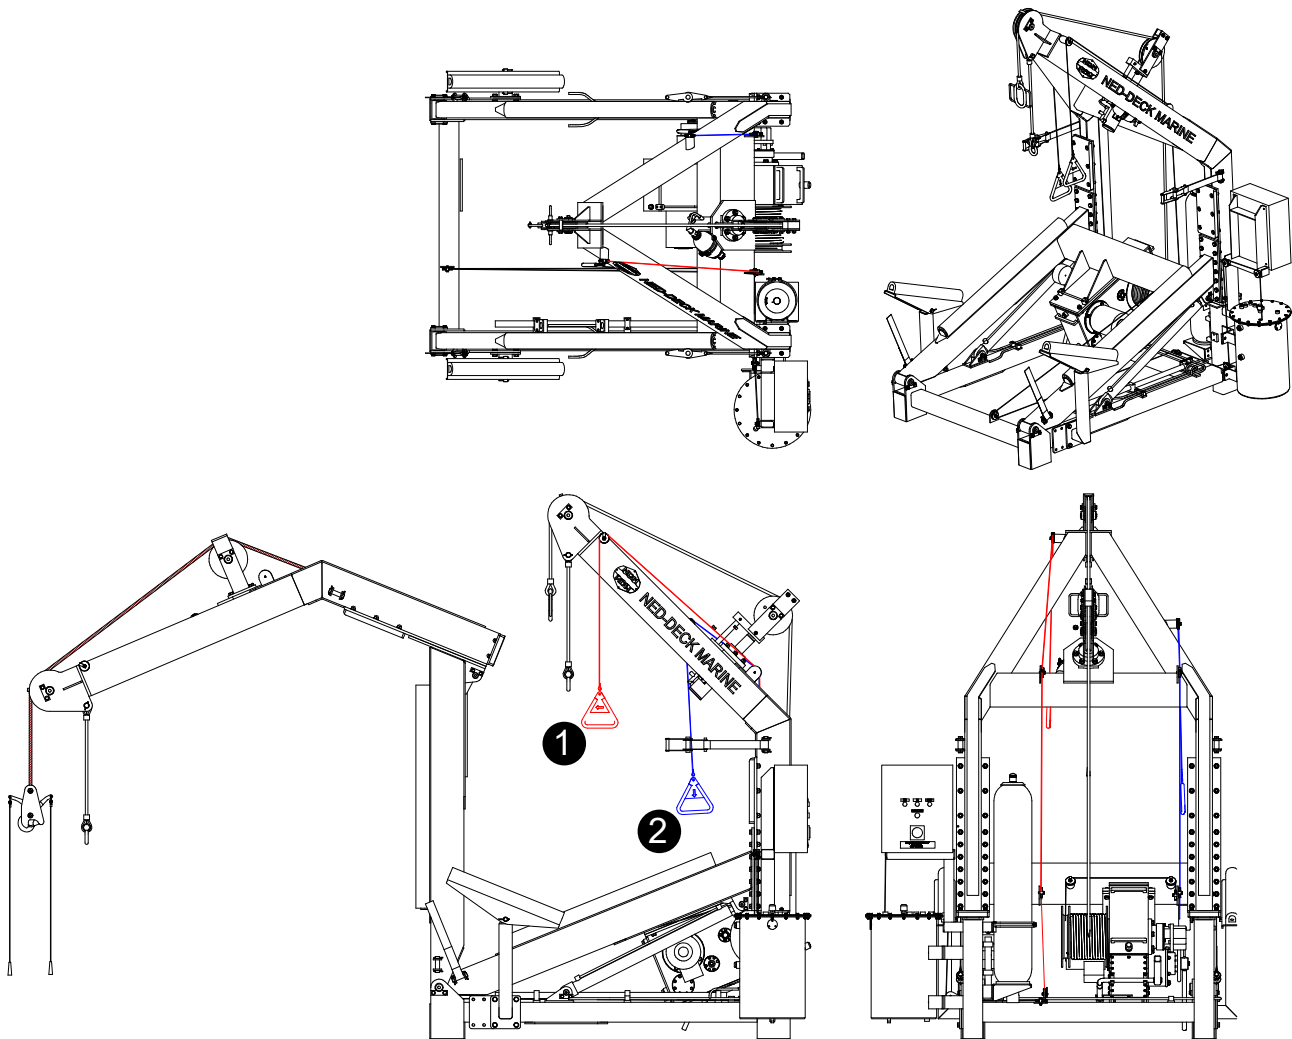
Figure 6. Ned Deck Marine PRH-20 davit.

The davit is then swung from its stowed position to the launch position. This maneuver is done from inside the boat using the swing handle indicated with a horizontal arrow (Figure 6 - Item 1 and Figure 12 - Item 1).

The handle indicated with a vertical arrow (Figure 6 - Item 2 and Figure 12 - Item 2) is then pulled to start lowering the boat toward the water's surface. The boat only descends while the handle is pulled back, and it stops when it is released.

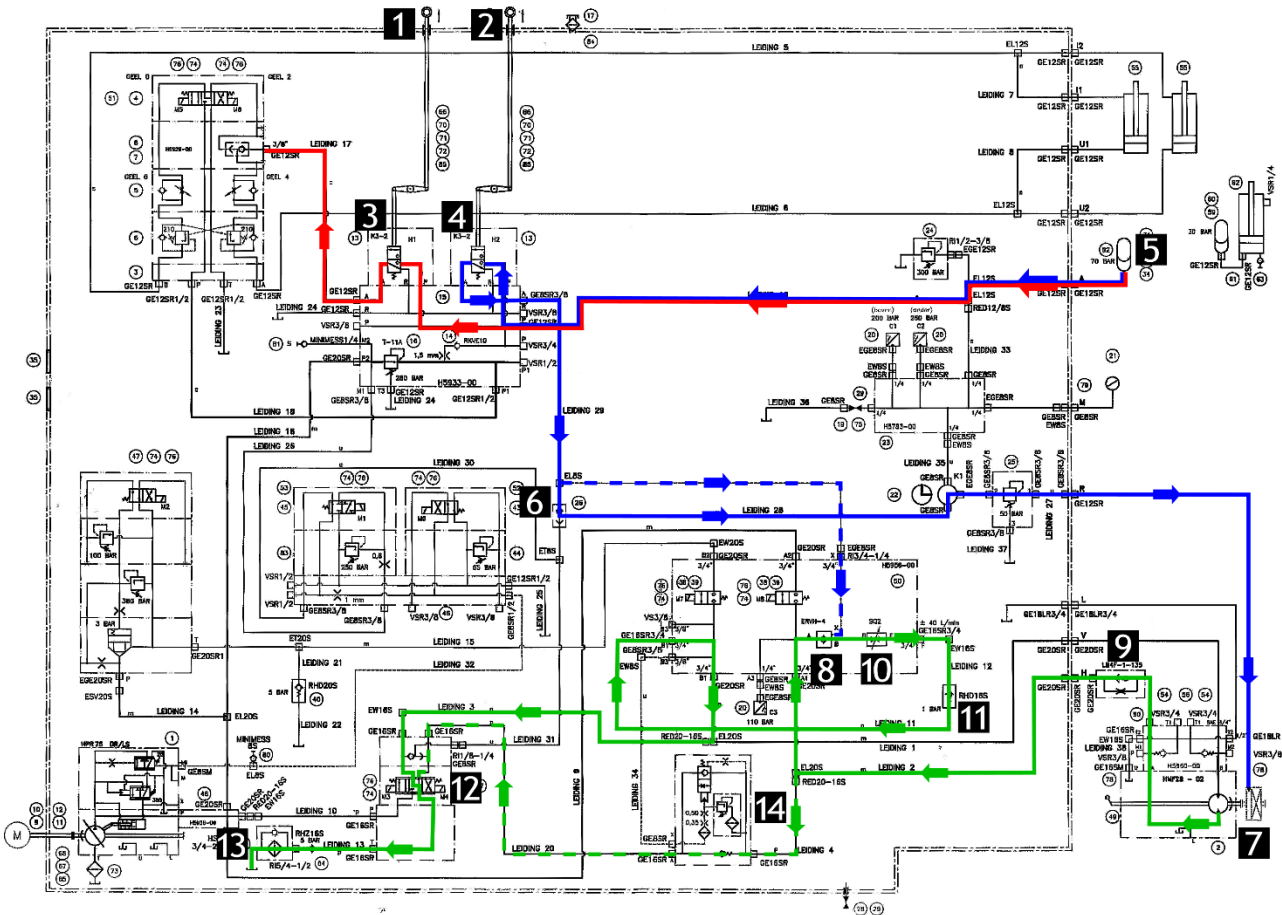
Figure 12. Hydraulic system for the davit.

When the swing handle is pulled, a steel cable and a rod (Figure 12 - Item 1) actuate directional valve K3-2 H1 (Figure 12 - Item 3), which allows oil to flow from the pressure accumulator (Figure 12 - Item 5).

When the operator in the rescue boat pulls on the launch handle, a steel cable and a rod (Figure 12 - Item 2) actuate directional valve K3-2 H-2 (Figure 12 - Item 4), which routes hydraulic fluid at accumulator pressure (Figure 12 - Item 5) through the selector valve (Figure 12 - Item 6) to the multi-disc brake (Figure 12 - Item 7), releasing the drum from the capstan and allowing the boat to drop by gravity. In the absence of hydraulic pressure, a system of springs locks the brake.

At the same time, to keep the “Linde Hydraulics HMF 28-02” hydraulic motor from impeding the rotation of the capstan, a bypass valve, EL85, on the line that releases the brake opens the check valve (Figure 12 - Item 8), which allows the fluid from the hydraulic motor to flow via burst valve “LB4F-1-135” (Figure 12 - Item 9), to then continue to the variable flow regulator, SQ2 (Figure 12 - Item 10) and the check valve (Figure 12 - Item 12), finally flowing to the directional control valve (Figure 12 - Item 12) and from there to the tank (Figure 12 - Item 13).

First is the burst valve (Figure 12 - Item 9), which is designed to allow a maximum flow rate through it of 135 liters/minute. If this rate is exceeded, the pressure will tend to overcome the opposing spring pressure, which will reduce the flow rate and prevent the boat from descending faster. This automatic change in the flow rate will lead to a smooth and uniform motion of the boat in the event of a hypothetical pipe break downstream.

The variable flow rate regulating valve (Figure 12 - Item 10) is the second safety feature in the system, and also limits the descent speed of the rescue boat. In parallel with this line is a bypass, “EL20S”, toward an overflow valve (Figure 12 - Item 14), which also leads to the directional control valve (Figure 12 - Item 12).

In the opinion of the specialists from this company, the equipment failure indicates the presence of air in the hydraulic system. The fluids (water or oil) in hydraulic systems are essentially incompressible. These fluids make the system respond quickly and precisely. The presence of air in a hydraulic system leads to instability in the compression of the hydraulic fluid, preventing it from operating correctly and causing the unstable operation of the elements actuated by the system.

Following the analysis of the incident, it was concluded that the accident could have been caused by the presence of air in the hydraulic system. According to VIKING S.A., the air could have penetrated due to wear on some hydraulic component and remained in the system due to how little the emergency launch system had been used in previous months. This air presence in the motor line (Figure 12 - Green line) could lead to faulty operation and to an inability to control the speed when lowering the boat.

An analysis of the accident indicates that it was most likely caused by the presence of air in the hydraulic system for the davit, and by the absence of a procedure to regularly purge the hydraulic system.

An underlying cause is the design of the davit, which did not anticipate the improper operation of the hydraulic system due to the presence of air in the system.

According to VIKING S.A., previous tests had shown that running the hydraulic pump for a few minutes guarantees that no air will be present in the system. Therefore, this company recommended that the hydraulic pump be started and run for a few minutes before every drill, and that launch drills be conducted every month.

In the opinion of the CIAIM, the best way to avoid these accidents is to equip the davits with a centrifugal brake that acts on the winch to limit the speed at which the boat falls in the event of a fault in the hydraulic system.

- All manned lowerings of FRBs/RBs/LBs were forbidden for all of their fleet's vessels.
- Installation of an upgrade kit to the hydraulic system of the davit, to avoid air inside the system, as per the manufacturer recommendation.
- Implementation of an easy to follow, pictured, launching procedure. This instruction includes the unmanned lowering and lifting before final launching as another safeguard.

1. Include in its davits a centrifugal brake in the winch that limits the speed at which the boat is lowered if the hydraulic system malfunctions, as well as an automatic purge system to prevent the presence of air in the hydraulic system.
