CIAIM REPORT-12/2016

Structural fault in M/V STOLT BOBCAT cargo tanks at Barcelona Port on 7 August 2015

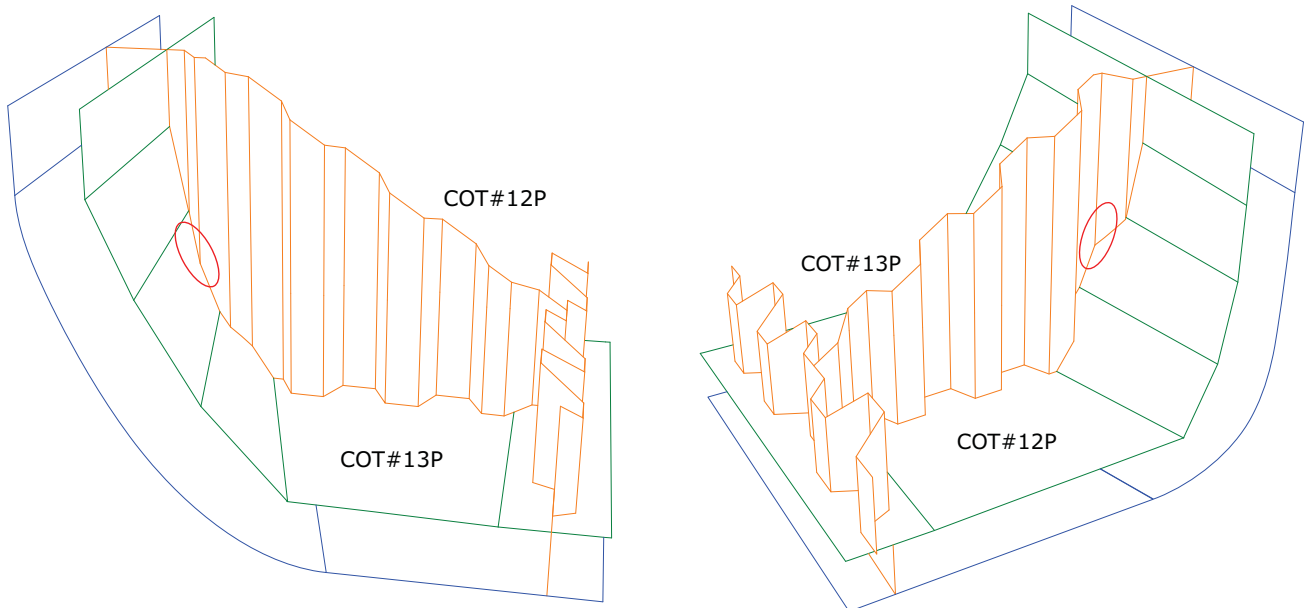
Figure 7. Location of crack between tanks.

The crack was located on a weld seam joining the double hull to the corrugated transverse bulkhead separating cargo tanks COT#12P and COT#13P, at a height of approximately 3.5 m above the bottom of the tanks. The crack began at one of the corrugation angles, as shown in figure 7.

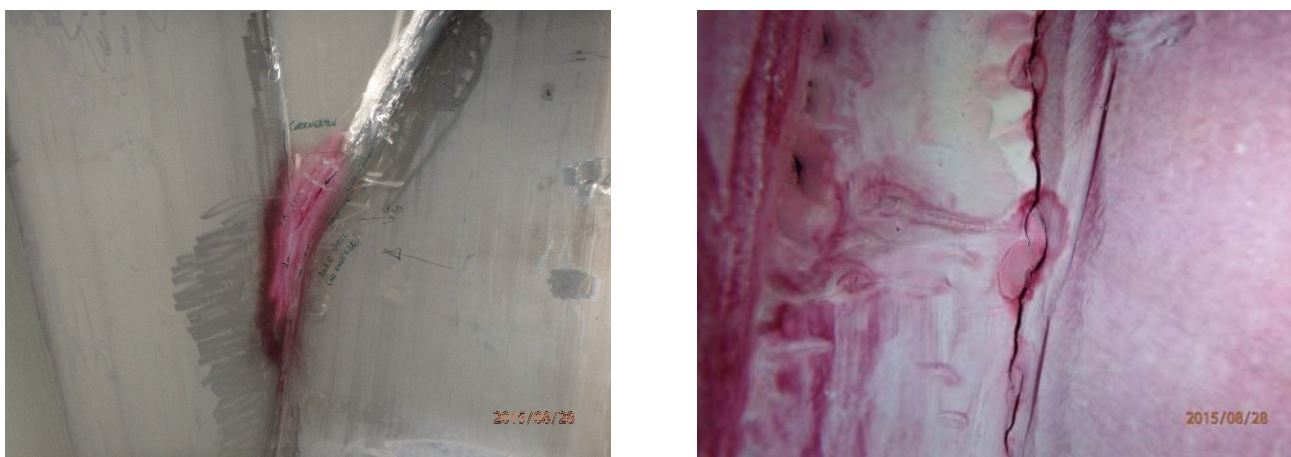
Figure 8. Current crack (seen from COT#12P) and close up of crack.

The crack measured 23 cm long, and passed through both cargo tanks throughout its length, running along the foot of the welding (figure 8). Along the lower part of the crack, next to the corrugation angle, it continued beyond the welding and into the metal sheeting.

Although no mention is made in any inspection or repair docket, by observation of the welding and of the crack currently found in the port bulkhead, it was found that this welding had been repaired previously although the date cannot be confirmed.

One can therefore be certain that the same fault had occurred to this vessel on at least four occasions during its six years of active life. When one finds repeat faults of this type, it is an indication that an earlier problem exists that originated in the design and construction stages.

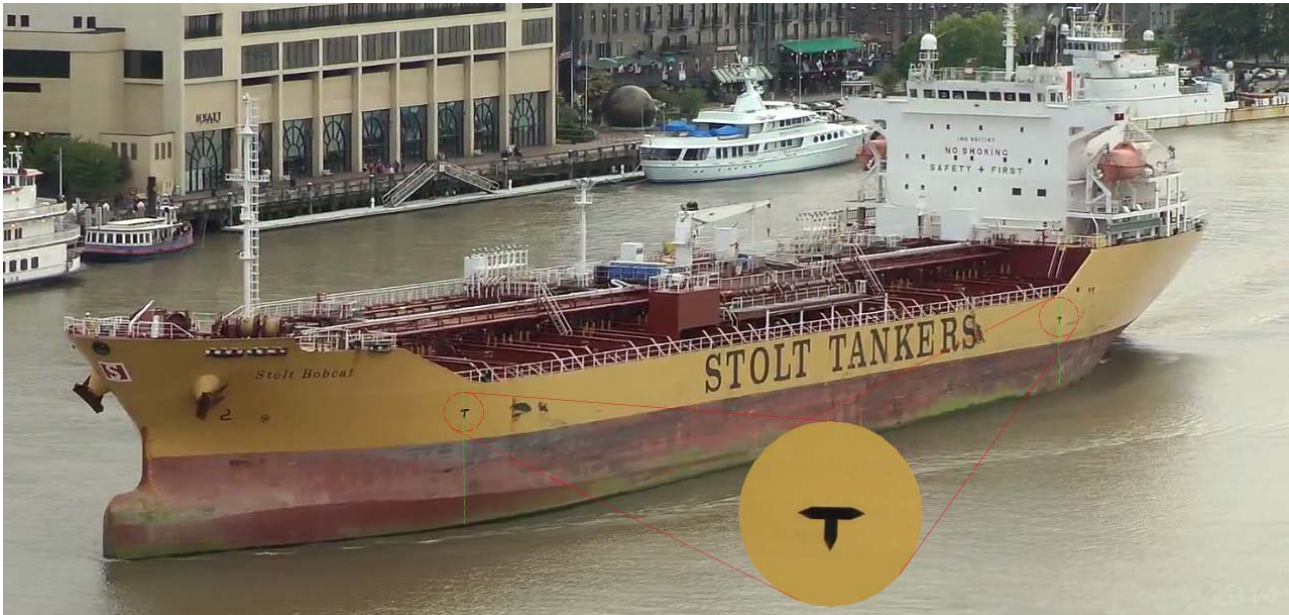
Figure 9. Tug pushing points.

The vessel has two areas marked as pushing points for tugs, located along each side: one toward the bow in construction area 172, which coincides with the corrugated bulkhead separating cargo tanks COT#2 and COT#1; the other toward the stern in construction area 52, which coincides with the corrugated bulkhead separating cargo tanks COT#13 and COT#12.

During 2015 the vessel entered into a great many ports and, in most of those ports, required the assistance of pusher-tugs in order to dock. This fact (see ¡Error! No se encuentra el origen de la referencia.) might have played a part in weakening the contact area.

EMPA recommends that such markings clearly define the limits for the area up to which it is safe to push and the maximum force that can be exerted.

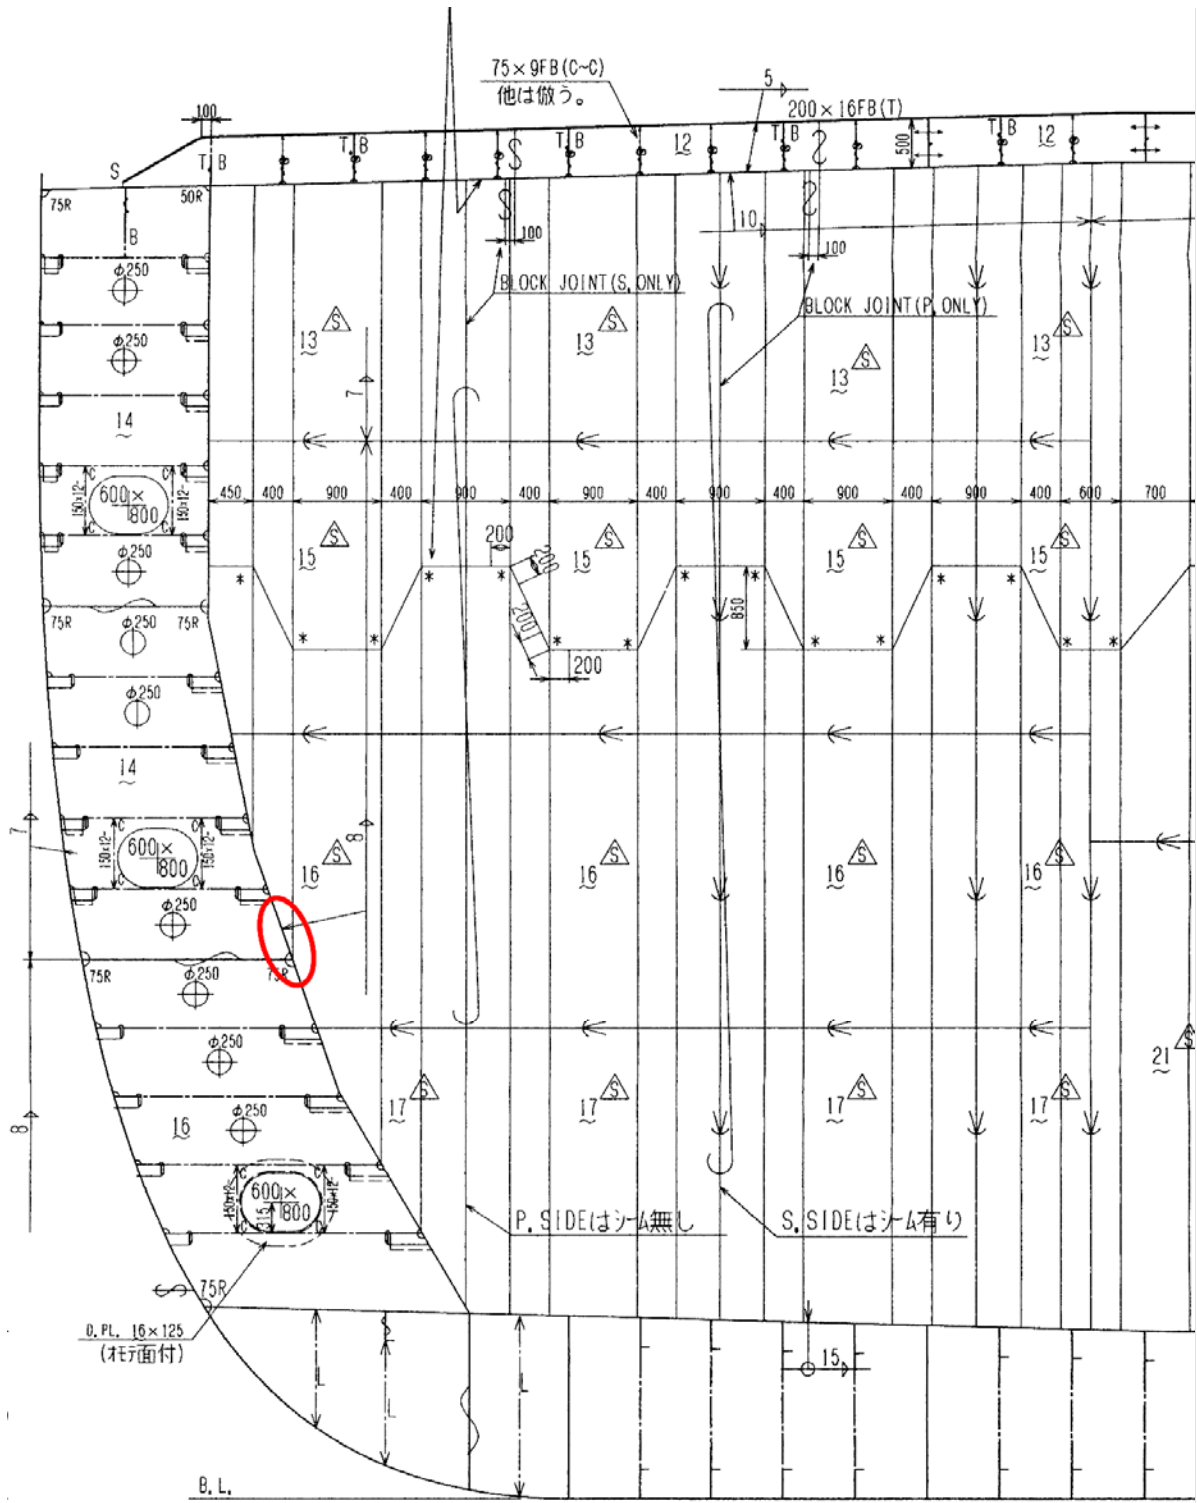
According to the vessel construction design, tug pushing points have not been defined in any way, nor was the scantling in those vessel areas reinforced or different from the rest, as can be seen in figure 11.

One can also see that the corrugated bulkhead intersects with a surface, the double bottom, which is at an incline in the accident area. Linear tracing, cutting, bending and welding of corrugated bulkheads in areas joining other structures that are not perfectly horizontal or vertical is considerable difficult and particularly when dealing with stainless steel. Minor errors of line tracing, cutting or bending can result in irregular welding veins which can be excessive at many points and require filling with large lumps of solder.

This creates intrinsically fragile areas and if the fragile areas are located in areas that receive atypical forces, such as the tug pushing areas, then cracks will occur. Repairs usually involve filling the cracks with solder or even a small local graft. A fault of this kind would therefore be a recurring fault.

Figure 11. Internal structure of area with fault. The area where the crack occurred is marked in red.

One can conclude from the accident analysis that the crack between cargo COT#12S and COT#13S was caused by an error in vessel design and construction, deriving from the difficulties in joining a corrugated bulkhead and an inclined sheet, and particularly when it concerns stainless steel. An error in linear tracing or bending of the corrugated bulkhead can create a separation far in excess of admissible tolerances between the bulkhead and the inclined sheet in the vessel side. Furthermore, such errors are difficult for the shipyard to correct if the bulkhead and hull material is stainless steel. This can lead to a weakness at the welding join, which will be susceptible to cracks appearing in the vessel structure in that area. The effect is further amplified if the area concerned is the tug pushing point.

In order to avoid such problems, many vessels place support beams beneath the corrugated bulkhead where holds or cargo tanks have inclines and up to the height of the incline. This circumvents the difficulties referred to in the previous paragraph. The shipyard should have adopted similar construction practices to avoid recurring cracks appearing in these areas.

1. Constructive solutions must be adopted in areas where corrugated bulkheads join the sides, in order to avoid this type of fault.
