CIAIM REPORT 29/2017

Dragging of anchor and subsequent grounding of the bulk carrier INTERLINK UTILITY at the “South Harbor” anchorage of the Port of Las Palmas on 13 March 2017

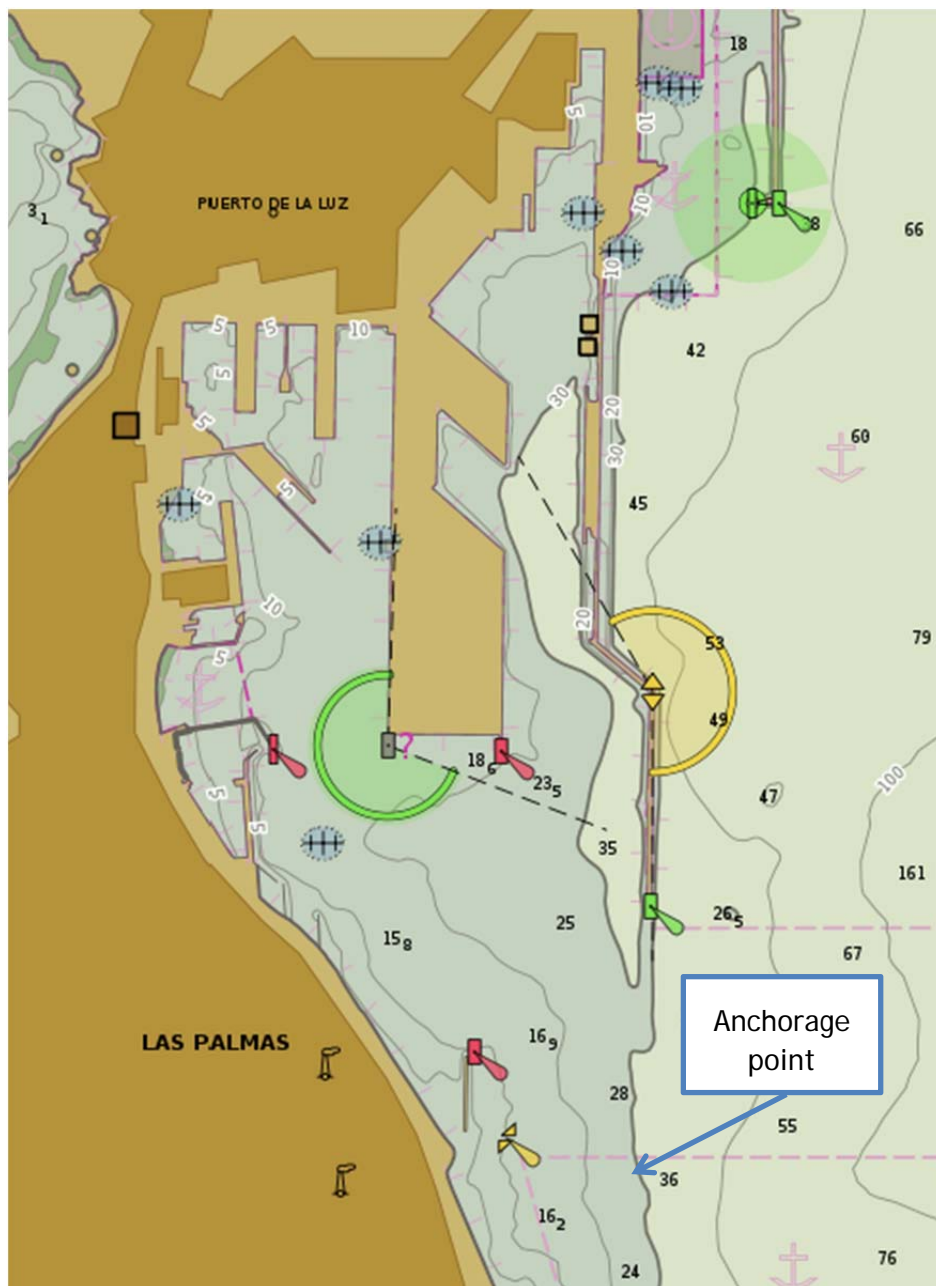
Figure 4. Puerto de La Luz and anchorage point of M/V INTERLINK UTILITY

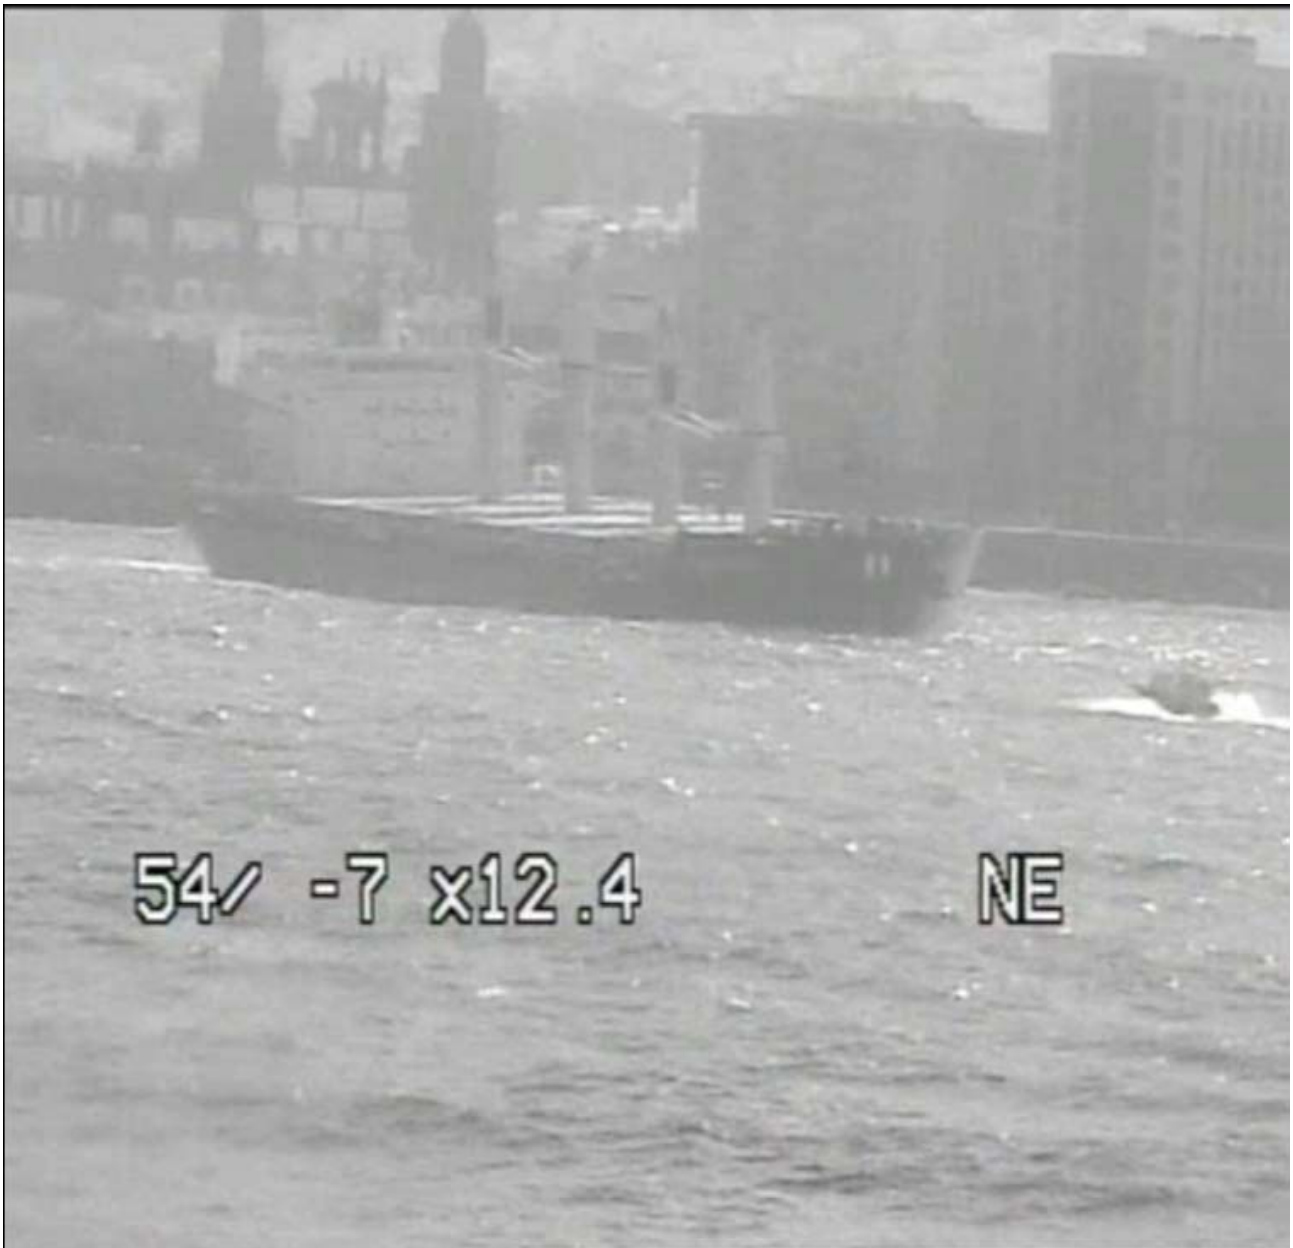
Figure 5. Still from the surveillance video at the Port of Las Palmas at 15:35.

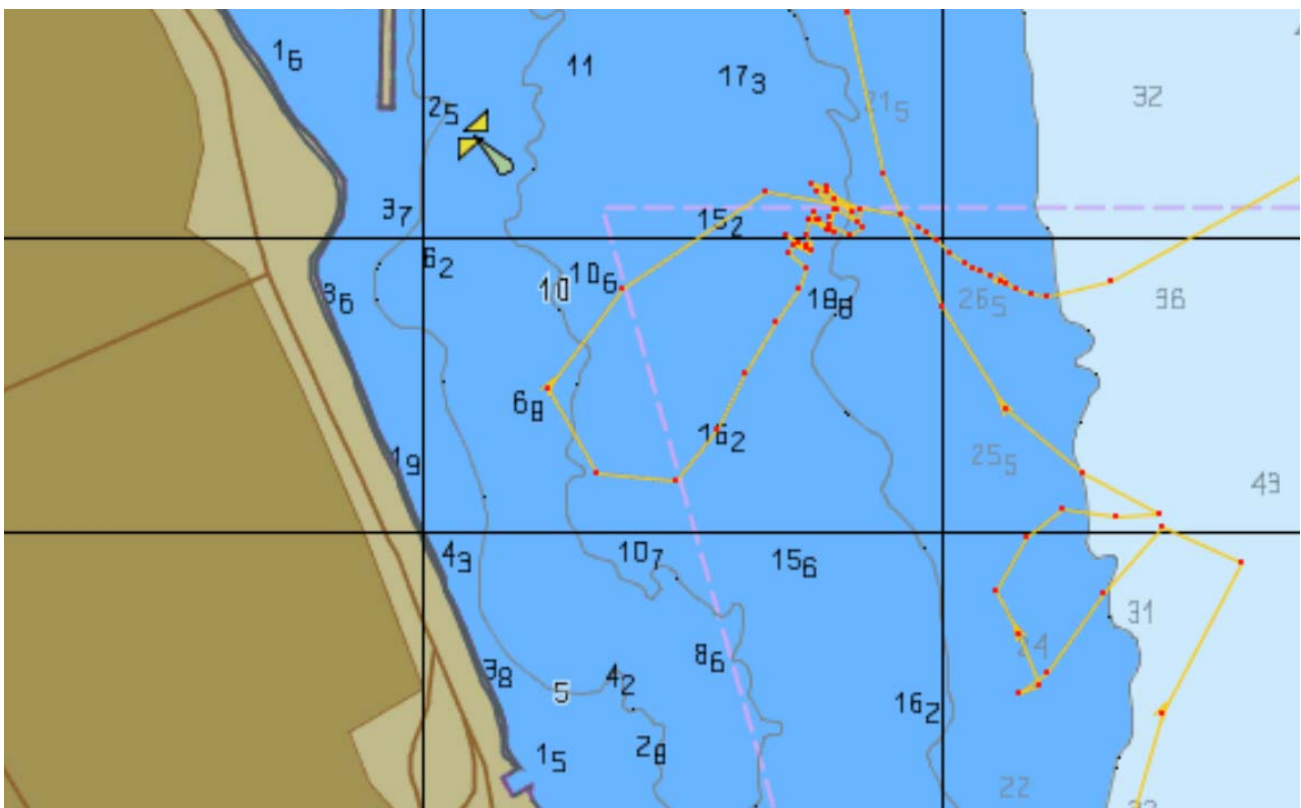
Figure 6. Track of the AIS antenna on the M/V INTERLINK UTILITY.

A study of the movements of the ship's AIS (figure 6) shows that the point of closest approach of the ship's antenna¹⁰ to the coast took place shortly after 15:34, at a distance of one cable length. That was when the ship crossed the 10-m depth curve and stopped dragging its anchor. It was thus after this point when the ship contacted the bottom with its hull.

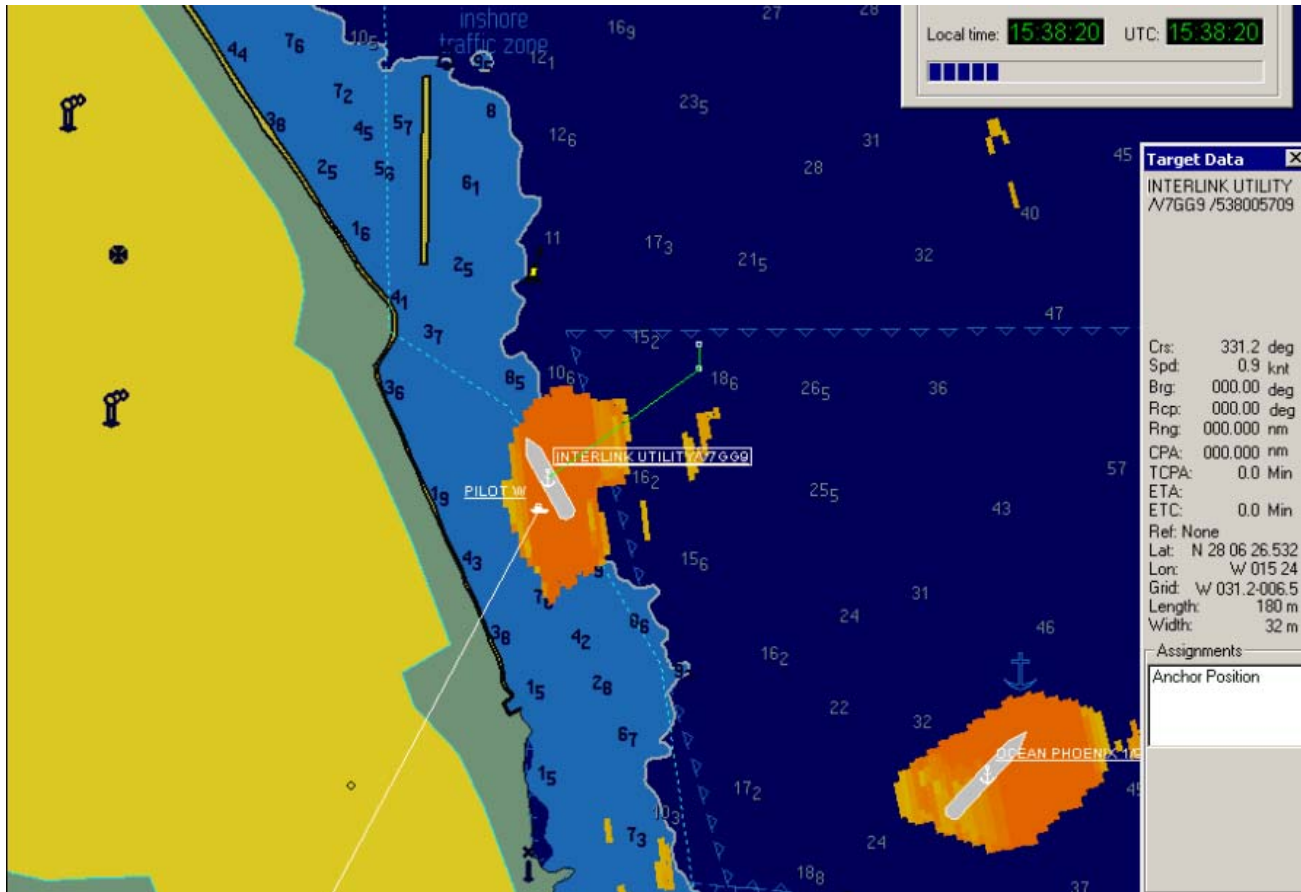
Figure 7. Radar images obtained by SASEMAR

The point of maximum penetration inside the 10-m depth curve was at 15:38. See figure 7. From then on, the ship started moving away from the coast.
