TECHNICAL REPORT A-30/2012

Investigation of the collision between high speed ferry MILENIUM DOS and bulk carrier NEW GLORY in the Straits of Gibraltar on 13 January 2012

COMISIÓN PERMANENTE DE INVESTIGACIÓN DE ACCIDENTES E INCIDENTES MARÍTIMOS

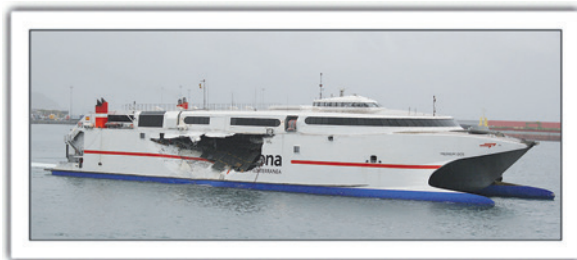
Figure 6. Damage to vessel MILENIUM DOS

During the collision a 26 m long and 6 m high hole was inflicted to the starboard side of ferry MILENIUM DOS, causing damage to the garage

deck, empty spaces 4, 5 and 6, and to two fuel tanks, which resulted in a fuel spill. The passenger deck only suffered minimal damages and the vessel stayed afloat.

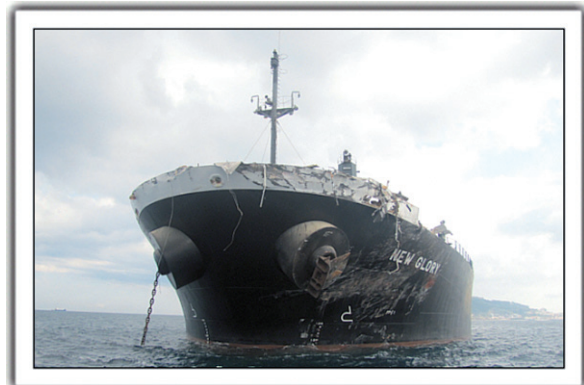
Figure 7. Damage to vessel NEW GLORY

There were no injuries to personnel on board the vessel NEW GLORY, which suffered minor damage to her bow.

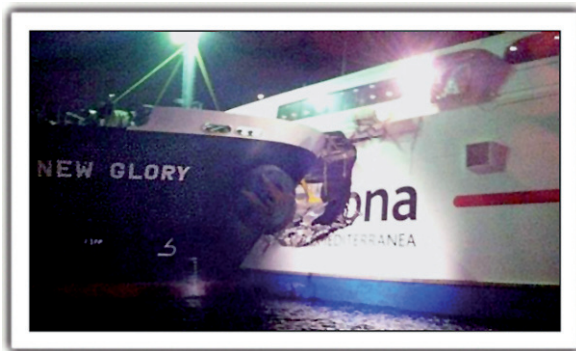
Figure 8. Moment when the vessels were separated

Tug boat LUZ DE MAR pulled from NEW GLORY's starboard quarter.

02:06 Vessel NEW GLORY completely separated from MILENIUM DOS's hull.

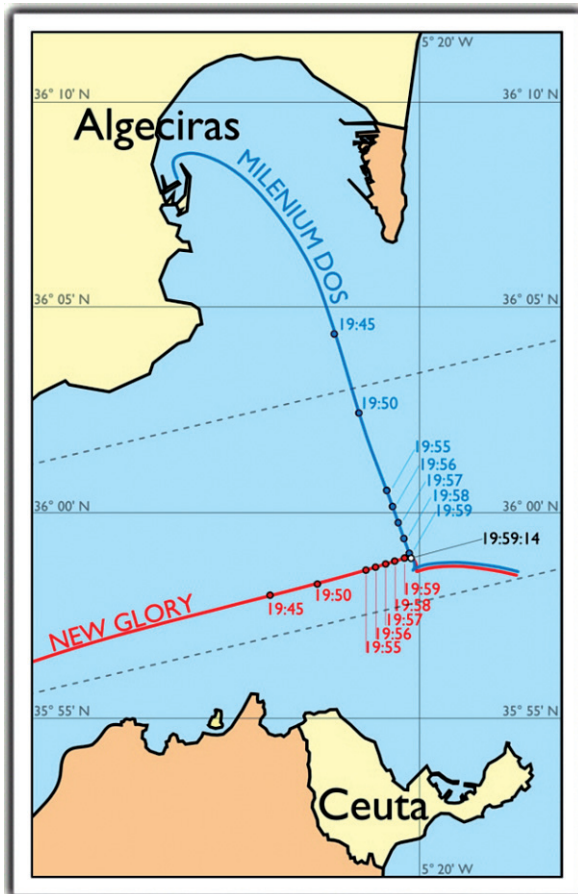
Figure 9. Trajectories of vessels MILENIUM DOS and NEW GLORY

Figure 9 shows the headings of vessels MILENIUM DOS and NEW GLORY, highlighting the positions they were in during the 15 minutes prior to the accident. In the figure we can see how both vessels maintained almost constant courses.

- Vessel MILENIUM DOS practically did not vary her course.
- Vessel NEW GLORY turned starboard a minute prior to the accident.
- The dotted silhouette of the vessel shows the positions that vessel NEW GLORY would have had if she had not changed course. In this case, probably vessel NEW GLORY would not have collided with vessel MILENIUM DOS; instead, she would have passed very close to the MILENIUM DOS's bow.

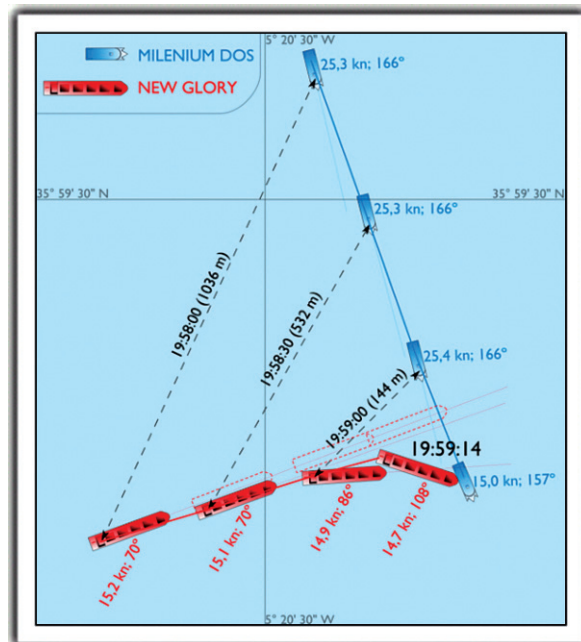
Figure 10. Positions of vessels MILENIUM DOS and NEW GLORY during the last minute prior to the collision

Figure 10 shows a more detailed graph of the manoeuvres carried out by both vessels during the last minute prior to the collision. In this graph we can see the following:

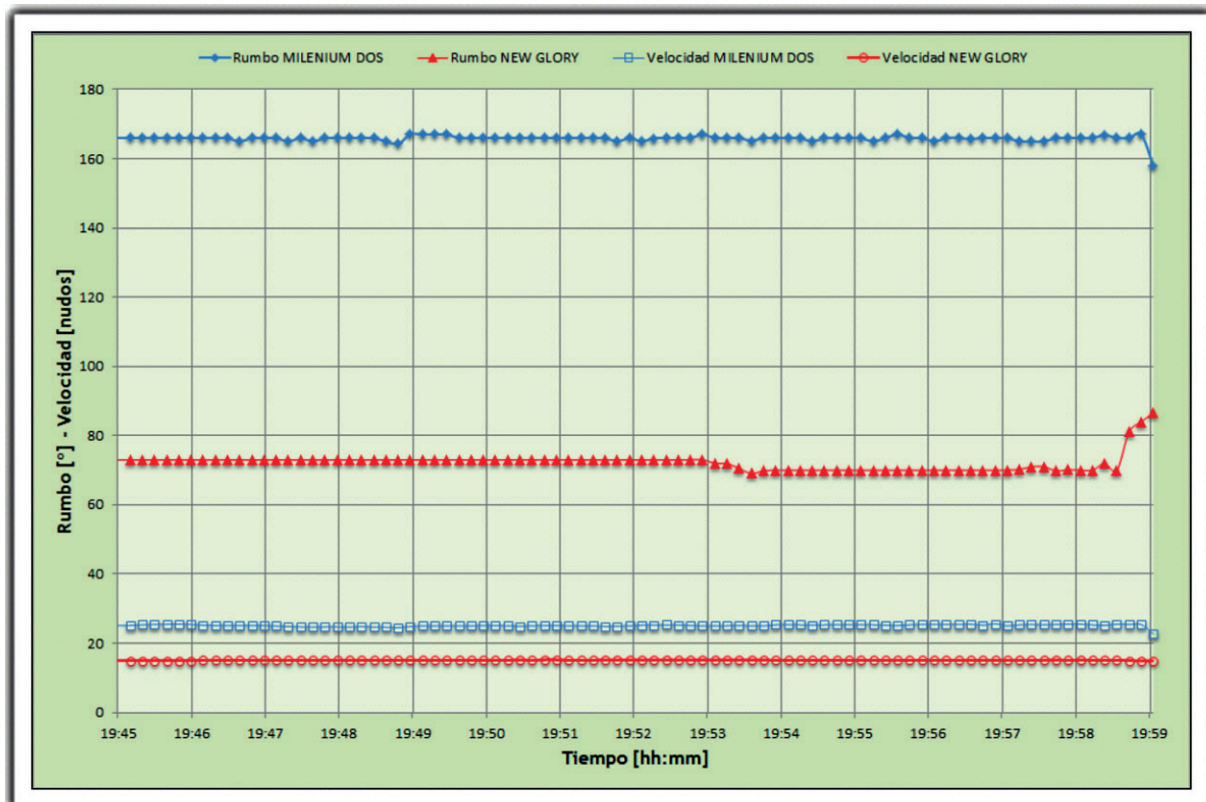
Figure II. Courses and speeds of vessels MILENIUM DOS and NEW GLORY during the fifteen minutes prior to the collision

The graph of figure 11 represents the values of the courses and speeds of both vessels during the 15 minutes prior to the collision. From the analysis of this data we can conclude the following:

- Even though they did not see the other vessel, this vessel did clearly appear on the ARPA screen that was recorded by the RDT.
- It has been confirmed that the navigation lights of vessel NEW GLORY were visible from the wheelhouses of other vessels that were navigating in the area at that time.

- The Watch Officers in the wheelhouse of vessel NEW GLORY did not warn of the danger via radio, nor did vessel MILENIUM DOS or Tangier Traffic.
- The Watch Officers on the wheelhouse of vessel NEW GLORY had difficulty in identifying vessel MILENIUM DOS. The data of vessel MILENIUM DOS appeared in the vessel's equipment about two minutes prior to the accident; however, they thought they had collided with vessel FRISIA LUBECK.
- The first Officer of vessel NEW GLORY ordered an AB seaman to alert the other vessel using signal lights from the port wing two minutes prior to the accident.

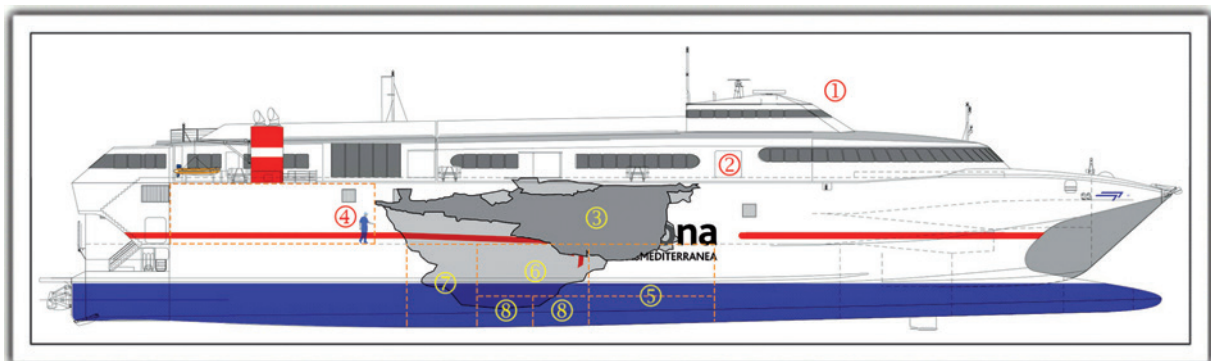
Figure 15. Damage to vessel MILENIUM DOS

Figure 16 shows a diagram of the damage suffered by the vessel, which were primarily a break in the plates and reinforcements of the starboard side at the following locations:

An undetermined fuel spill from the starboard tanks of vessel MILENIUM DOS occurred as a consequence of the accident. At the time of the accident there was approximately 36,000 litres of gas oil in these tanks.

- ① wheelhouse, ② passenger deck, ③ garage deck, ④ engine anteroom,
- ⑤ empty spaces 4, ⑥ empty space 5, ⑦ empty space 6, ⑧ gas oil tanks.

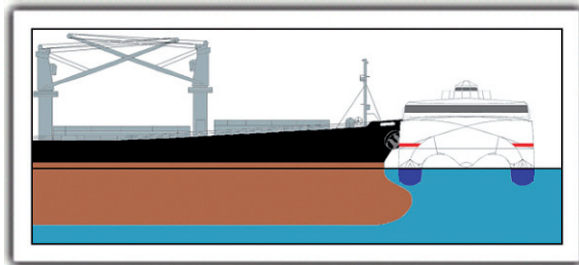
Figure 16. Forward bulb of vessel NEW GLORY under the hull of vessel MILENIUM DOS (figure to scale)

The vessel's structure resisted the impact from NEW GLORY mainly due of the following reasons:

- The forward bulb of vessel NEW GLORY did not collide against the starboard hull of vessel MILENIUM DOS; instead, it remained underneath it as can be seen in the diagram of figure 16.
- The bow of vessel NEW GLORY collided below the passenger deck of vessel MILENIUM DOS, lifting the central block from the superstructure.

Under other vessel load conditions the consequences could have been much worse.

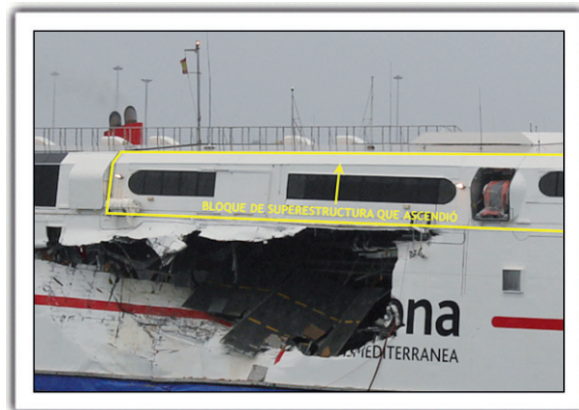
Figure 17. Superstructure block of vessel MILENIUM DOS that was raised

The fact that the part of the superstructure that was impacted by vessel NEW GLORY was raised with the vessel's bow had the following effects:

- The superstructure block was raised instead of broken, preventing this area from being destroyed by the impact and preserving the integrity of the passengers.
- No sheers or breaks occurred that would have endangered the integrity of the structure.
- Both vessels became joined until the bow of vessel NEW GLORY dropped as her forepeak filled, and the superstructure block, which had been raised, dropped along with it, freeing both vessels from each other.

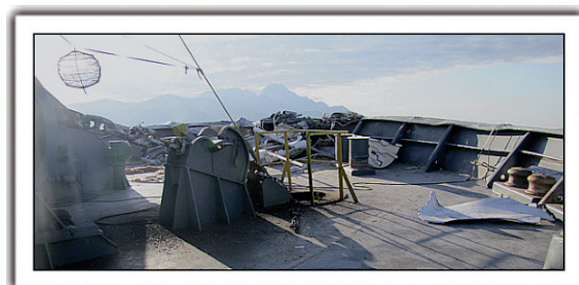
Figure 18. Damage to the bow of vessel NEW GLORY

Vessel NEW GLORY suffered little damage to the port side of her bow and none of her passengers were injured.

The damages, which were located forward on the port side and extended longitudinally from hatch 1 to half way to the bow, were the following:

- The railing on the bow was bent.
- Damages occurred to the platform, the ventilation ducts and the beacon.
- The flag pole fell down.
- The port capstan and stopper were bent.
- The port deck was dented.
