## Technical report S-22/2013

# Investigation of the running aground of vessel CELIA, on 28 September 2012 at the beach of El Saler in Valencia.

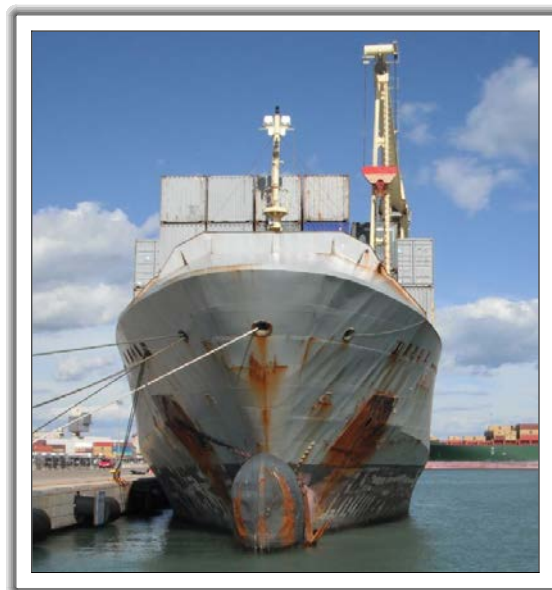
Figure 2. Proa del buque CELIA

At 23:00 hours M/V CELIA ran aground on the beach of El Saler, at position 39°21.83'N, 000°18.92'W, in a sandy bottom, 0.1 miles stern of M/V BSLE SUNRISE. The entire crew of M/V CELIA was in perfect health. One minute later, at 23:01 hours, pilots from Valencia reported this fact to the RCC in Valencia.

At 23:58 hours, the crew of M/V CELIA reported that the depth around the vessel were 4.8 m at the bow, 3.5 m at half length and 3.5 m at the stern. After an inspection was conducted, they also reported that there were no fuel leaks near the vessel and that no water was present in her bays, but that the port anchor chain was broken and the anchor had been lost.

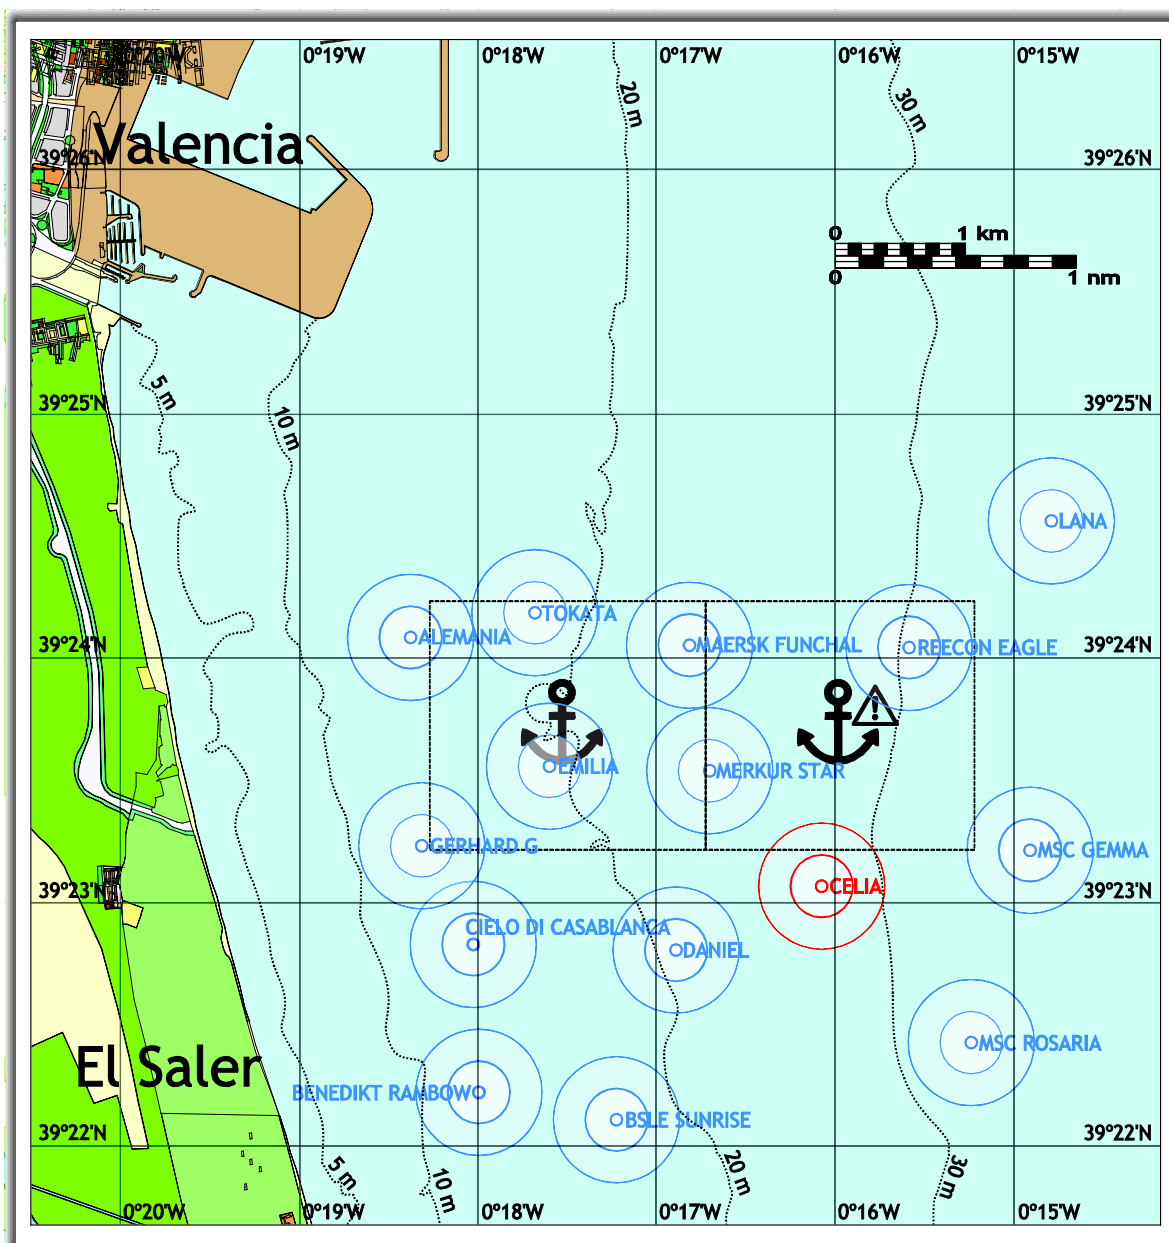
Figure 3. Vessels run aground on 28 September 2012 at 17:06 hours near the port of Valencia.

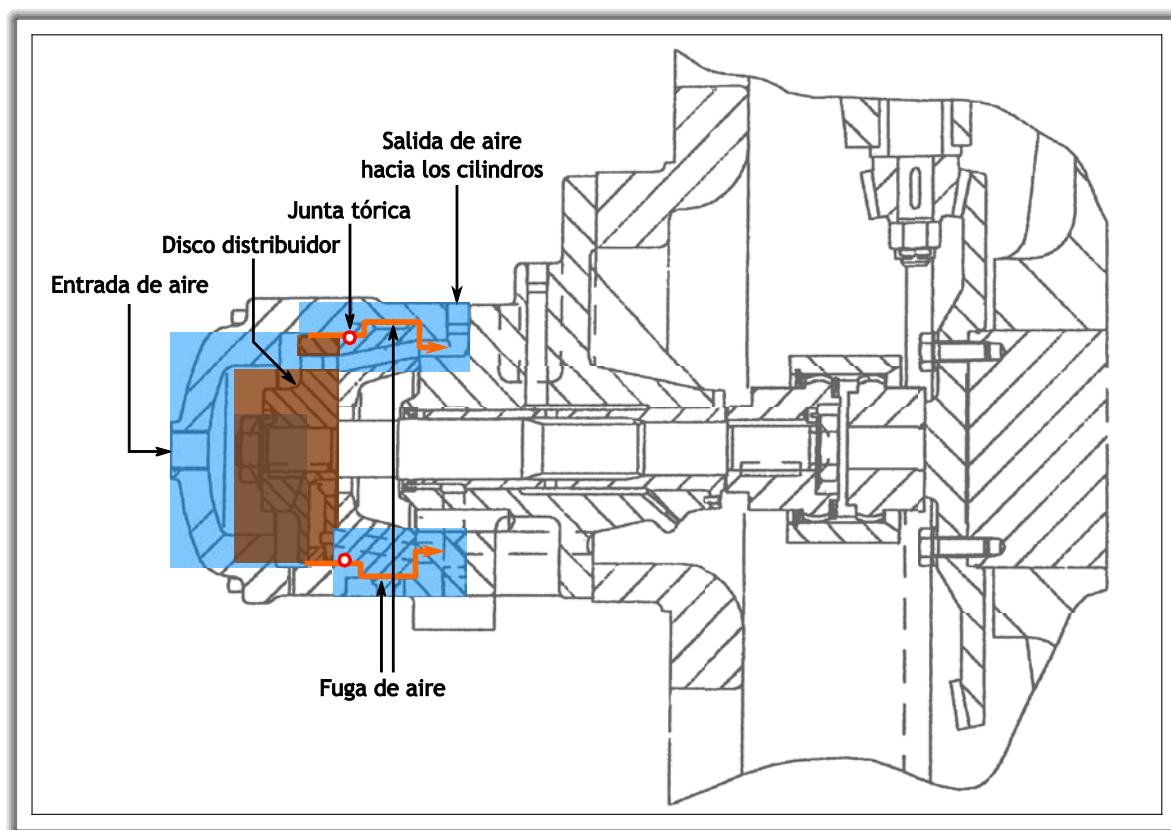
Figure 5. Start air distributor

After conducting an inspection of the different components involved in starting the main engine, it was determined that all the components were in perfect working order except for an o-ring from the start air distributor, which was broken. In order to check if said broken o-ring may have been the cause of the engine failure, they simulated starting the engine after disconnecting the cylinder aeration control lines. It was discovered that air exited the distributor towards all the start valves at the same time, which would prevent starting the engine.

Once these tests were completed the air distributor was removed and sent to Man engine manufacturer for them to study the component. They concluded that the broken o-ring may have been the reason why the main engine did not start.

Subsequently the start air distributor cover was re-opened and a new o-ring was installed. Another start was simulated, checking that the air exited exclusively through the two lines that are supposed to provide air to the start valves.

1. To incorporate a periodic inspection and maintenance of the start air distributor o-ring to its safety management system in accordance with the instructions provided by the engine manufacturer.

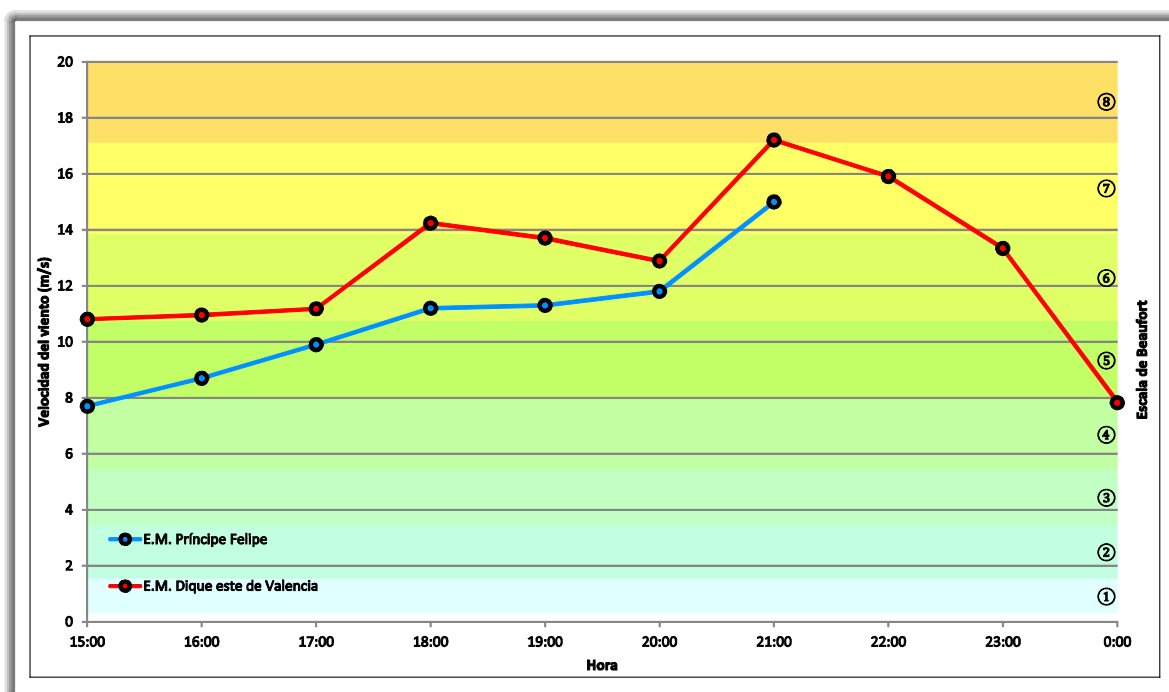
Figure 7. Wind speed records on 28/09/2012 at the Weather Stations (W/S) of the port of Valencia

figure 7 shows the data collected by weather stations near the Port of Valencia for the day of the accident. Weather Station Principe Felipe shows values that are slightly lower because its position is located further inward and protected from the port.
