TECHNICAL REPORT A-20/2012

Investigation of the capsizing of merchant vessel DENEBO
at the Port of Algeciras on 11 June 2011

COMISIÓN PERMANENTE DE
INVESTIGACIÓN DE ACCIDENTES
E INCIDENTES MARÍTIMOS

Technical report

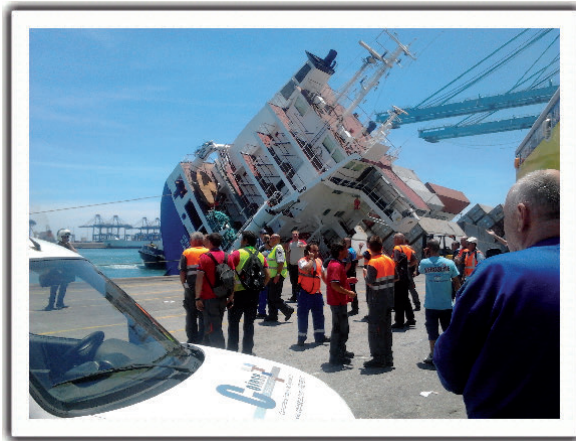
to heel to her starboard side, slowly at first and then progressively at a faster speed until the containers located on the deck touched the pier. Some mooring ropes were missing, which allowed the ship to move several metres forward. According to witnesses, the heel angle at that moment was approximately 45°.

Figure 5. Moments after the accident

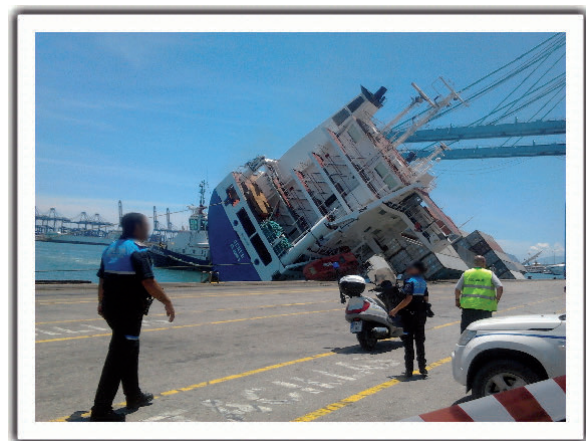
Figure 6. Position at 14:00 on 11 June

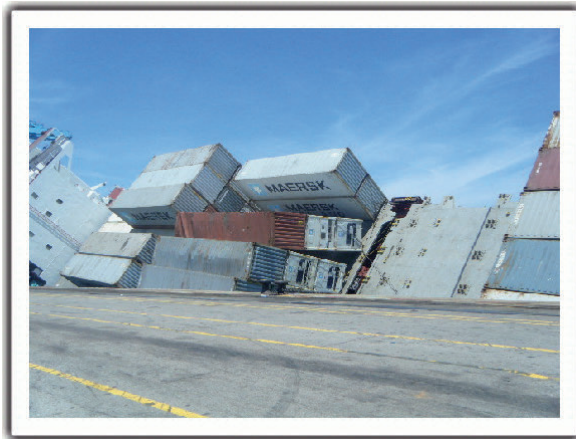
As the ship heeled, part of the containers located on the deck and over bay 2 came loose and their locking mechanisms moved starboard (see Figure 7).

Figure 7. Containers over bay 2, whose locking mechanisms did not withstand the heeling

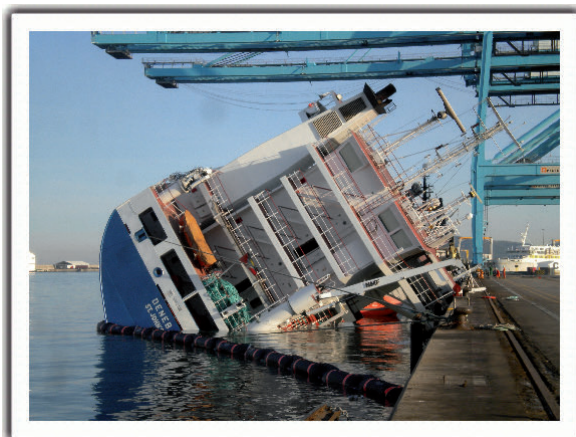
The ship's heel angle increased and initially, her bow began to flood until it touched the bottom, while her stern remained afloat while the heel angle continued to increase. As the day progressed and the engine room flooded, the stern of the M/V DENEBA began losing floatability until finally resting on the bottom; she slightly separated from the pier with an approximate heel angle of 54°. At 20:00 hours, the starboard wheelhouse's wing contacted with the pier, and remained balanced in that position (Figure 8).

Figure 8. Position at 20:00 on 11 June

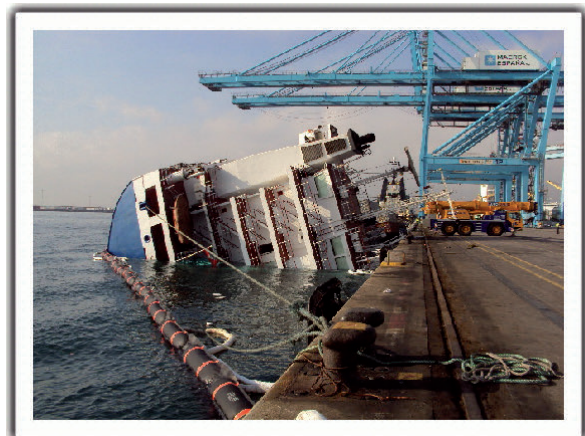
The following day, on 12 June at 06:50 hours, an operations technician from SASEMAR reported that no air was exiting along the quay, which was interpreted as a sign that the ship must be lying on the bottom. Figure 9 shows the ship's condition moments later.

Figure 9. Position at 08:30 on 12 June

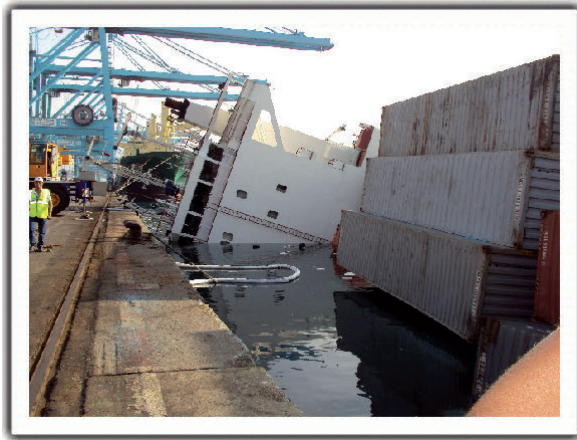
As shown in Figures 6 and 7, which correspond to the evening of the 11th of June, the ship continued heeling throughout the night until ending up in the position shown in Figure 10 on the morning of the 12th of June.

Figure 10. Position at 09:30 on 12 June

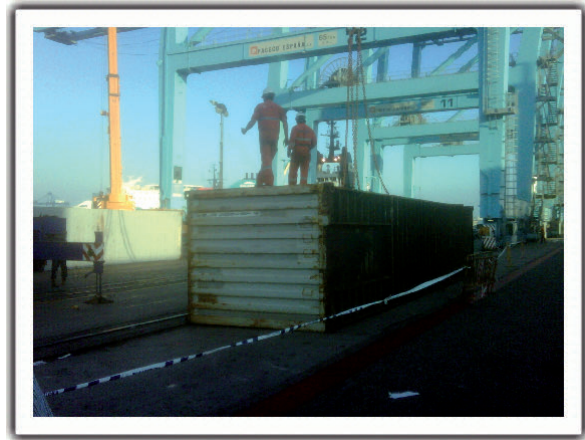
Figure 11. Container removal work carried out by the company in charge of the salvage operations on 12 June

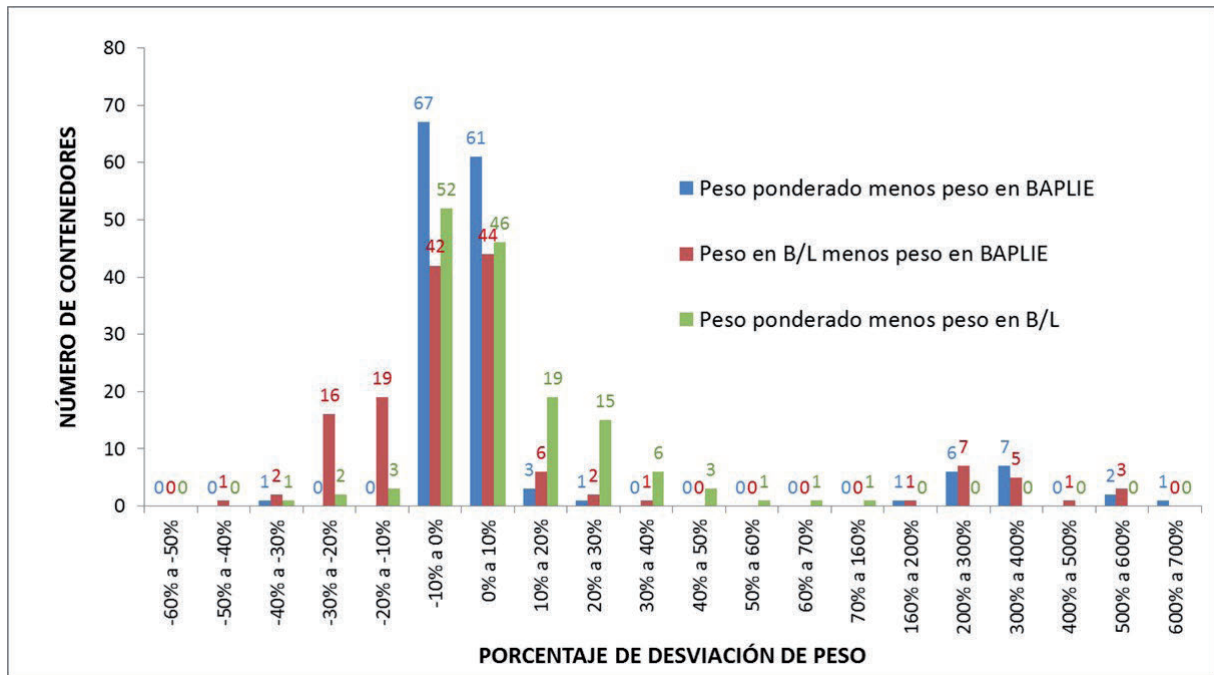
weight difference, the graph in Figure 12 is obtained, which reflects the percentage differences summarized in the previous paragraphs. If the difference in weights observed in the containers is random, the associated distribution of probability should follow a Gaussian bell curve. An anomaly is observed in a significant number of containers (located on the right hand side of the graph) where the error in weight of the BAPLIE is greater than 160 %.

Figure 12. Distribution of the weight differences found in loaded containers

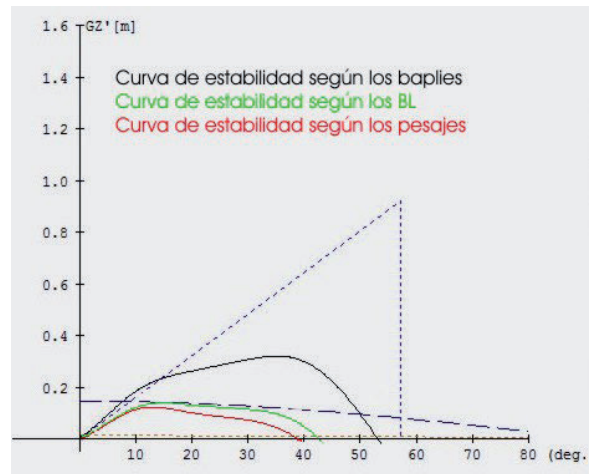
However, the same load condition considering the weights declared according to the B/Ls or the calculated weights after the containers were weighed does not comply in any case with the stability criteria. Figure 13 shows the three stability curves obtained for the scheduled stowage plan:

- In black: Stability curve drafted by the ship using the BAPLIEs exchanged between the ship and the load terminal.
- In green: Stability curve for the same load condition devised with data from the B/Ls; in other words, with the information provided by the owners of the cargo to the line.
- In red: Stability curve for the same load condition but using the calculated weights of the containers obtained when these were weighed after the accident.

In all three cases the ship maintains a positive MG. If the ship had been loaded according to the scheduled stowage plan, in her final configuration, she would not have capsized in port. Also, she would have been overloaded had her ballast not been modified. In this respect, it is worth mentioning that the ship was carrying 65 t in starboard side tank no. 1 and that the forward double lined tanks had been filled.

Figure 13. Scheduled stowage plan: comparison of the three stability curves corresponding to the three available weights

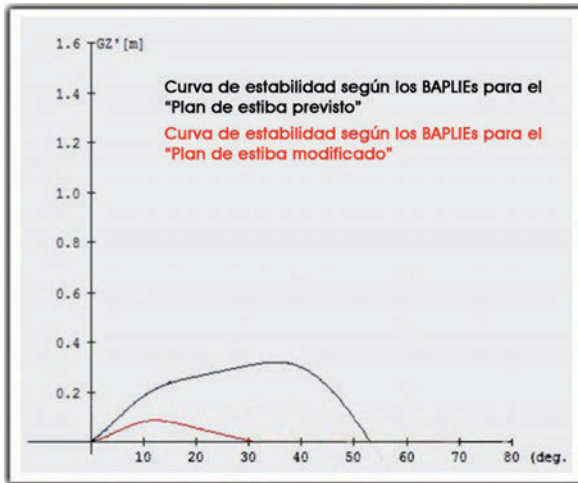
In the figure we can see how the ship’s stability curve for the new condition, represented in red, was considerably reduced. In this load condition most of the regulatory stability criteria were no longer complied with.

Figure 14. Comparison of the stability curves using the data in the BAPLIEs for the scheduled and modified stowage plan

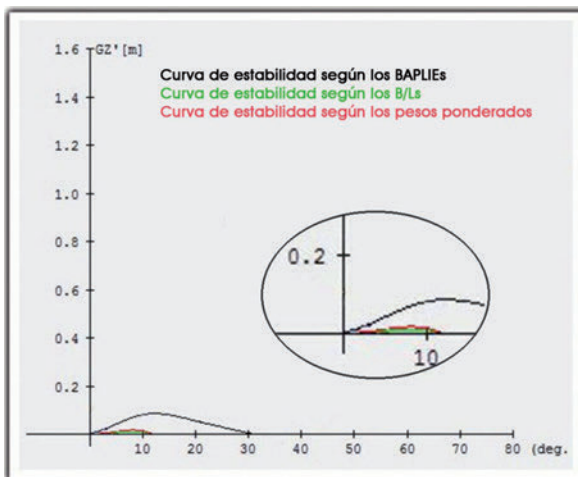
Likewise, considering the calculated weights or the weights listed in the B/Ls, the ship did not comply with the stability criteria. Figure 15 shows the three corresponding stability curves.

Figure 15. Modified stowage plan: Comparison of the stability curves drafted using the three analyzed weight lists

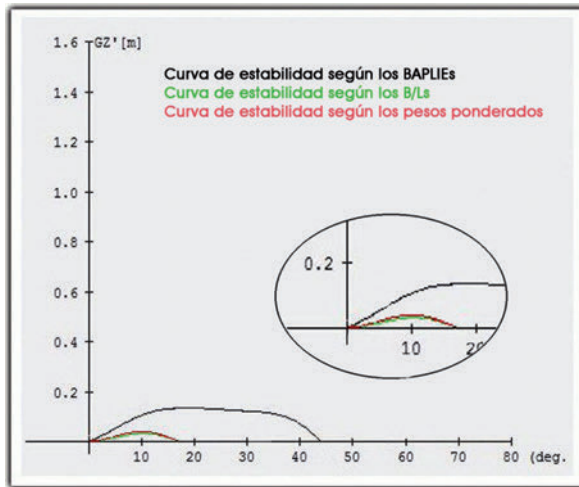
The corrected metacentric height was 5, 11 or 47 cm, depending on what data is used for the stability calculations.

In any case, the actual stability of the ship was so compromised that a slight breeze or small swell would have sufficed to counteract the ship's residual righting torque.

Figure 16. Comparison of the righting arm curves at the time of the accident

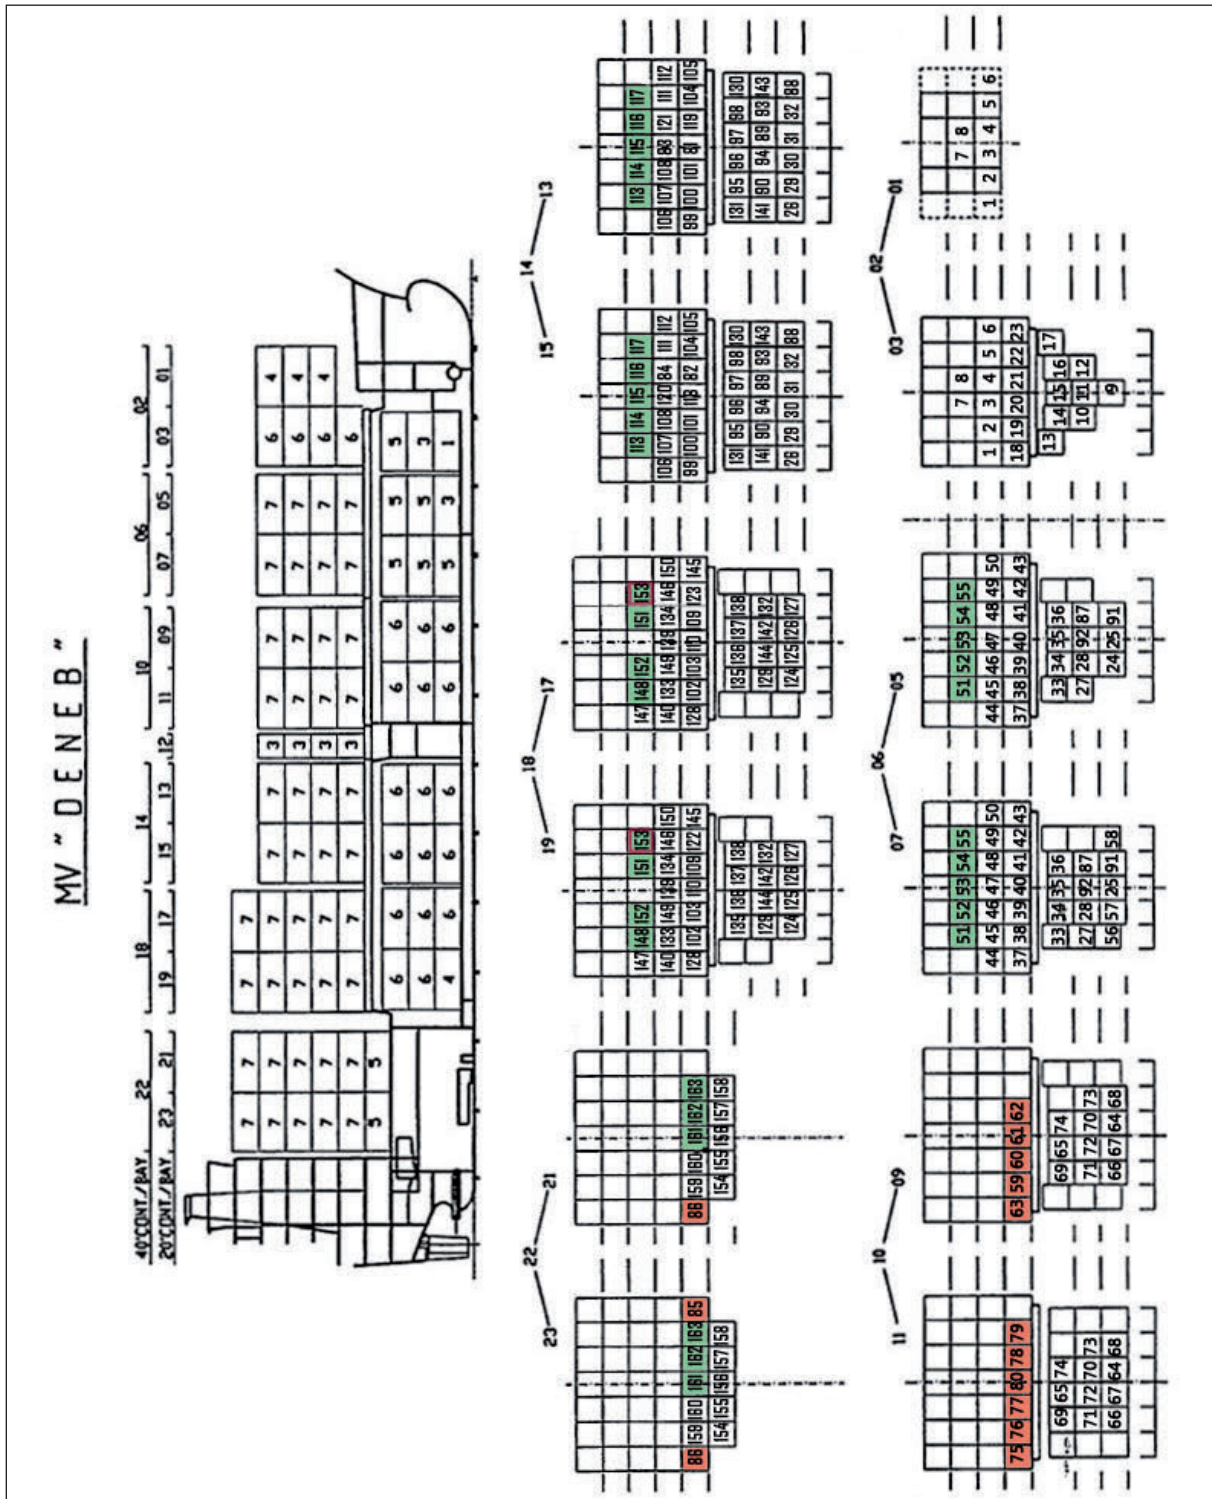
Figure 19. Final condition of the cargo of M/V DENE B Container 153 marked with a red square was the last container loaded on board. The containers marked with a green background are those whose actual weight exceeded the weight listed in the BAPLIE by more than 200%. Containers with a red background are those that at the time of the accident were not on board; however, their position on board was reflected in the modified stowage plan
