TECHNICAL REPORT A-13/2010

Investigation of the running aground of CH/T SICHEM COLIBRI
in the Guadalquivir River on the 11th of August, 2009

Technical report

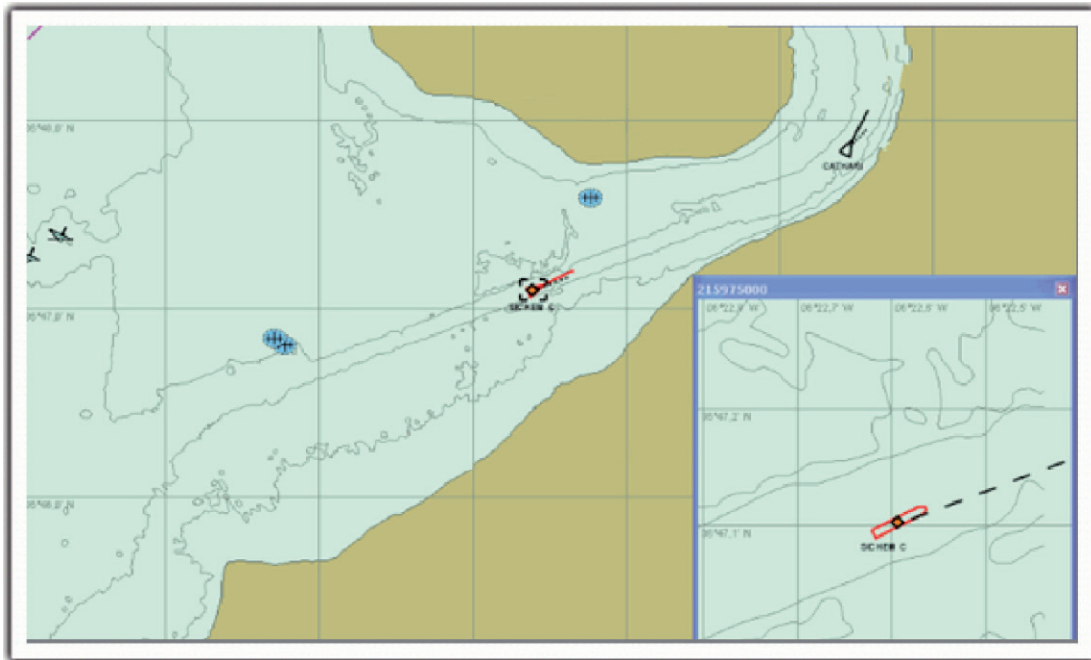
Figure 5. Moment prior to the steering gear failure (picture taken by the SASEMAR's AIS)

Figures 5 and 6 show the position of the SICHEM COLIBRI while she was travelling through the entry canal bar, at the exact moment prior to the steering gear failure being detected and turning towards her port side.

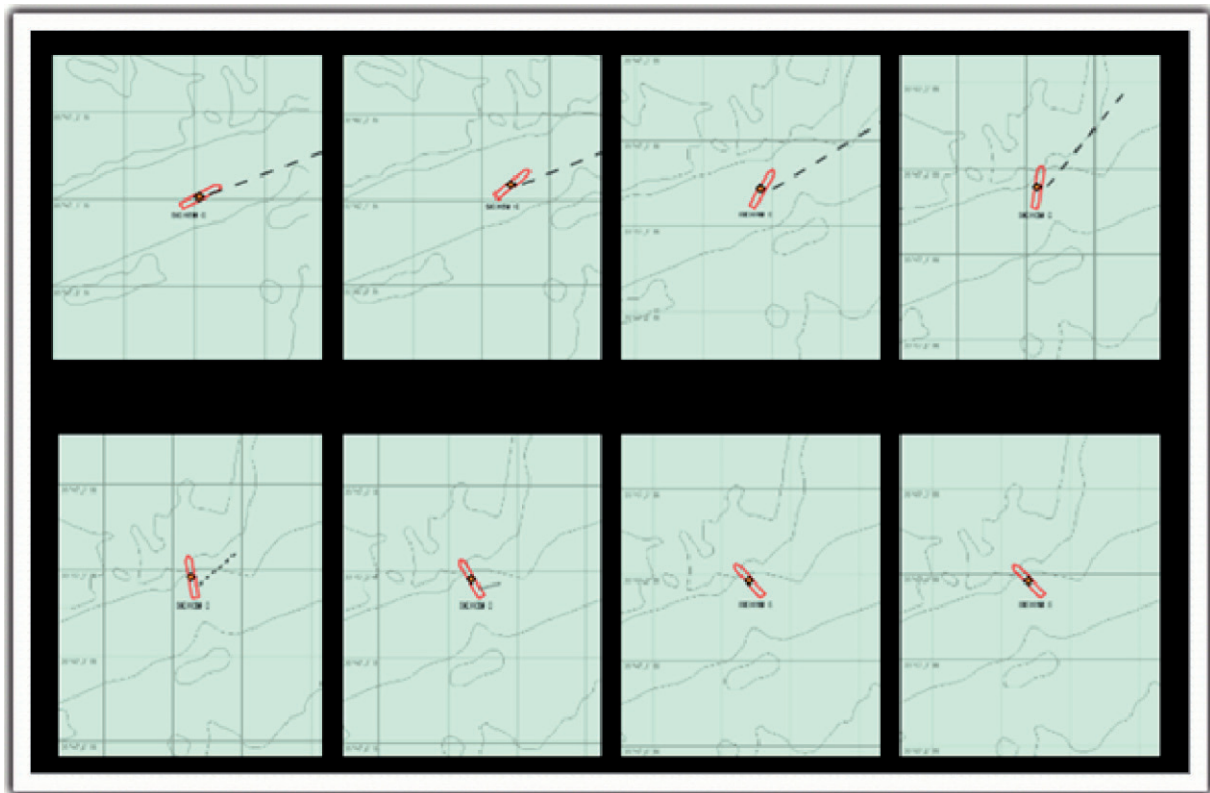
Figure 7. Sequence of events shown via the SASEMAR Rescue Centre's AIS screen.

Figure 7 shows the sequence of events from the time the vessel began to turn towards her port side until she ran aground on the left margin of

the bar, in an up river direction. The vessel went from moving at 11.1 knots, to completely stopping in approximately 90 seconds.

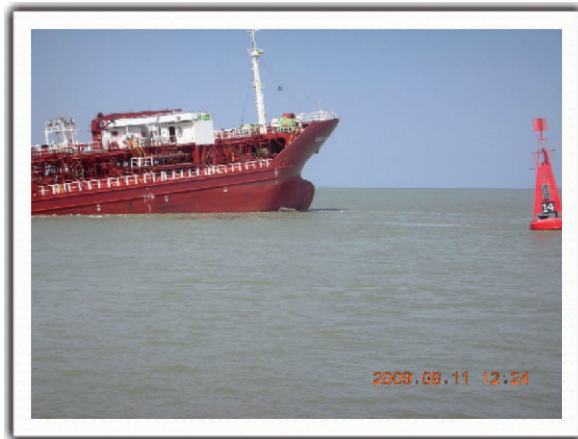
Figure 9. Position in which she ran aground next to buoy n.º. 14 (La Riza)

The vessel pivoted about her bow, turned and stopped at heading 317°, heeling towards port at about 4°, at position 36° 47.2' N; 06° 22.5' W (next to buoy 14 - sandbar known as Bajo de la Riza) aground over a weak oyster rock.

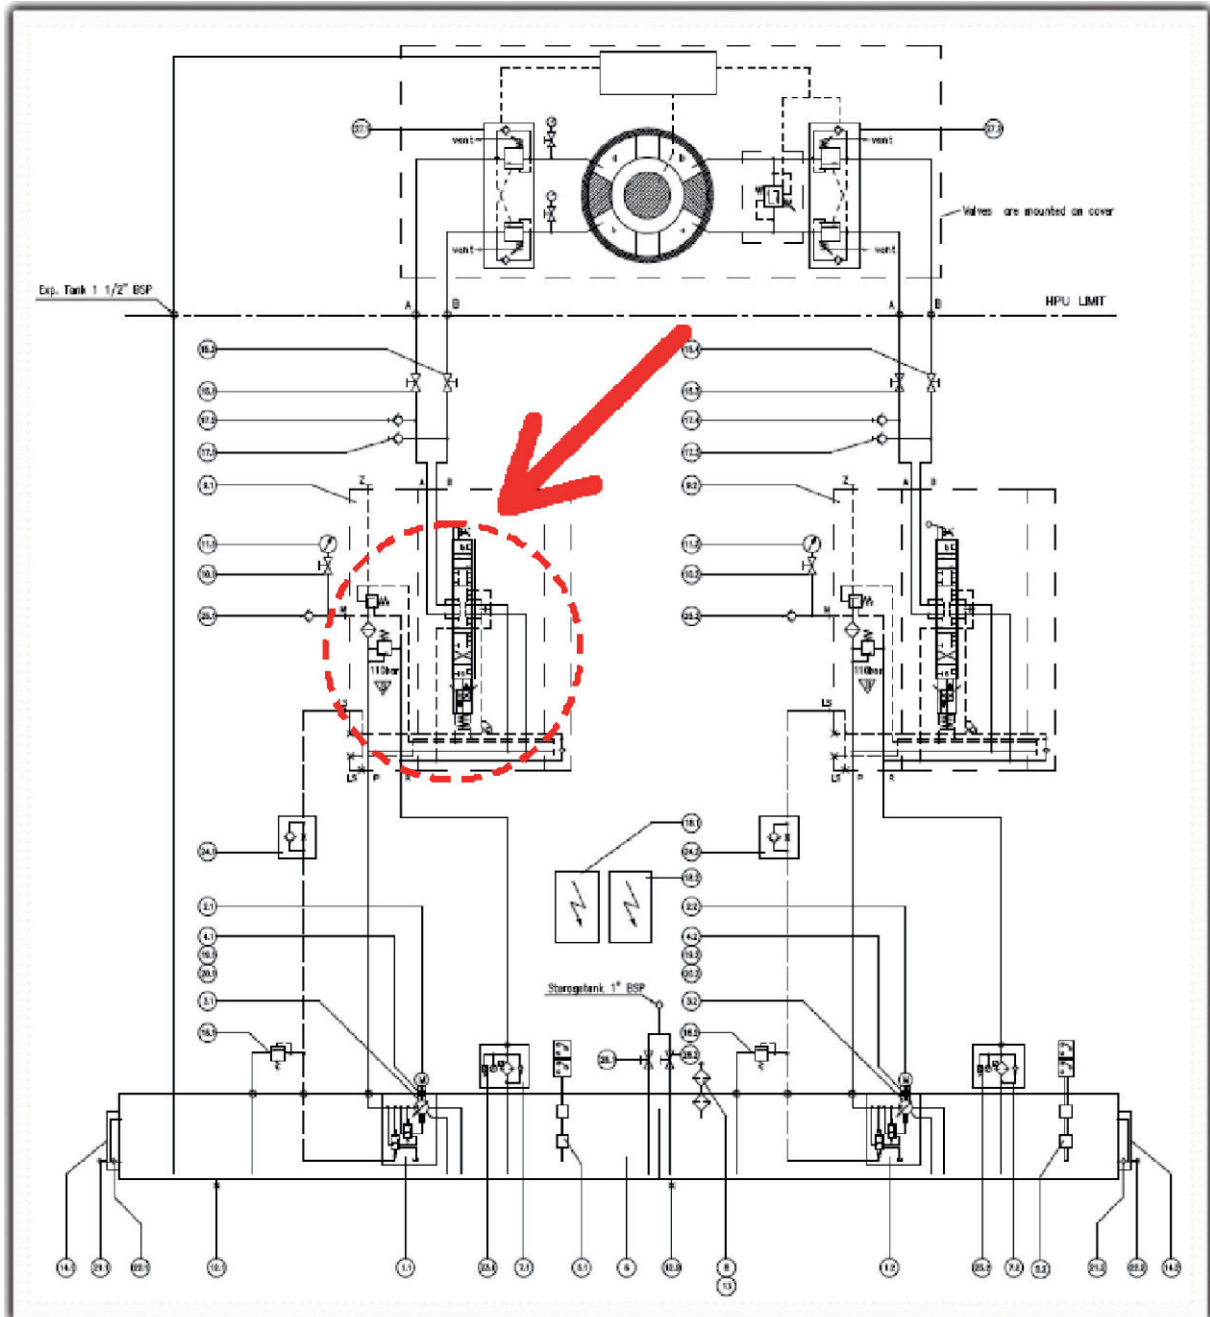
Figure 11. Hydraulic diagram of the steering gear: solenoid valve malfunction.

From the analysis of the technical reports drafted by the steering gear manufacturer, we can conclude the following:

- The cause of the accident was a failure in the remote controlled valve or solenoid valve, of the number 1 (starboard) steering gear system.
- One of the actuators that connected the emergency steering lever to the solenoid valve's piston was discovered broken. A fragment that had detached from this piece was obstructing one of the valve's lines.
- The result was that the valve line was left in a permanently open position, allowing unrestricted flow of hydraulic fluid to the system, which caused the rudder to move to the port side and remain in this position, without responding to rudder commands that were being executed from the Wheelhouse to the steering system.
- According to the manufacturer, this is the first time they have seen this type of failure.

- The cause of the vessel running aground was a failure in the vessel's steering system due to the rupture of a component of the number 1 servomotor solenoid valve, resulting in the detachment of a metallic piece, which blocked another part of the valve, causing hydraulic fluid to constantly flow in one of the circuits. This occurrence caused the steering system to move the rudder towards the port side and to remain blocked in that position, at a 20° angle.

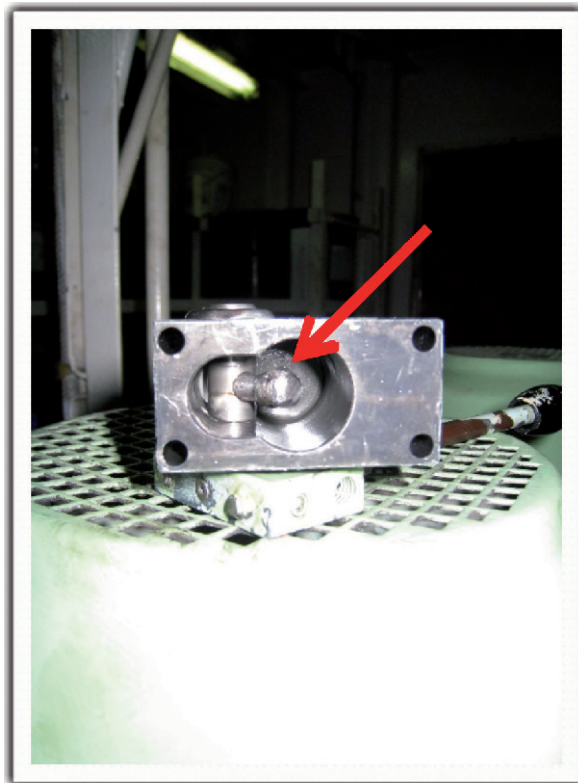
Figure 12. View of the broken solenoid valve actuator

- No proof exists that enables us to explain if the rupture was due to poor maintenance, material fatigue, an error in its design, or if it was due to any other cause.

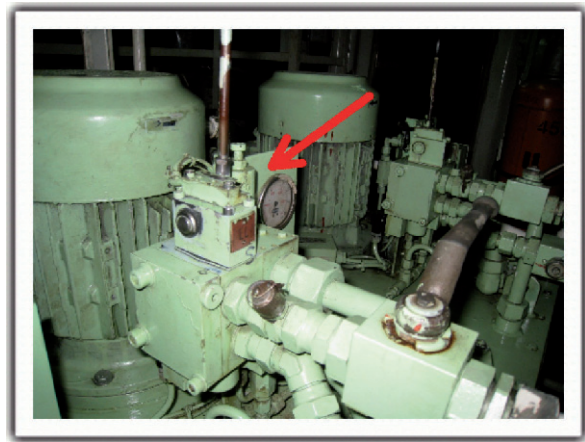
Figure 13. Location of the n°.1 steering gear emergency steering lever

- Had the builder's instructions been followed in the event of a steering system failure or fault, this would not have been able to prevent the grounding, due to the limited time that was available to react and the distance required to carry out the manoeuvre in accordance with the vessel's performance charts.

- The instructions for acting in the event of a steering system failure should have been available at a location that was readily accessible to personnel steering the vessel, instead of being kept in the panel opposite the steering console.

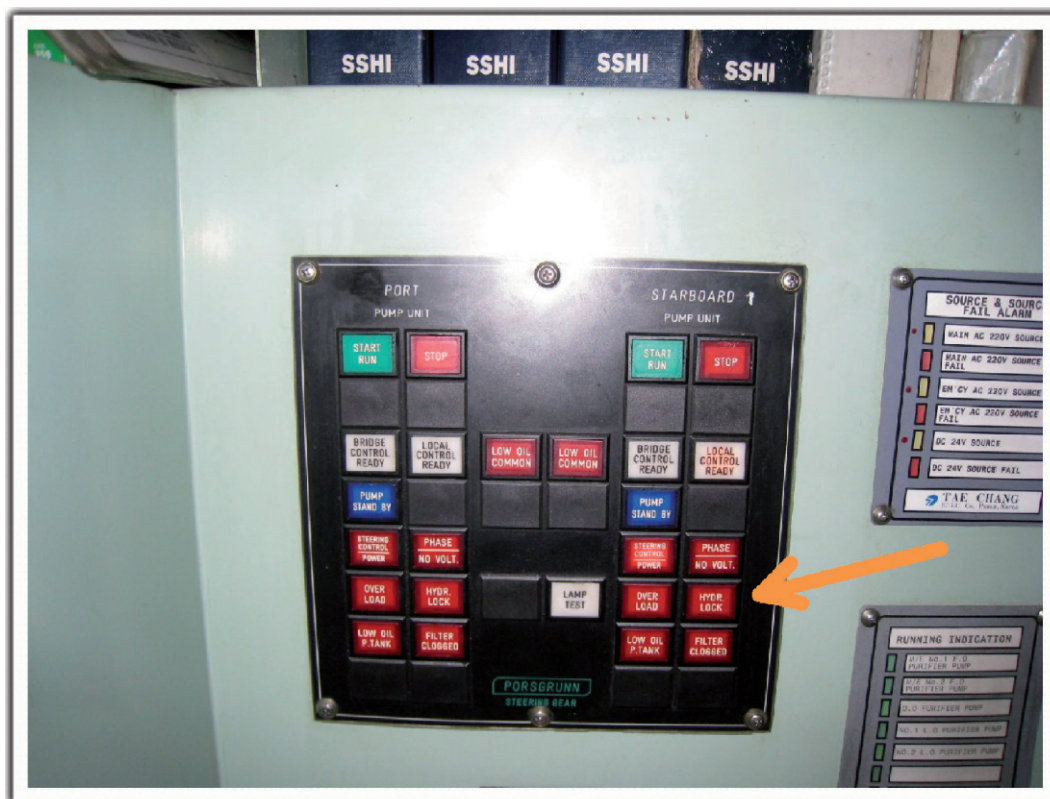
Figure 15. View of the location of the hydraulic blockage indicator on the steering system's warning panel

The alarms system installed on board included the required alarms as well as the capability of detecting a hydraulic blockage problem and triggering the corresponding alarm, as shown in the picture of Figure 15.

- The hydraulic blockage alarm built in to the system, which should have detected the failure, did not work properly. However, the proper operation of the alarm would probably have not prevented the grounding of the vessel.
