## **Mv MANISA STAR**

**VERY SERIOUS MARITIME CASUALTY**

**Loss of contention, with loss of one life**

Maritime safety investigation report

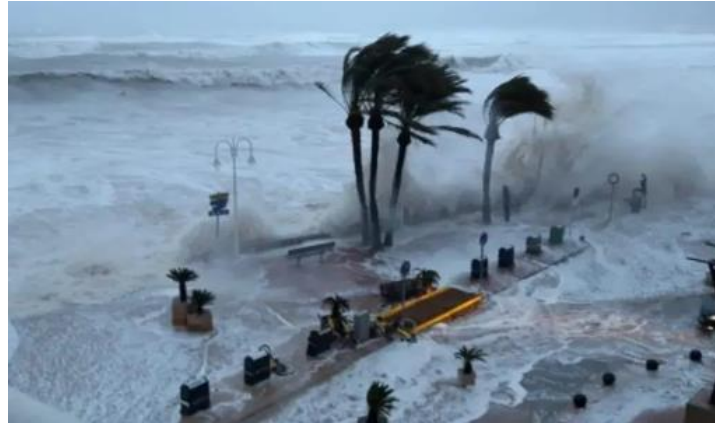
The storm Gloria that hit the port of Palamos in January 2020 was Spain's worst since the winter of 1983. Wind gust up to 43 knots (kts) were registered and 10-meter waves were also registered. The swell inside the port of Palamos was 1 meter high.
