Panama Maritime Authority
Directorate General of Merchant Marine
Marine Accident investigation Department

REPORT: M/V “TERVE”R-047-2014-DIAM
IMO No. 9204348
DATE: 27th February 2014

REPORT ON THE INVESTIGATION OF THE COLLISION OF

**m.v. “TERVE”
IMO number 9204348
Register Number 2639499CH**

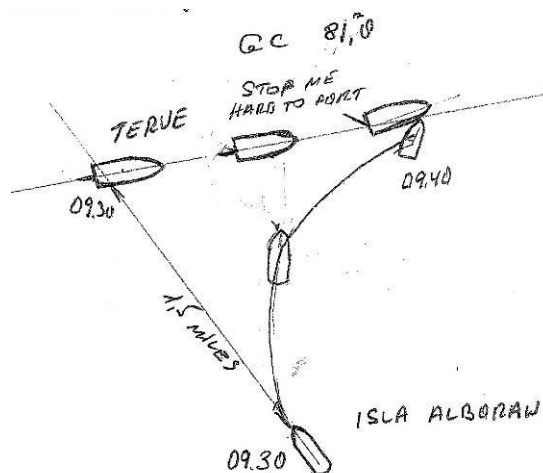
Figure 4.3– Collision sketch

- 4.24 All the sudden the ISLA DE ALBORAN TRES changed her course to her starboard hence in collision course with TERVE.
- 4.25 This was unnoticed by the Master of the TERVE.
