Report on the investigation of the
grounding of
Muros
Haisborough Sand
North Sea
3 December 2016

At 0248 (UTC+1) on 3 December 2016, the bulk carrier *Muros* ran aground on Haisborough Sand on the east coast of the United Kingdom. Attempts to manoeuvre clear of the shallows were unsuccessful but the vessel was re-floated 6 days later with tug assistance. There were no injuries and no pollution, but damage to *Muros*'s rudder necessitated the vessel being towed to Rotterdam, Netherlands, for repair.

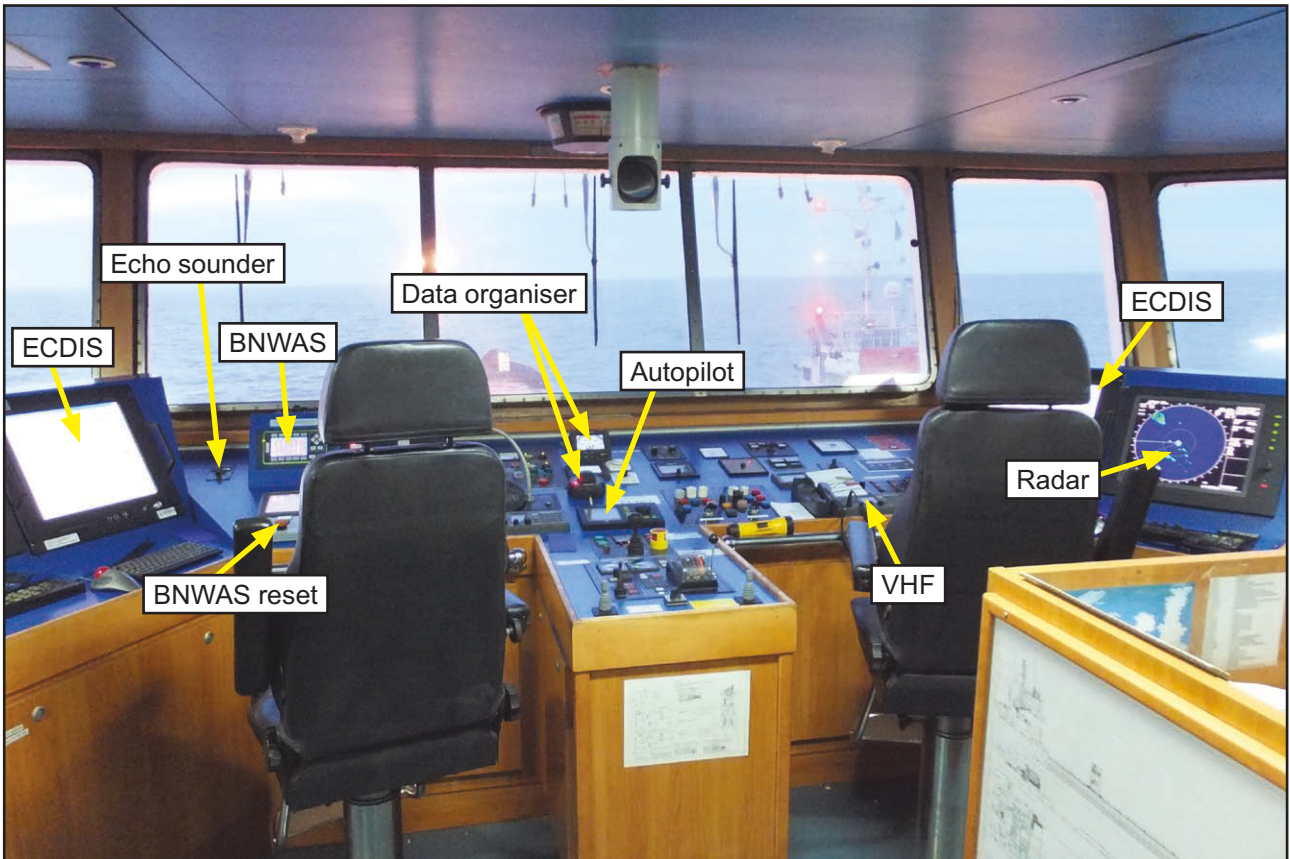
Figure 2: Bridge layout

The 2/O amended the passage plan on the ECDIS at the starboard bridge conning position (**Figure 2**) and at 0025 she adjusted the vessel's heading set on the autopilot to 140° to follow the revised track (**Figure 3**). The 2/O then sat in the starboard chair. The lookout alternated between standing on the bridge's port side and sitting in the port chair. He routinely reset the BNWAS.

Muros's ECDIS comprised two terminals, one on each side of the bridge centre console (**Figure 2**). The port terminal was marked as 'planning' and the starboard one as 'monitoring'. However, both terminals could be used in either mode. The vessel's electronic navigational charts (ENC) were supplied by PRIMAR, operated by the Norwegian Hydrographic Service.

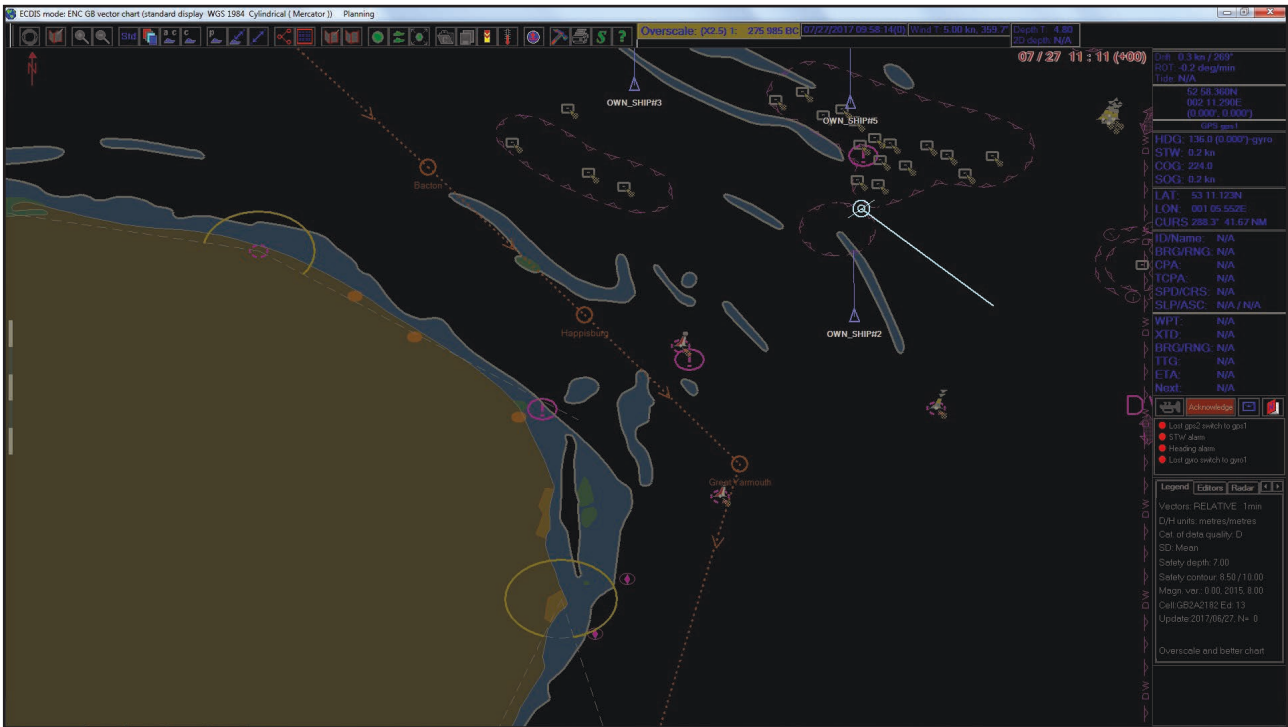
Figure 10: Muros's passage plan on ENC GB2A2182

During the simulations, the method used by *Muros*'s 2/O to check the proximity of the intended track to the 10m safety contour near Cross Sand was repeated. When the display was zoomed out, ENC cell GB 2A2182¹⁴ was selected and the intended track passed over the 10m contour (**Figure 10**). However, when the display was zoomed out, ENC cell GB300106 was selected and the intended track was over 2 miles from the 10m contour (**Figure 11**), which was further to the south-west.

The 2/O saw that the course line near Cross Sand was close to the safety contour shown on the display (**Figure 10**), but when she zoomed in, the track was clear of the safety contour (**Figure 11**). The simulations conducted at Red Ensign Ltd (**paragraph 1.6.1**) showed that this was due to differences between ENC cells GB2A2182 (scale 1: 700000) and GB300106 (scale 1: 90000). The larger scale cell was more accurate and contained more detailed information and, although the change of ENC when zooming in and out would have been displayed, this was either not seen by the 2/O or the implications of the change of chart scale were not recognised. This led to the incorrect assumption that the track over Haisborough Sand would also be clear of the shallows by a similar margin to the course line further to the south.
