**INDEPENDENT INVESTIGATION REPORT
INTO THE VERY SERIOUS MARINE
CASUALTY**

MV “HANSE FORTUNE”

AT BARCELONA

ON the 12.09.2015

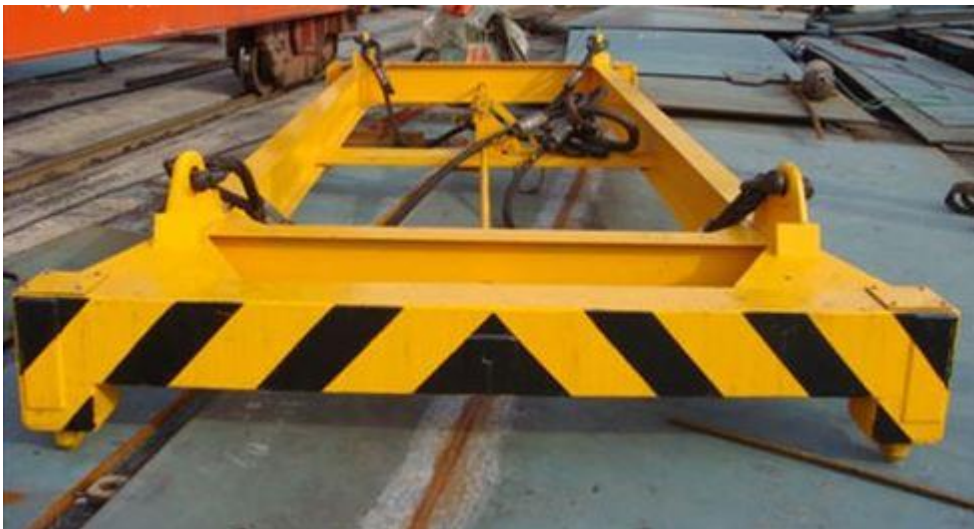
Source: Made-in-China website

The spreader, used for lifting standard ship cargo containers, is a steel frame with steel wire attached to the top side and twist lock connections to the bottom corners to connect to containers and lift them by the on board or, in some situations shore cranes. The spreader weighs over 2 t and is designed to lift a maximum of 32 t. Due to the own weight it can only be moved by lifting and positioning by crane, in the case of the accident the on board cargo crane.

The spreader is attached to the crane hook by a single point connection of four wires attached to the corners of the spreader (see above image). To position the spreader at the designated agreed position, the crew attached it to the forward ship's crane and the crane operating crew member lifted and swung as per the directions given by the OS positioned on deck, proceeding to the forward of the vessel.
