Panama Maritime Authority
Directorate General of Merchant Marine
Marine Accident investigation Department

REPORT: M/V “SICHEM AMETHYST”R-038-14-DIAM
IMO: No. 9354571
Date: 28th March 2014

REPORT ON THE INVESTIGATION OF THE FIRE OF

m.v. “SICHEM AMETHYST”

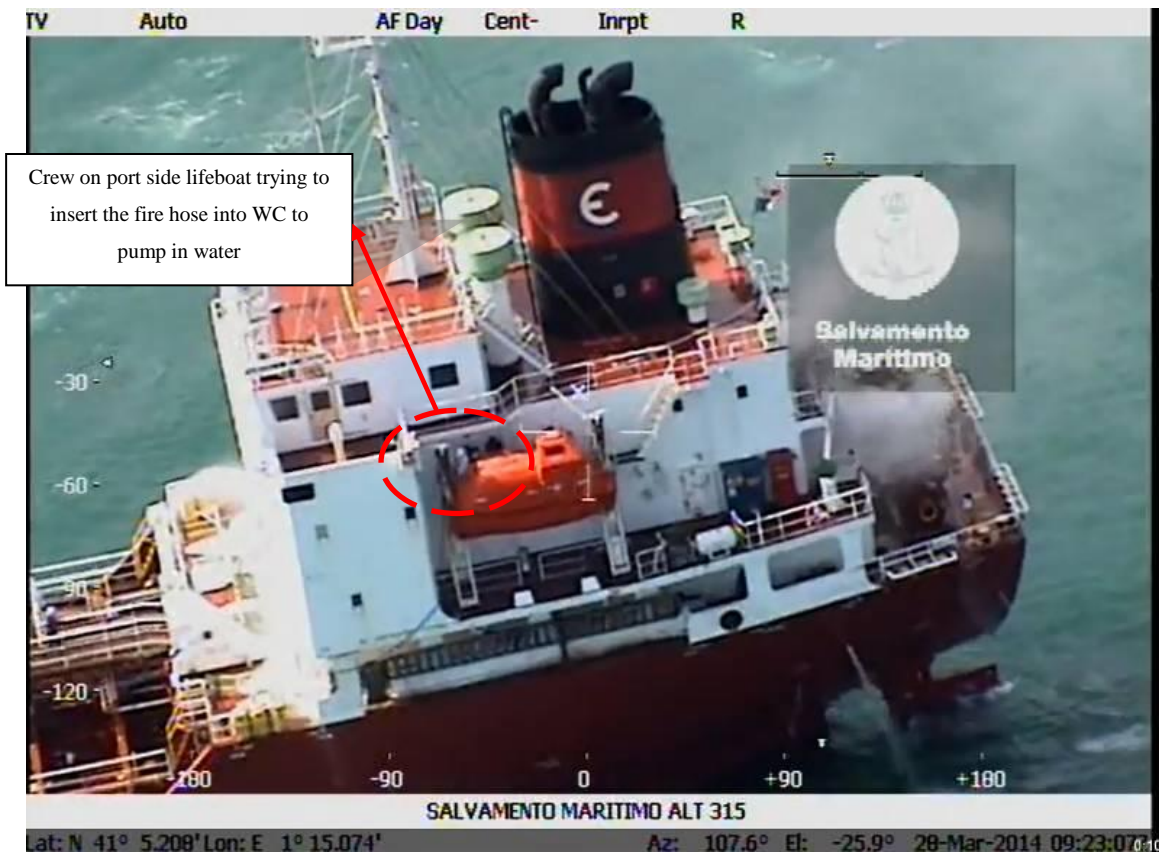
Figure 5.1– Photo from SALVAMENTO MARITIMO

- 5.32 The Chief officer and Chief engineer were on top of the starboard lifeboat trying to insert a fire hose through the Chief Engineers WC natural ventilation opening.

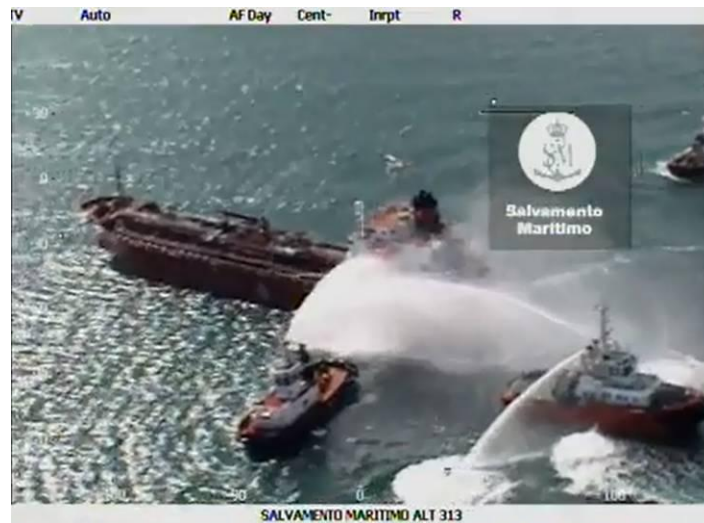
Figure 5.2– Photo from SALVAMENTO MARITIMO

- 5.33 Tugs approached the vessel the firefighting cannons under pressure and pointing towards the superstructure aft and superstructure port side.

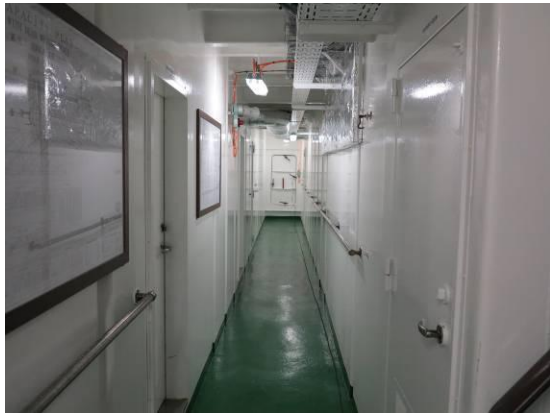
Figure 7.8– Repaired Captain’s deck

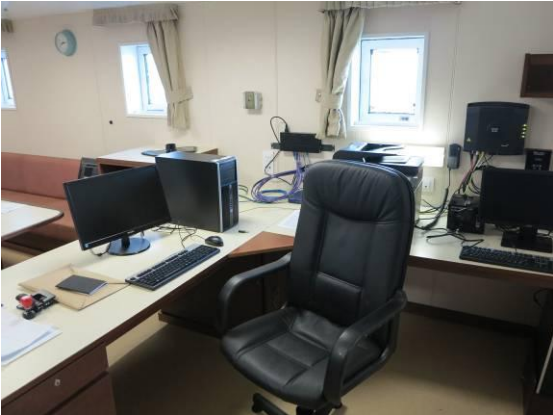
Figure 7.10– Repaired Captain’s Office

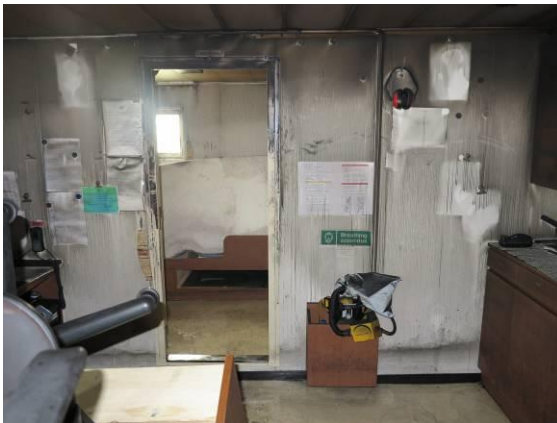
- 8.23 Steel paneling on the chief engineer's cabin was buckled and deformed clearly due to heat exposure hence giving an indication that temperatures above 528°C.
- 8.24 Smoke deposits were evident in walls and surfaces along the captain's deck, captain office and captain cabin denoting that the door leading to the captain office was left open.

Figure 8.8 – Captain Office Smoke deposits

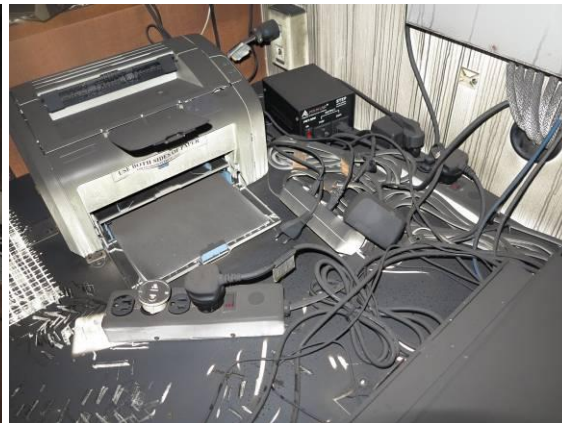
Figure 8.9 – Captain Office Smoke deposits

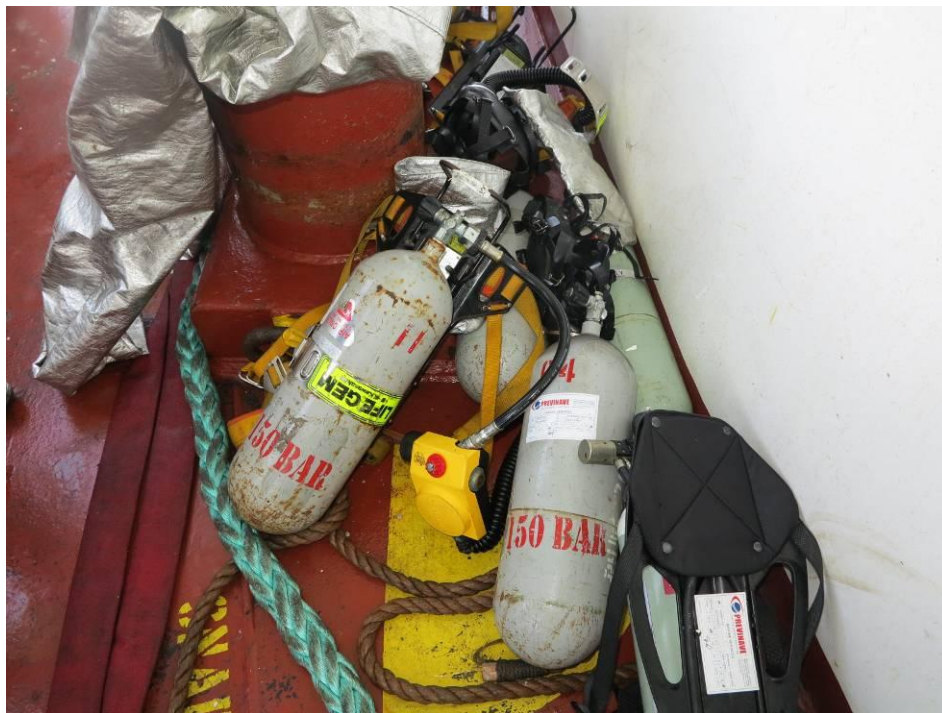
- 8.43 The KAWASAKI, LIFE GEM type breathing apparatus used onboard worked correctly during the fire fighting
- 8.44 The type was described by shore fire fighters of being of an old and unreliable.
- 8.45 All compressed bottles were used but not being capable of being refilled since the compressor room and surrounding area had been filled up with smoke.

Figure 8.13 – Type of B.A. used onboard

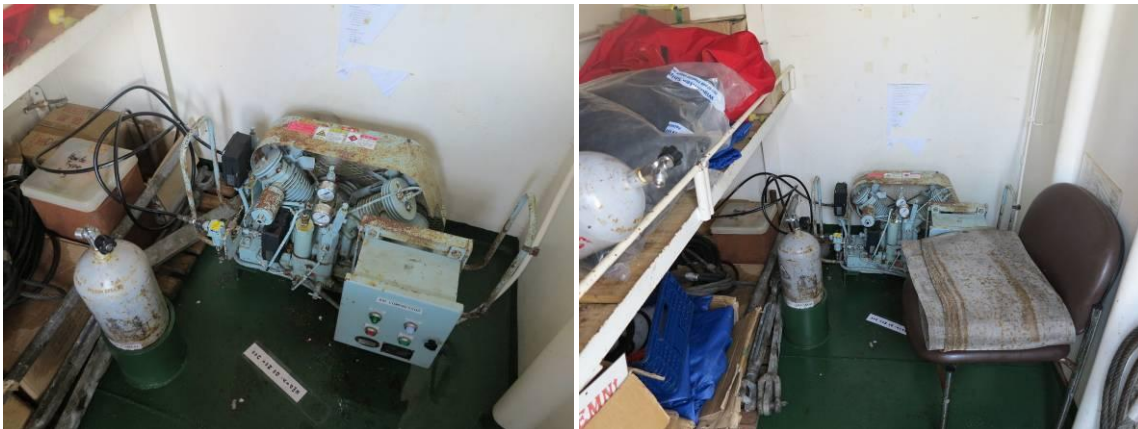
- 8.49 It was reported by the crew that the compressor could not be used due to heavy smoke entering the room from the inside.
- 8.50 The lack of wind and the fact that the vessel's course could not be changed since vessel was in anchorage contributed to smoke building up around the captain's deck. Such smoke entered the compressor room and hence fresh air could be collected to refill breathing air bottles

- 8.51 The compressor had been last shore serviced in Portugal on the 26th December 2013 and air analysis was issued with satisfactory results.

Figure 8.14 – Type of B.A. compressor
