MARINE SAFETY INVESTIGATION REPORT

Safety investigation into the failure of a lifeboat
wire rope fall resulting in five fatalities and three injuries
on board the Maltese registered passenger ship

THOMSON MAJESTY

MARINE SAFETY INVESTIGATION REPORT NO. 05/2014

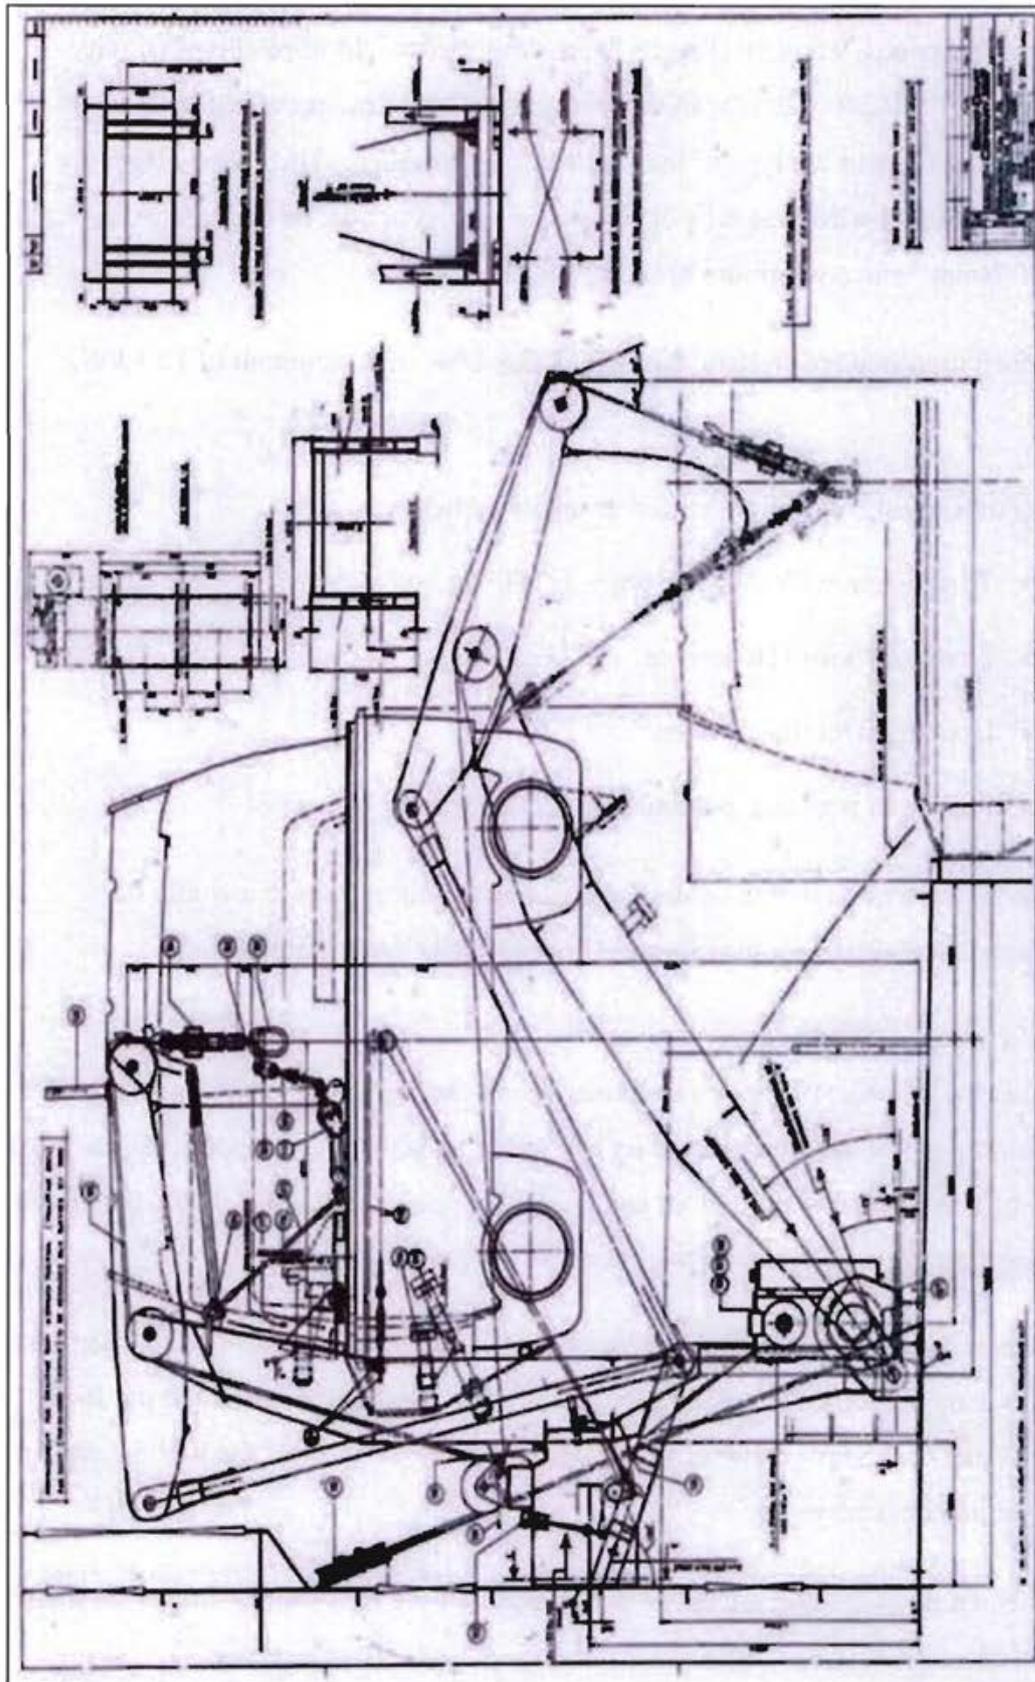
Figure 1: Davits Arrangement Plan

Lifeboat davits nos. 9 and 10 (Figure 1) are described as “Multiple Pivot Gravity Davits Type “MP 246”, similar to those originally installed, but modified by the manufacturers to suit the type of the lifeboat to be installed. They were originally fitted with 24 mm wire rope falls of Python 505 construction, having a tensile strength of 1770 Nmm⁻² and a minimum breaking load of 474 kN.

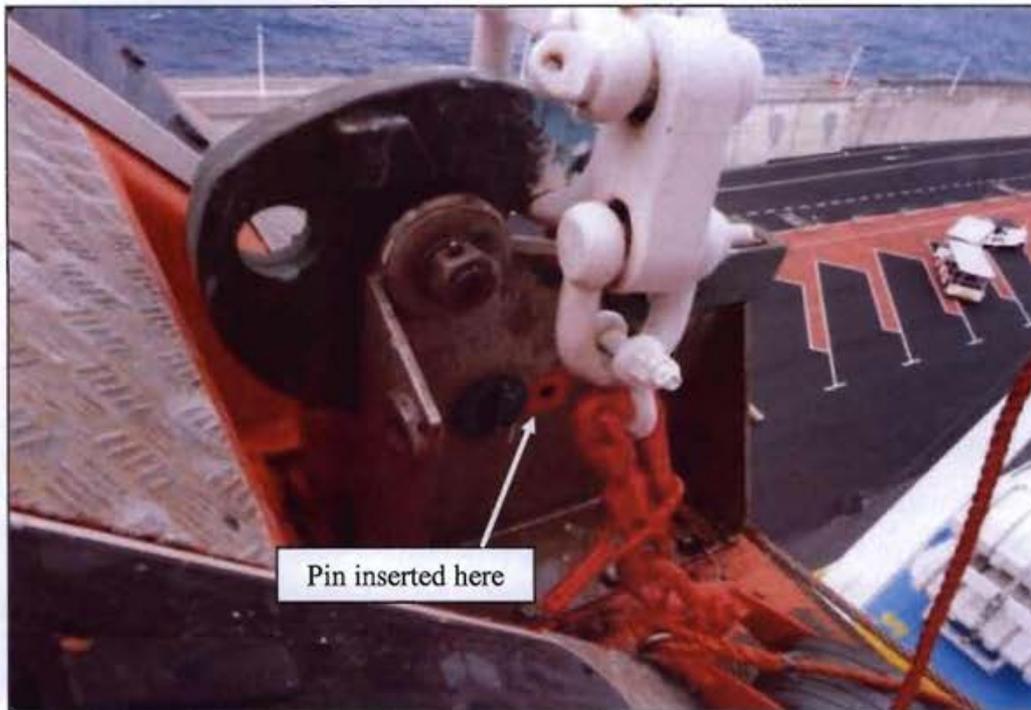
Figure 2: Locking pin arrangement as an FPD

Following the publication of the International Maritime Organization (IMO)’s MSC.1/Circ.1392, all lifeboats on board the then *Louis Majesty* were fitted with Fall Prevention Devices (FPDs)³. These were fitted and approved by Fassmer GmbH & Co. KG (the original manufacturer) to comply with the requirements of MSC.1/Circ.1392. This resulted in introducing a locking pin to the lifeboats’ hooks to prevent the inadvertent release of the lifting hooks during operations (Figure 2).

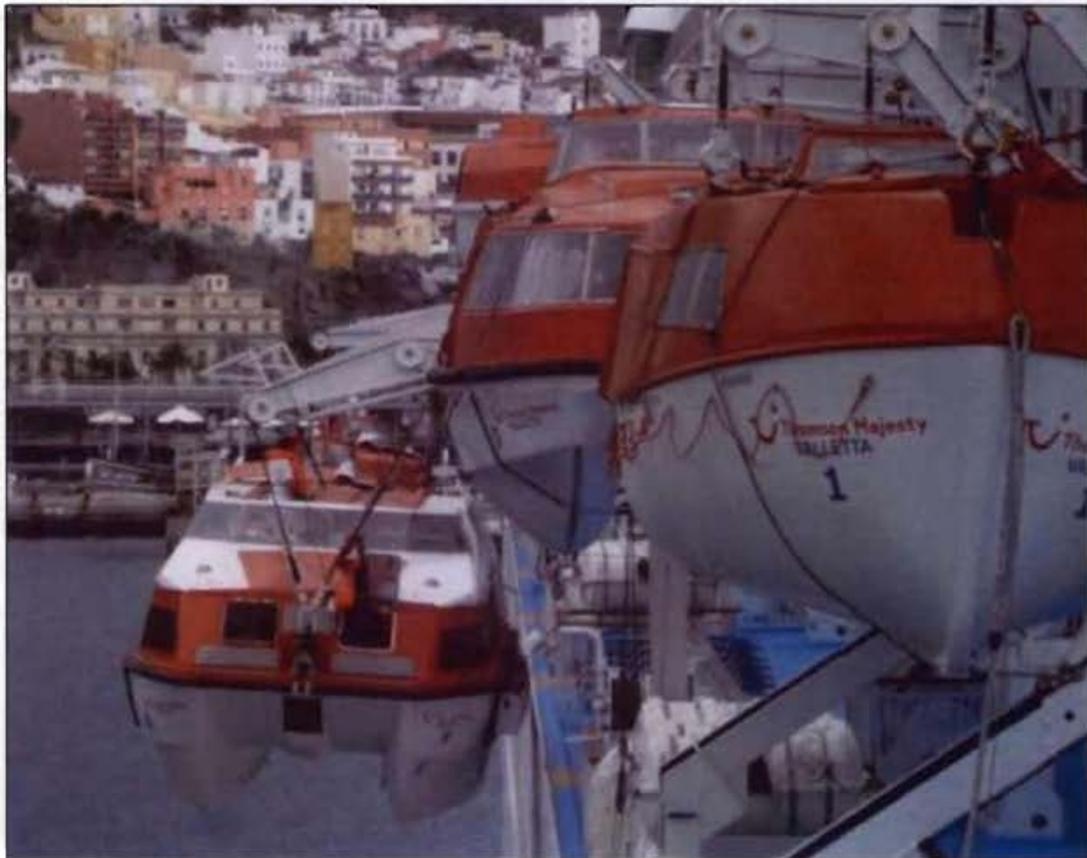
Figure 3: Lifeboat no. 9 awaiting lowering

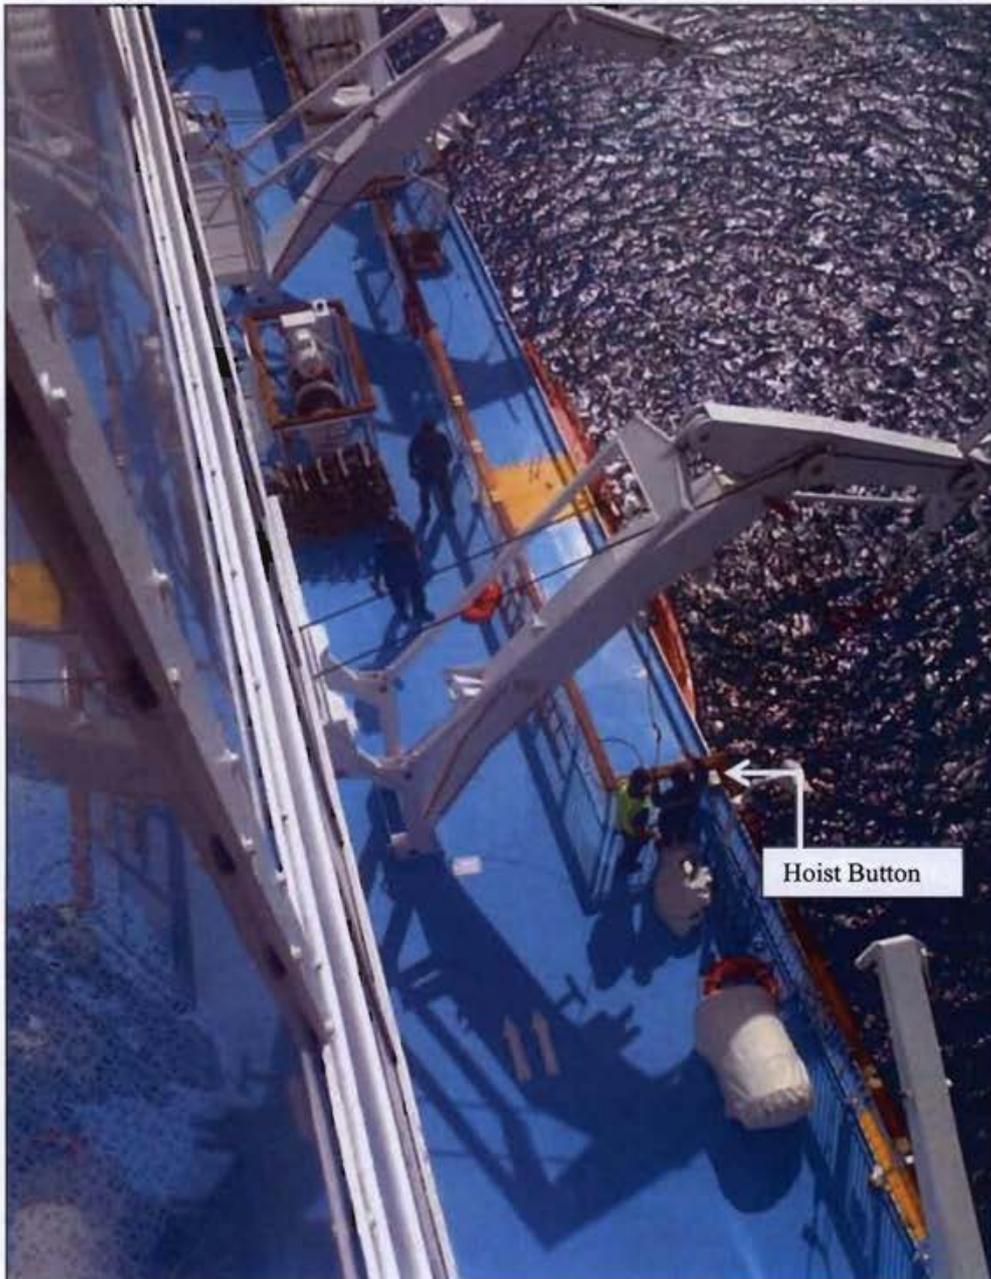
The safety officer stood at the hoisting position (Figure 5) and hoisted the lifeboat. The lifeboat was raised to a position where the bowing tackles could be re-attached. This was successfully done, but when lowering the lifeboat to bring it level to the embarkation deck, he found that the aft tackle was too slack to bring the lifeboat safely alongside. The lifeboat had to be hoisted again to further adjust the aft bowing tackle.

Figure 5: Hoist position

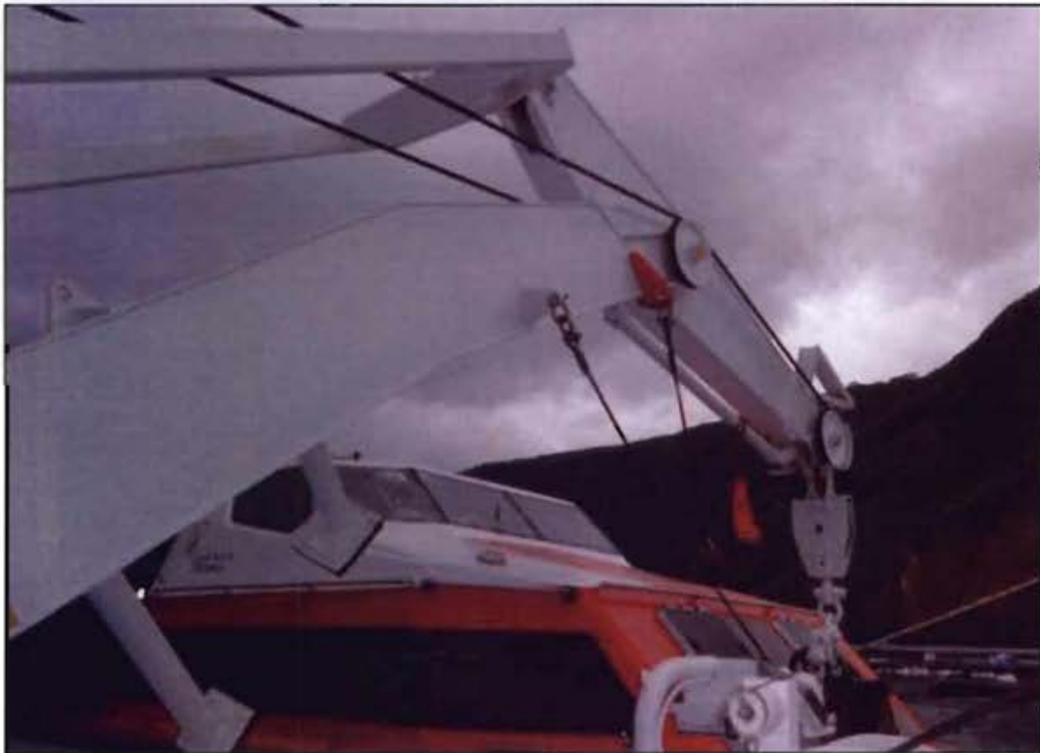
The safety officer re-hoisted the lifeboat and just as the blocks had engaged with the davit head and the davit arms had started to move upwards (Figure 6), the forward wire rope fall parted (Figure 7). The lifeboat then swung through around 45° and as the weight of the lifeboat was taken by the aft wire rope, the transom of the lifeboat and the aft lifting hook failed. The lifeboat dropped about 20 m, landing upside down in the water. The time of the accident, as recorded by the vessel's Closed Circuit Television (CCTV) footage, was 1154.

Figure 6: Block engaging with davits head (lifeboat no. 10)

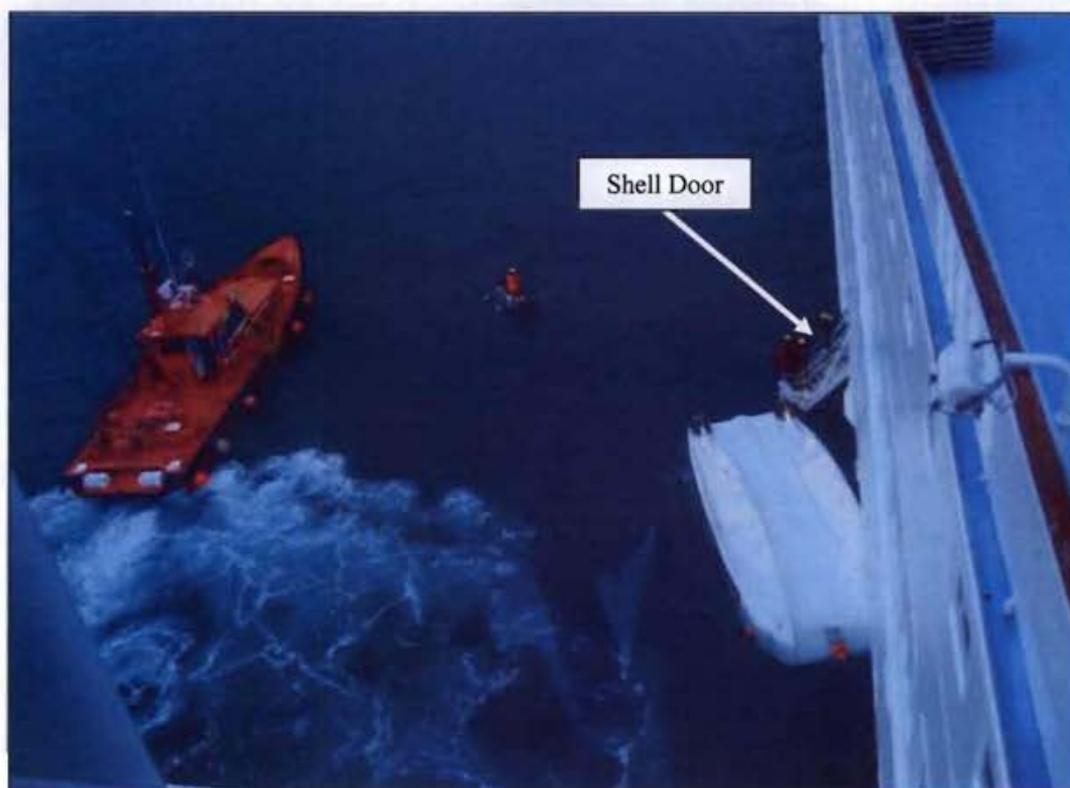
Figure 8: Shore assistance in close proximity of the upturned lifeboat

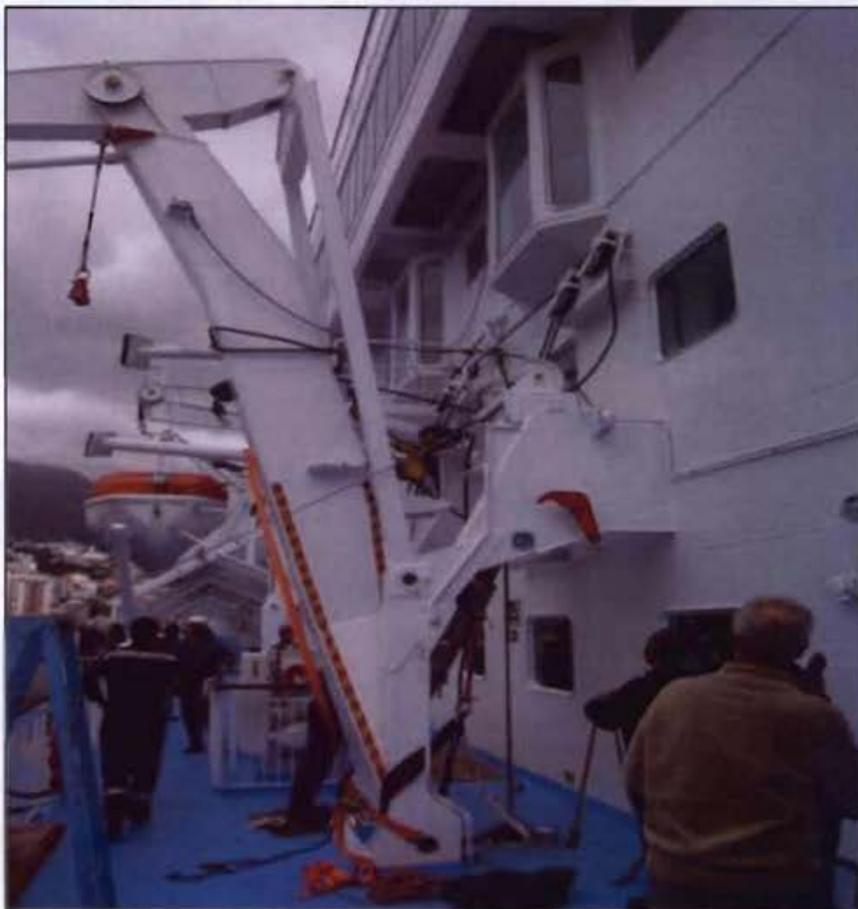
By the time the accident investigation team arrived on site, the davit arms had been raised and secured (Figure 9). The outboard wire rope which had parted, had been removed from the sheaves and the Spanish authorities had cut and removed as evidence one of the parted ends of the broken wire rope.

Figure 9: Davits arm hoisted after the accident
