CIAIM REPORT 03/2018

Fall of the rapid rescue boat on the vessel AL ANDALUS EXPRESS at the Port of Motril (Granada) on 5 October 2016, injuring two crewmembers

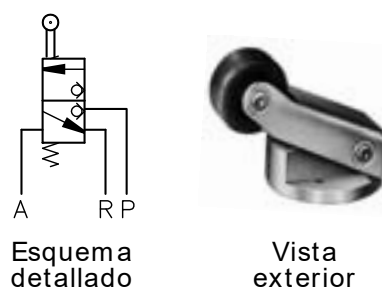
When the swing handle is pulled, a steel cable and a rod (Figure 12 - Item 1) actuate directional valve K3-2 H1 (Figure 12 - Item 3), which allows oil to flow from the pressure accumulator (Figure 12 - Item 5).

When the operator in the rescue boat pulls on the launch handle, a steel cable and a rod (Figure 12 - Item 2) actuate directional valve K3-2 H-2 (Figure 12 - Item 4), which routes hydraulic fluid at accumulator pressure (Figure 12 - Item 5) through the selector valve (Figure 12 - Item 6) to the multi-disc brake (Figure 12 - Item 7), releasing the drum from the capstan and allowing the boat to drop by gravity. In the absence of hydraulic pressure, a system of springs locks the brake.

Figure 7. Directional control valve K3-2

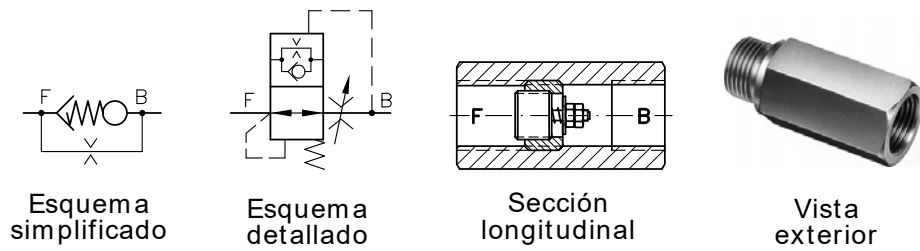
First is the burst valve (Figure 12 - Item 9), which is designed to allow a maximum flow rate through it of 135 liters/minute. If this rate is exceeded, the pressure will tend to overcome the opposing spring pressure, which will reduce the flow rate and prevent the boat from descending faster. This automatic change in the flow rate will lead to a smooth and uniform motion of the boat in the event of a hypothetical pipe break downstream.

Figure 8. Burst valve LB4F-1-135

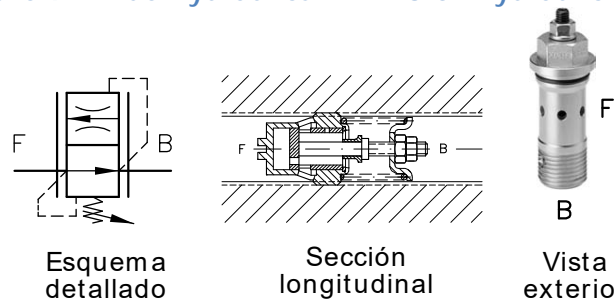
The variable flow rate regulating valve (Figure 12 - Item 10) is the second safety feature in the system, and also limits the descent speed of the rescue boat. In parallel with this line is a bypass, “EL20S”, toward an overflow valve (Figure 12 - Item 14), which also leads to the directional control valve (Figure 12 - Item 12).

Figure 10. Variable flow rate control valve SQ2

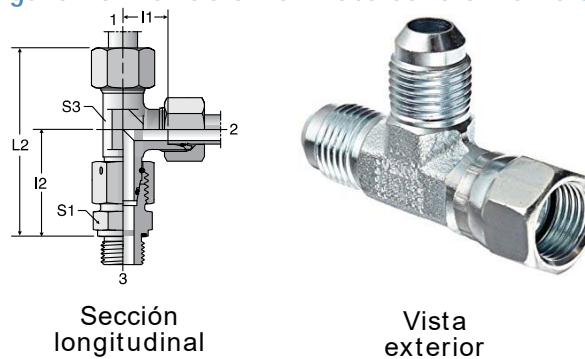
At the same time, to keep the “Linde Hydraulics HMF 28-02” hydraulic motor from impeding the rotation of the capstan, a bypass valve, EL85, on the line that releases the brake opens the check valve (Figure 12 - Item 8), which allows the fluid from the hydraulic motor to flow via burst valve “LB4F-1-135” (Figure 12 - Item 9), to then continue to the variable flow regulator, SQ2 (Figure 12 - Item 10) and the check valve (Figure 12 - Item 12), finally flowing to the directional control valve (Figure 12 - Item 12) and from there to the tank (Figure 12 - Item 13).

Figure 11. EL8S and EL20S bypass valves
