CIAIM REPORT-12/2016

Structural fault in M/V STOLT BOBCAT cargo tanks at Barcelona Port on 7 August 2015

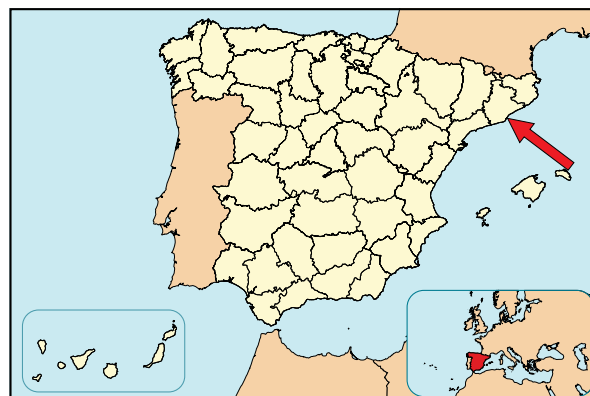
Figure 2. Accident area

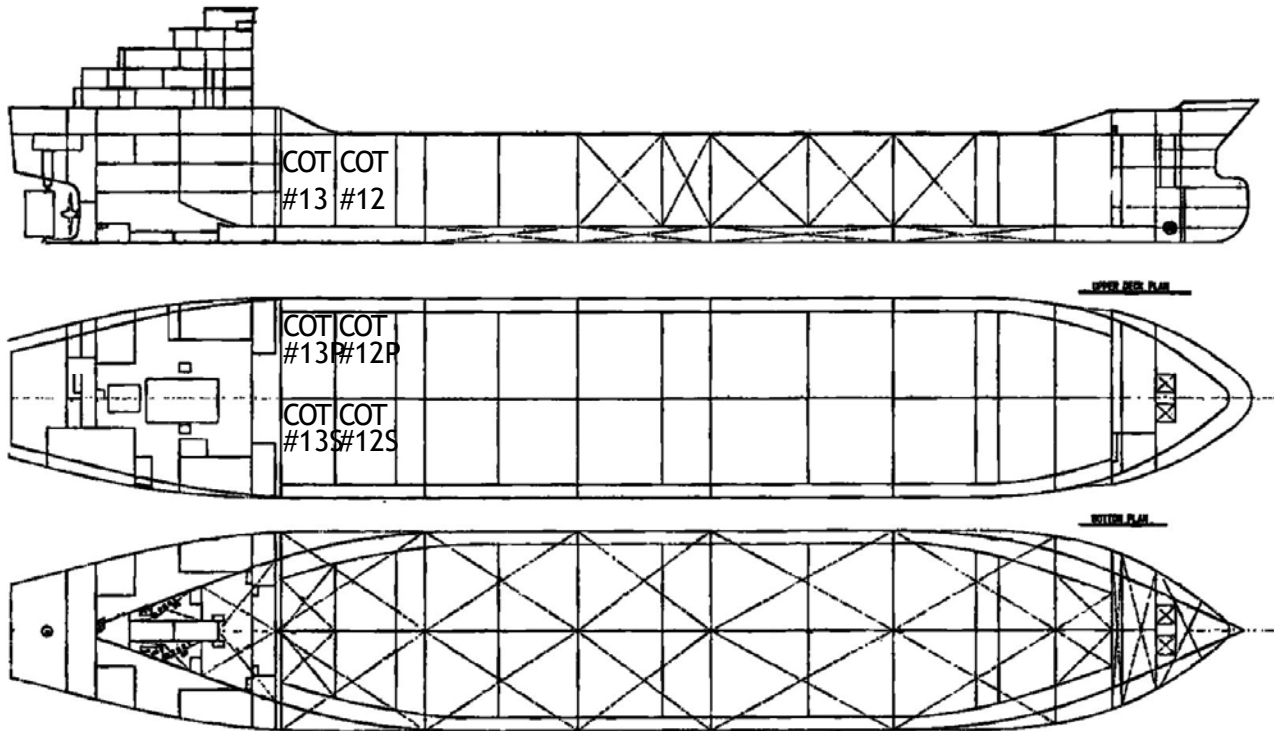
Figure 3. M/V STOLT BOBCAT General layout.

29 March 2010 Vessel inspected in Shanghai (China) by the class society in relation to a leak the crew had found between cargo tanks COT#12S and COT#13S (see figure 3). Cracks also found in some welding on cargo tank COT#4P. All welding cracks were repaired.
