CIAIM REPORT 29/2017

Dragging of anchor and subsequent grounding of the bulk carrier INTERLINK UTILITY at the “South Harbor” anchorage of the Port of Las Palmas on 13 March 2017

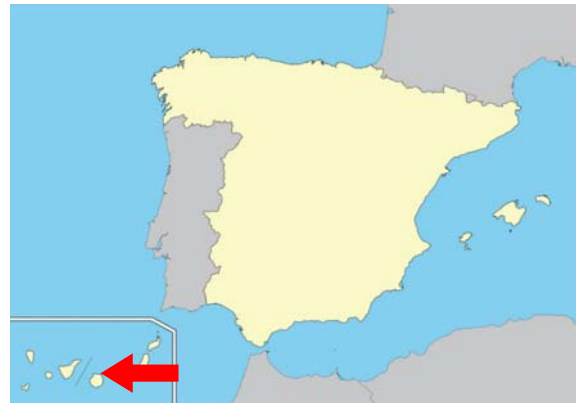
Figure 2. Area of the accident

At some point, the officer of the deck noticed that the ship was starting to drag the anchor, so he called the captain. When he reached the bridge, the captain called the engine room to start start the main engine. The start was delayed a few minutes, enough for the ship, which had anchored near the coast, to continue dragging toward the coast until its stern impacted the rocky bottom.

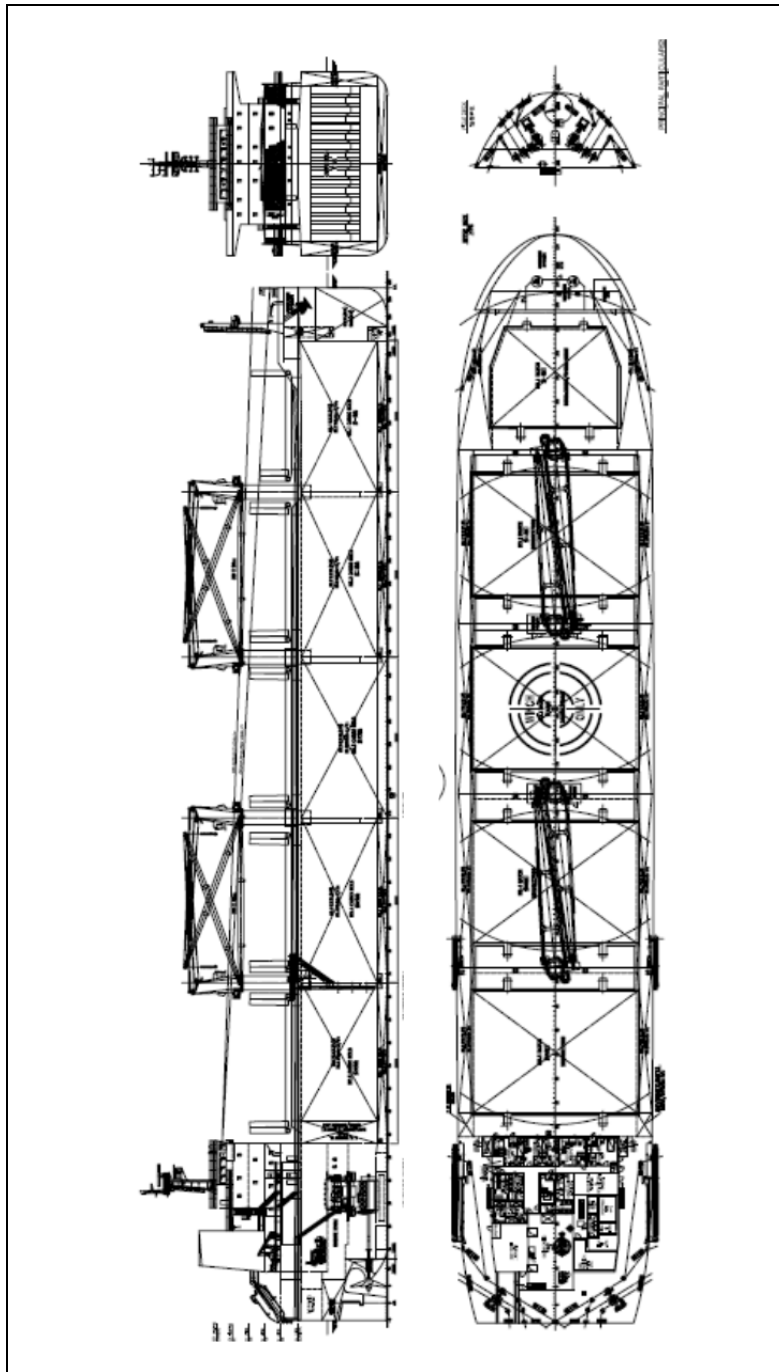
Figure 3. General layout

"Damage no. 1: The first of them, the crack N°1 is located in the frame 140, in the tank N°3 forward portside, it is located inside of an indent of 72 cm of large x 45 cm of wide and 1.3 cm of arrow, the aperture of the crack is big.

Damage no. 2 :More to aft between the frames 130-135 we observed one indent with friction and loss of paint of 65 cm large x 39 cm wide and 8 cm of arrow, no cracks.

"Damage no. 3: We continue toward stern and between the frames 125-130 we observed one indent with frictions and loss of paint of 49 cm large x 49 cm wide and 6 cm of arrow, no cracks.

Damage n°4 and n°5 : We continue toward stern and between the frames 120-125 we observed one indent with frictions and loss of paint of 71 cm large x 20 cm wide and 3 cm of arrow, no cracks. One meter more to aft from last one, we located other indent with frictions and loss of paint of 68 cm large x 15 cm wide and 7 cm of arrow

Damage no. 6 : We continue toward stern and in the frame 85 we observed one indent with frictions and loss of paint of 223 cm large x 116 cm wide and 7 cm of arrow, no cracks.

Damage no. 7 :We continue toward stern and between the frames 45-50 we observed one area with frictions of 1 meter large , no indents, no cracks, only frictions.

Damage no. 8:We continue toward stern and between the frames 40-45 we observed one indent with frictions and loss of paint of 20 cm large x 7 cm wide and 2 cm of arrow, no cracks.

Damage no. 9 and 10 :We continue toward stern and between the frames 35-40 we observed one indent with frictions and loss of paint of 337 cm large x 70 cm wide and 11 cm of arrow, no

cracks. In this frame we observed other indents more to aft of 200 cm large x 150 cm wide and 10 cm of arrow, no cracks.

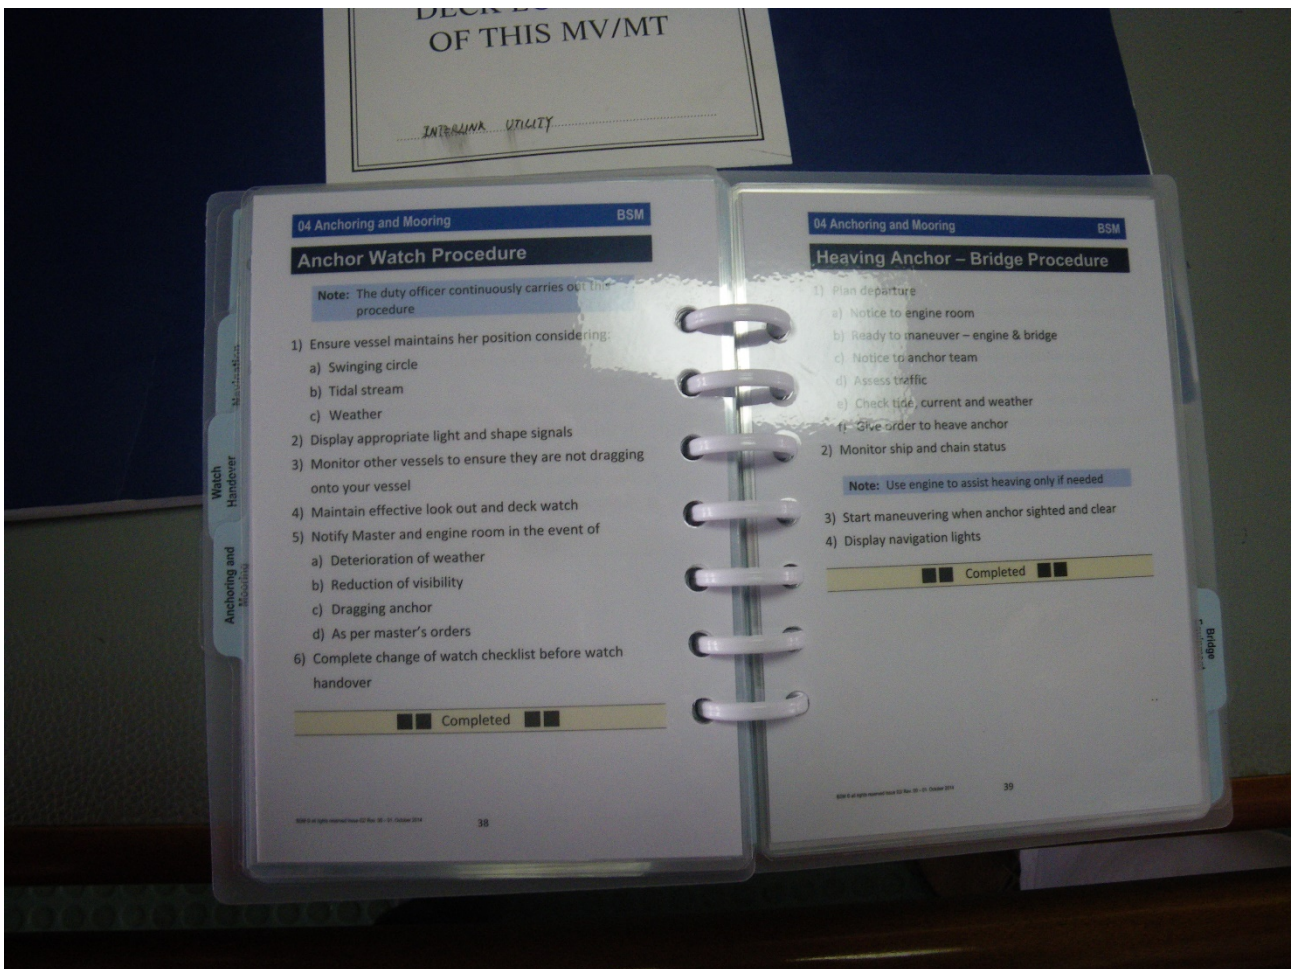
Figure 8. Company instructions for anchoring.

The Safety Management System in place on the ship includes the procedures shown in figure 8 for the duty officer on the bridge. In the case at hand, these procedures state that the officer must notify the captain and the engine room if the ship starts to drag the anchor.
