TECHNICAL REPORT A-30/2012

Investigation of the collision between high speed ferry MILENIUM DOS and bulk carrier NEW GLORY in the Straits of Gibraltar on 13 January 2012

COMISIÓN PERMANENTE DE INVESTIGACIÓN DE ACCIDENTES E INCIDENTES MARÍTIMOS

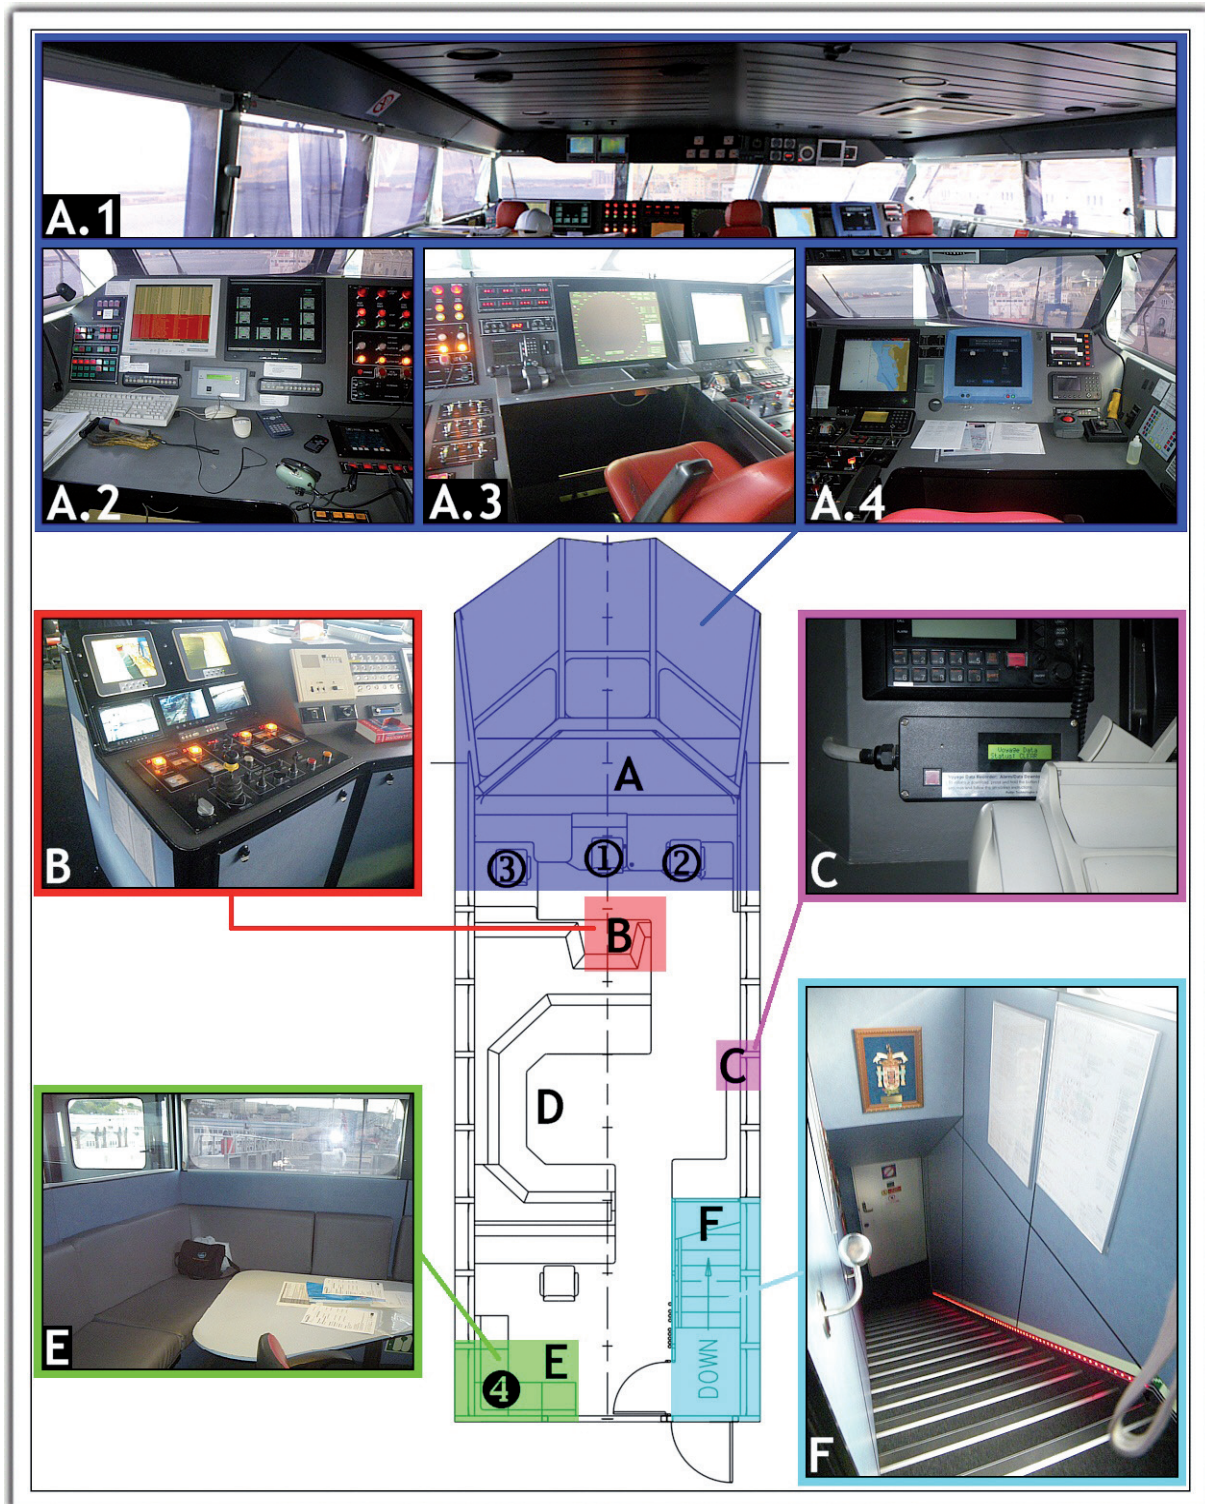
Figure 13. Distribution of the wheelhouse of vessel MILENIUM DOS.

Vessel MILENIUM DOS has a wheelhouse suitable for her operation, where the positions of the First Engineer, the Master and First Officer (images A.2, A.3 and A.4 respectively in figure 14) allow to easily access the information and the controls.

As can be seen in image A.1 of figure 14, the visibility from the wheelhouse was excellent, allowing a view of more than 90° to each side. The vessel has a console for executing the manoeuvres (image B of figure 14), which includes video cameras, sensors and joystick type controls that facilitate operations. It also has a communications area (D in figure 14).

The console of the trip's data recorder, RDT (image C of figure 14) is located on the starboard side. The wheelhouse is located in the highest area of the vessel and is accessed through a stairway (image F of figure 14), which is the one down which the passenger, who was sitting on the sofa that is located on the bow, fell and fractured his leg (image E of figure 14).

① Master, ② First Officer, ③ Chief Engineer, ④ Passenger.

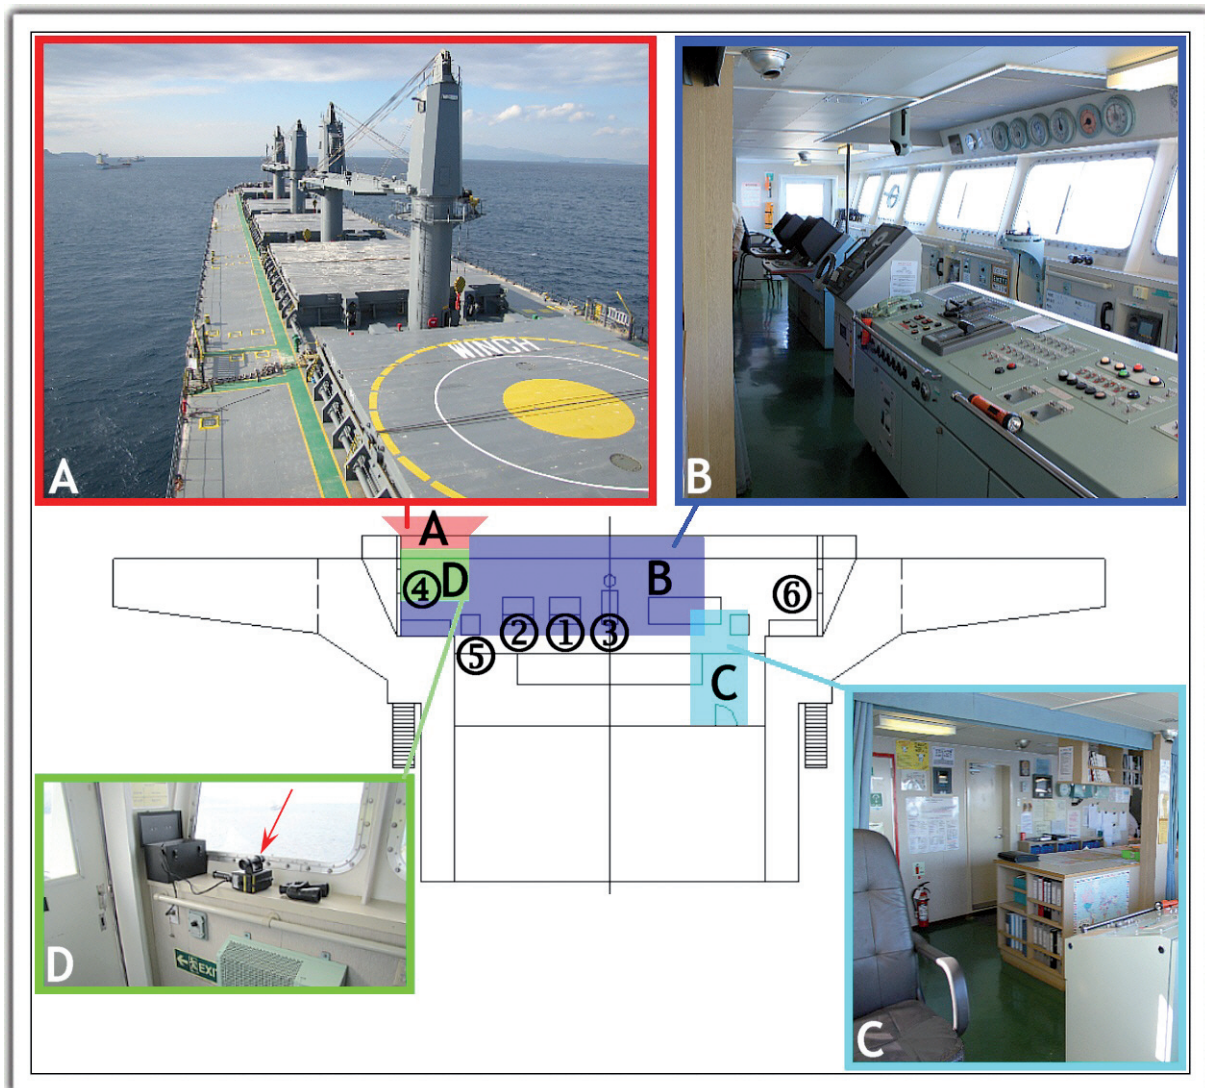
Figure 14. Distribution of the wheelhouse of vessel NEW GLORY.

- ① Master, ② First Officer, ③ AB Seaman, ④ AB Seaman (relief),
- ⑤ Third Officer (relief), ⑥ Bartender.
