TECHNICAL REPORT A-20/2012

Investigation of the capsizing of merchant vessel DENEBO
at the Port of Algeciras on 11 June 2011

COMISIÓN PERMANENTE DE
INVESTIGACIÓN DE ACCIDENTES
E INCIDENTES MARÍTIMOS

Technical report

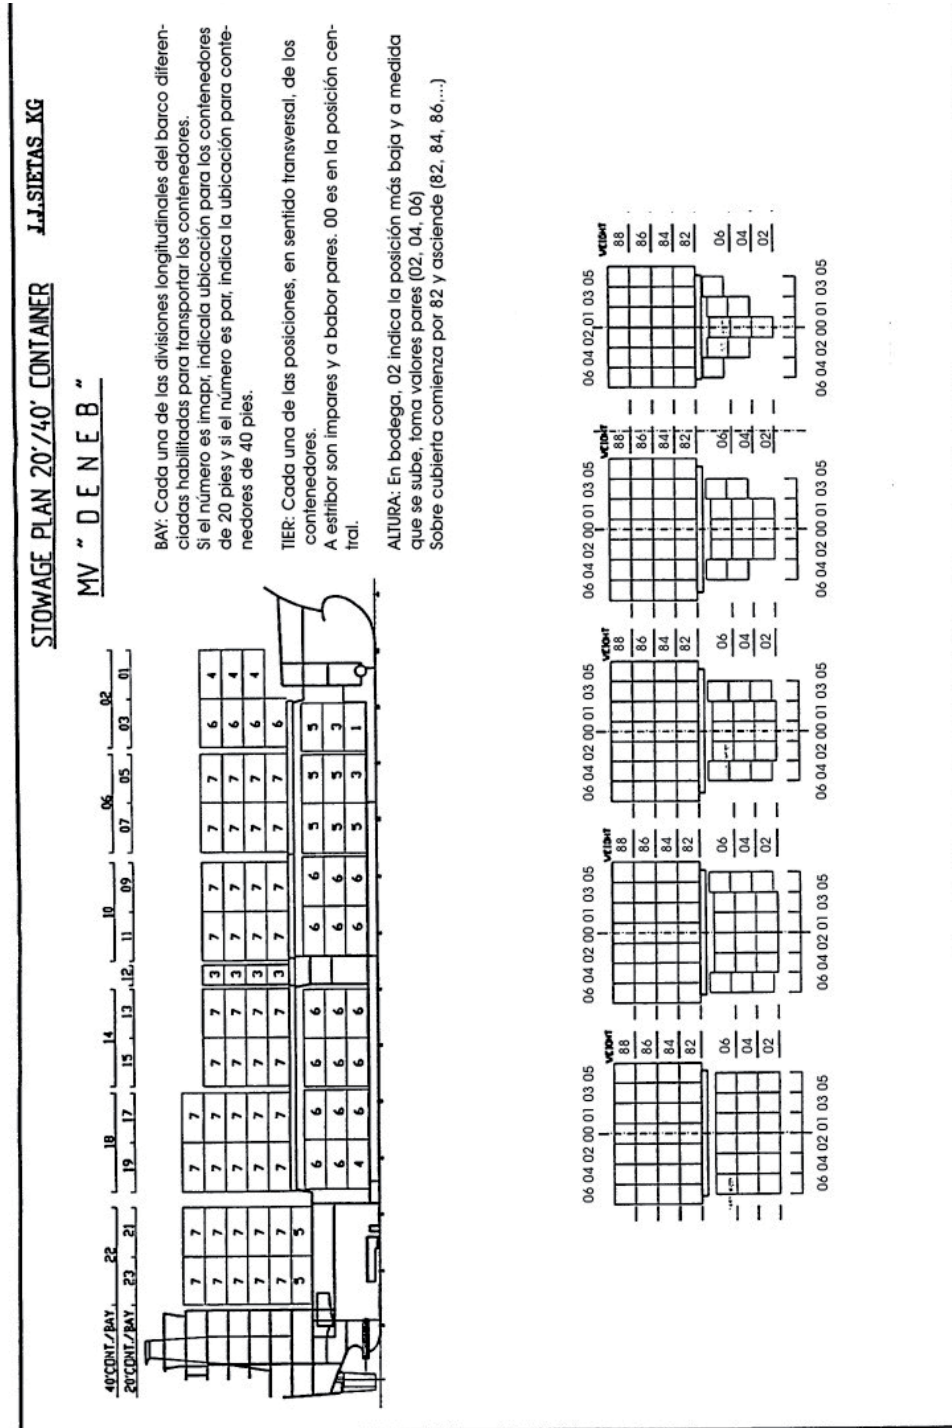
Figure 17. Diagram of ship divisions and nomenclature of the locations of containers

On the forward side of cargo hold 1 and the aft side of cargo hold 2, due to the narrowing of bays 07, 09 and 17 (see Figure 17), the bay plan was not uniform and stowage supports (the so called "elephant legs") had to be installed under the containers, located farther away from the centreline. These supports levelled the load plane, allowing containers to be stowed over them.

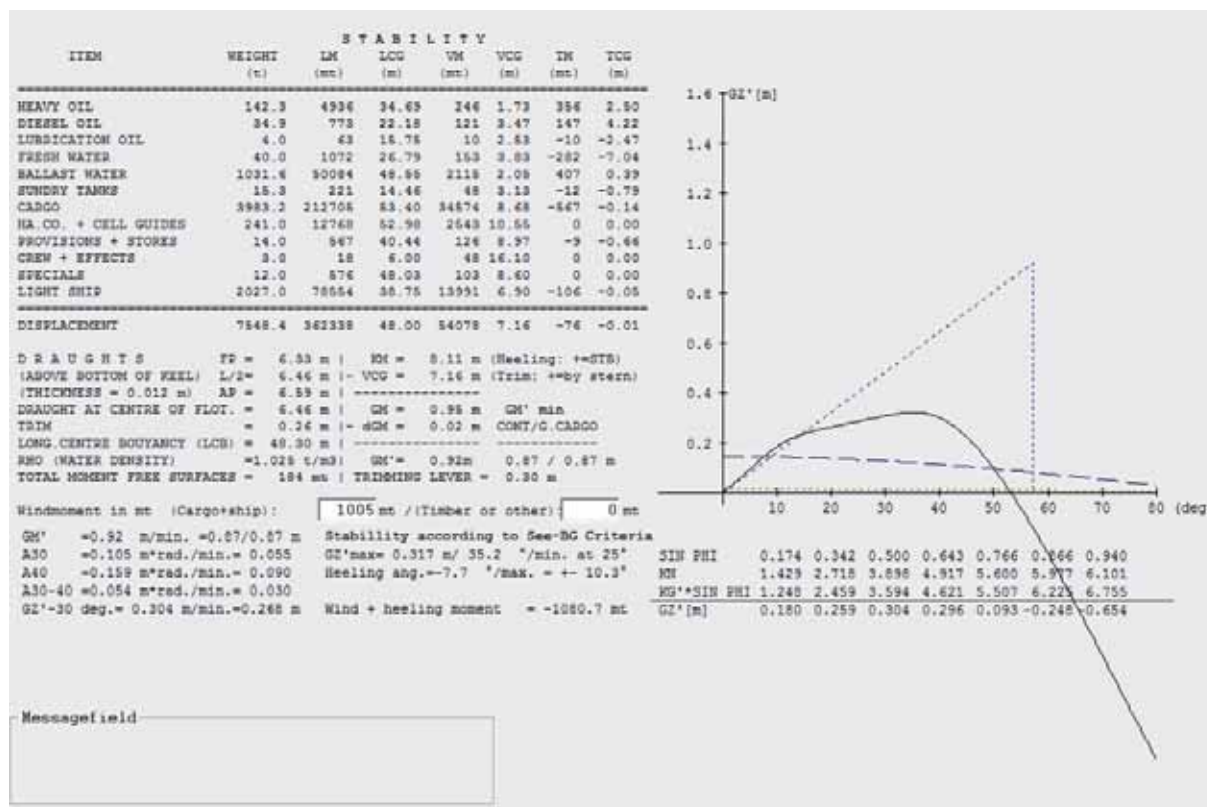
Figure 21. Scheduled stowage plan, weights according to the BAPLIE

| | Scheduled cargo stowage plan | | | |
|--|---|---|---|---|
| Heeling (+starboard) | | -0.61° | 3.70° | 1.48° |
| Notes relative to de status of the cargo | | | | OVERLOADED |

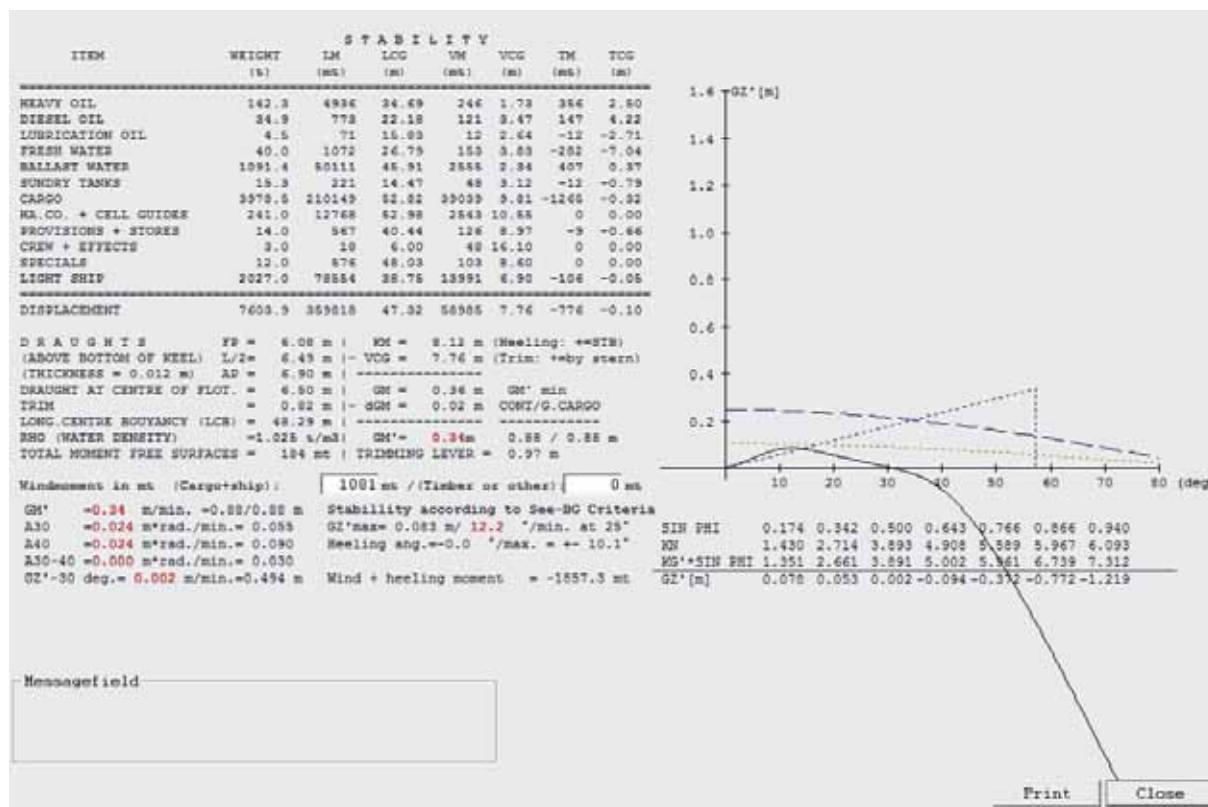
Figure 24. Modified stowage plan, weights according to the BAPLIE

| | Modified stowage plan | | | |
|--|---|---|---|---|
| Heeling (+starboard) | | <-5° | - | <-5° |
| Notes relative to de status of the cargo | OK | | OVERLOADED | OVERLOADED |

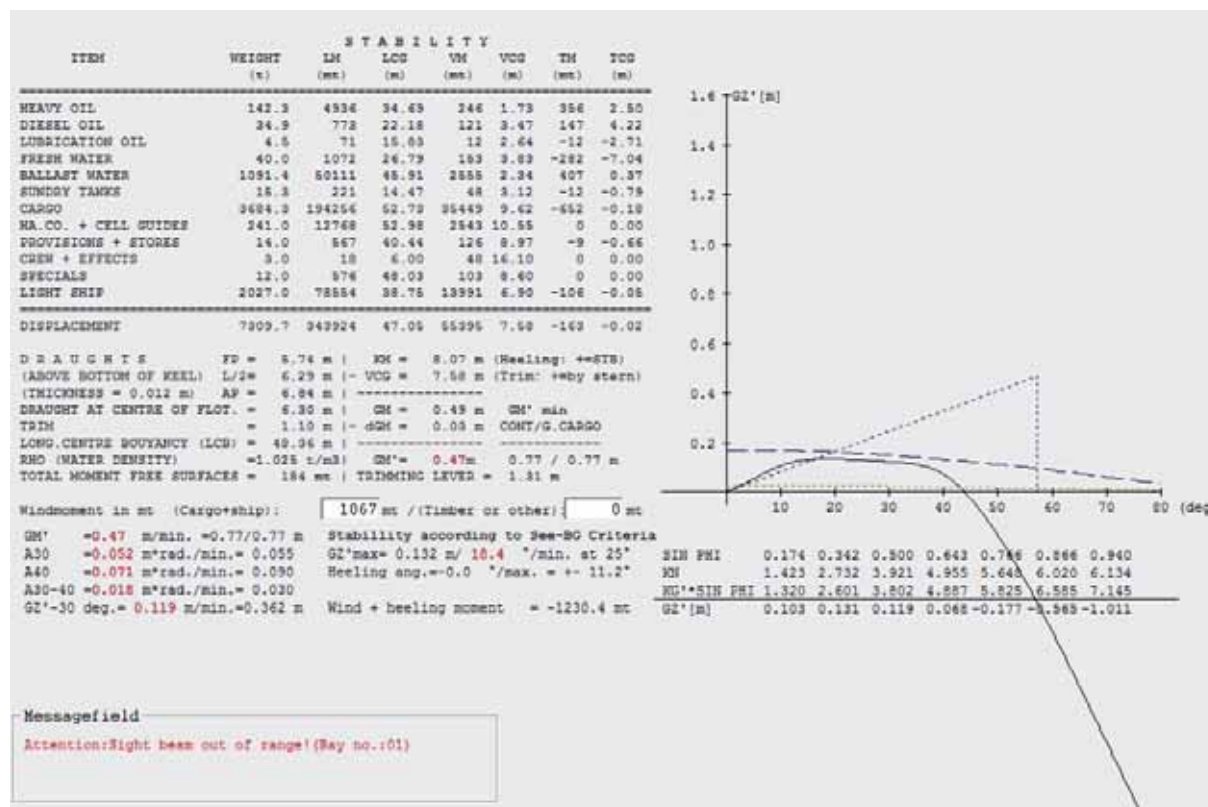
Figure 27. Time of the accident, weights according to the BAPLIE

| | Stowage plan at the time of the accident | | | |
|--|--|---|---|---|
| Heeling (+starboard) | | -2.59° | <-5° | <-5° |
| Notes relative to de status of the cargo | OK | | | |
