TECHNICAL REPORT A-13/2010

Investigation of the running aground of CH/T SICHEM COLIBRI
in the Guadalquivir River on the 11th of August, 2009

Technical report

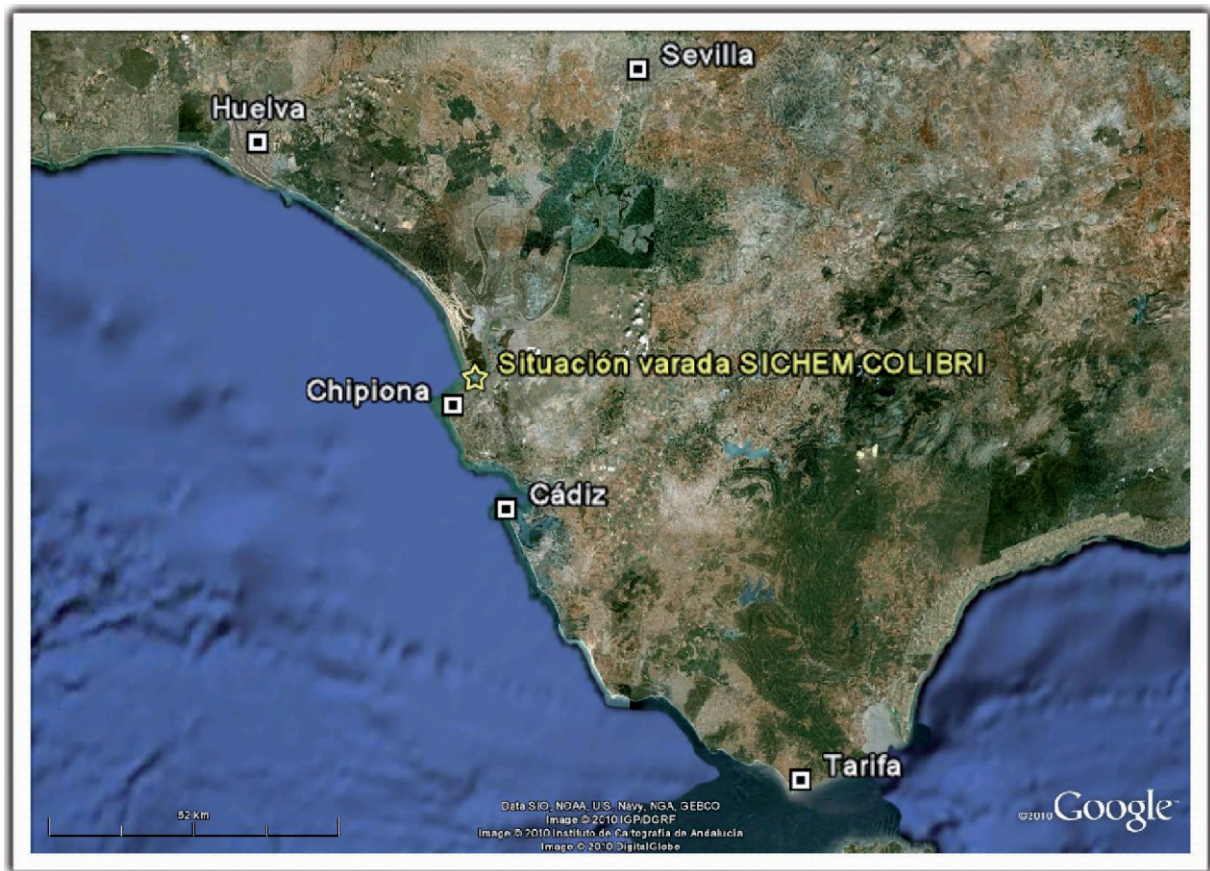
Figure 4. Location of the running aground of CH/T SICHEM COLIBRI, at the Guadalquivir River's mouth.

Figure 7 shows the sequence of events from the time the vessel began to turn towards her port side until she ran aground on the left margin of

the bar, in an up river direction. The vessel went from moving at 11.1 knots, to completely stopping in approximately 90 seconds.

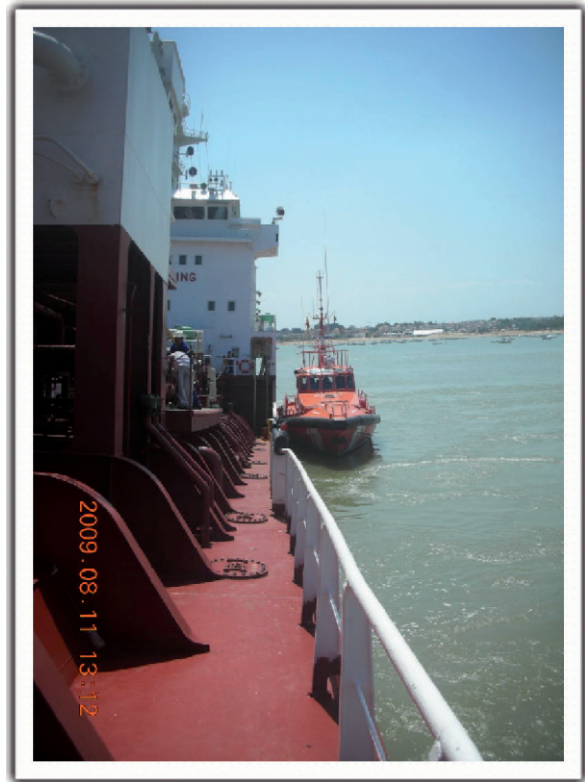
Figure 10. Salvamar rescue boat Suhail assisting the SICHEM COLIBRI

In Seville, inspectors from the vessel's Classification Society and from the Maritime Authority carried out an in-depth inspection that concluded on the 18th of August in Algeciras, where a submarine inspection was carried out to check the status of her hull. No serious damage was found in the steel but there were large areas in the forward bulb where the paint had disappeared (about 10%) or other areas where the paint had suffered serious damage (about 70% of the forward bulb) with numerous scratches. At the bottom area, in addition to areas in which the paint had been affected, a dent of approximately 1 square metre was discovered.
