# ANNUAL REPORT - 2009

Standing Commission for Maritime Accident and Incident Investigations - CLAIM

STANDING COMMISSION FOR MARITIME ACCIDENT AND INCIDENT INVESTIGATIONS

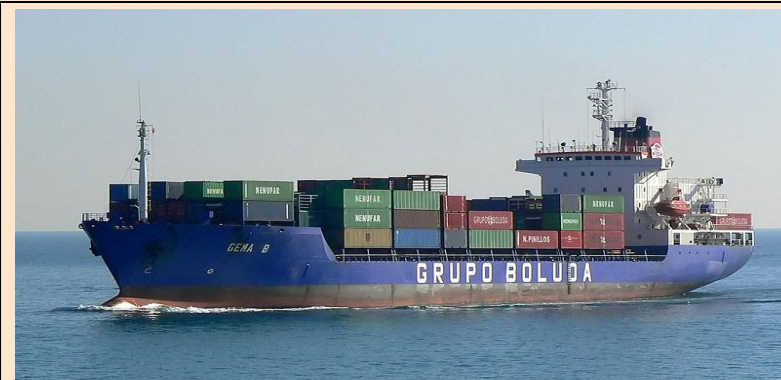
<b>CONCLUSIONS</b>						
The investigation determined that the accident was caused by the rupturing of the oil film on the forward port shaft support bearing bushing of the second order distribution system, also called the damper, due to a failure in the lubrication system.						
<b>RECOMMENDATIONS</b>						
Five safety recommendations were issued to the engine manufacturer and the ship owner, recommending improvements in the design, installation and maintenance of the engine.

Nº	Recommendation	Report	Addressee	Text
1	R-2009-A1-1	A-1/2009	engine manufacturer	It would be advisable that the damper be provided with a safety feature to prevent a possible failure in the lubrication systems of bearings for the system's sprockets and counterweights. Specifically, said system should include temperature probes in the areas adjacent to the aforementioned support bearings that would generate an alarm when an abnormal rise in temperature is detected.
2	R-2009-A1-2	A-1/2009	engine manufacturer	Filters should be placed in the lubrication line for the bearing in order to remove any impurities that may have been transported by the lubricating oil, as well as sensors that would warn against an abnormal drop in the lubricating system pressure established by the manufacturer.
3	R-2009-A1-3	A-1/2009	engine manufacturer	Incorporate a flame guard system on propulsion engine crankcase safety valves in order to minimize the outward propagation of flames.

4	R-2009-A1-4	A-1/2009	engine manufacturer	The manufacturer should establish a specific maintenance protocol for the equipment that guarantees safe operation and prevents failures like the one that occurred.
5	R-2009-A1-5	A-1/2009	shipowner	Follow the specifications for the materials stated by the engine manufacturer during repairs conducted on its equipment and components.
6	R-2009-A2-1	A-2/2009	crewmembers	The crew must ensure they check the actual situation of the ship load after each loading and unloading operation, and maintain the daily probe record updated.
7	R-2009-A2-2	A-2/2009	shipowner	This type of vessel should have an on-board checklist that is verified periodically, keeping the daily record updated, and which at least incorporates the checking of: / The water tightness of closure elements in the underwater body, and particularly the tank covers, including the status of their shutoff wing valves and vent pipes / The draught condition of the vessel / The condition of the mooring system.

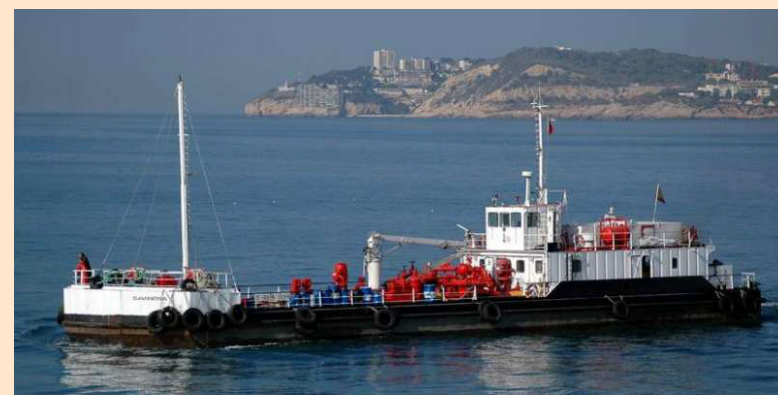
<b>SINKING</b>	Yes	<b>TYPE OF VOYAGE</b>	In port	<b>UNINJURED</b>	3
<b>CONCLUSIONS</b>							
The investigation carried out by CIAIM concluded that the cause of the sinking was the progressive entry of water in the afterpeak through a crack below the fender profile at the stern's port side edge. The cause of the crack was probably due to an impact operation overload due to the poor design and material condition of the fenders, the ship's as well as the dock's, and a high angle of incidence of the vessel with the pier during the docking and undocking manoeuvres.							
<b>RECOMMENDATIONS</b>							
Six safety recommendations were provided, directed at preventing and controlling the appearance of weak points in the structure that is subjected to fatigue due to improper load operations, as well as controlling the load conditions and guaranteeing the water tightness of closure elements.

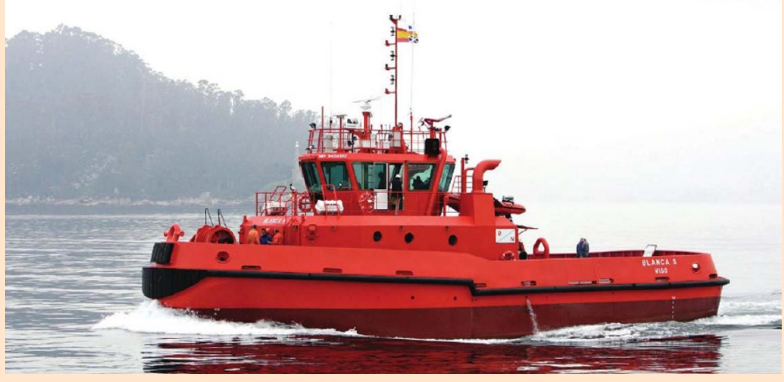
<b>DAMAGES</b>	Yes	<b>PORT OF DESTINATION</b>	Melilla	<b>INJURED</b>	0
		<b>SINKING</b>	No	<b>TYPE OF VOYAGE</b>	In port	<b>UNINJURED</b>	4
<b>CONCLUSIONS</b>							
The accident occurred because the vessel lost steering capability because the autopilot was engaged, which prevented the skipper from manually controlling the manoeuvre. It was the first time that the skipper had taken command of that vessel and he was probably not sufficiently familiarized with its systems and control mechanisms.							
<b>RECOMMENDATIONS</b>							
The recommendations in this case emphasized the advantages of providing the proper training to new crews that begin to provide services, as well as encouraging and assisting new crews to familiarize themselves with the specific technologies of each vessel prior to performing their jobs on board.

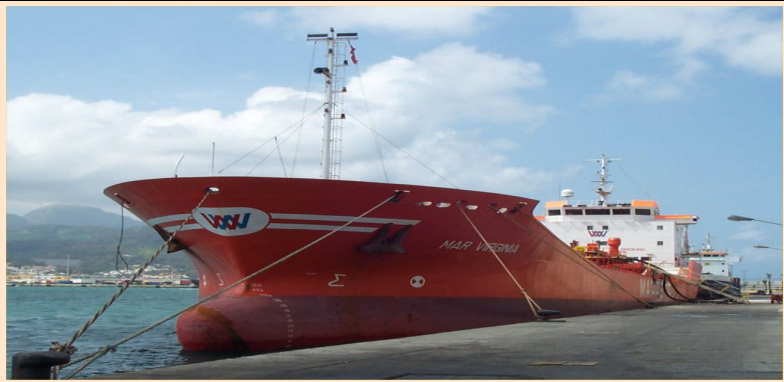
DAMAGES		Yes		PORT OF DESTINATION		Huelva		INJURED		0
			SINKING		No		TYPE OF VOYAGE		National		UNINJURED		13
CONCLUSIONS													
From the detailed study of all the documentation and technical reports that were acquired from the accident, the Commission concluded that the failure of the engine was caused by the seizing of the no.1 cylinder, possibly due to failure in the operation of the injector, which led to inadequate combustion, eliminating the lubricating oil film covering the cylinder, and generating metal friction between the sleeve and the piston that caused the piston to seize.													
RECOMMENDATIONS													
Although it was considered an unforeseeable event, two recommendations were provided to ship owners, emphasizing the importance of the maintenance of engines and alarm systems inside rooms that do not have permanent crews assigned.

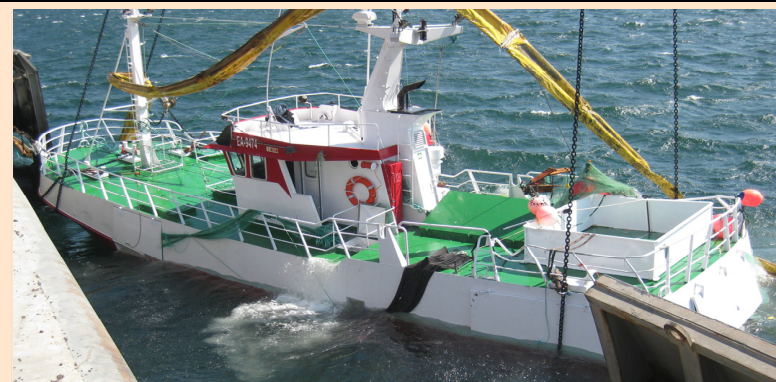
<b>SEVERITY</b>		Very serious		<b>PORT OF DEPARTURE</b>		Cedeira		<b>DEATHS / MISSING</b>		1	
				<b>DAMAGES</b>		Yes		<b>PORT OF DESTINATION</b>		Cariño		<b>INJURED</b>		0	
				<b>SINKING</b>		No		<b>TYPE OF VOYAGE</b>		Fishing, national		<b>UNINJURED</b>		6	
<b>CONCLUSIONES</b>															
During the investigation of this accident, the CIAIM observed the existence of numerous irregularities on the vessel, which had been subjected to several unauthorized modifications of its structure and was being operated under conditions that were not accounted for in the stability book. These irregularities contributed, even in good weather conditions, to the capsizing of the vessel. It was also confirmed that the crew was not properly trained on how to act during an emergency.															
<b>RECOMENDACIONES</b>															
As a result of the investigation, the CIAIM provided twenty recommendations directed at Public Administrations, at ship owners and crewmembers of fishing vessels, at shipyards, designers and Classification Societies. The common point in these recommendations is the oversight of modifications made to vessels and of the manner in which these are carried out.
